## **Risk Evaluation of Potential Coating Damage From HDD**

Ron Raphoon  
Raphoon, LLC  
2129 Farm to Market 2920  
Suite 190-319  
Spring, TX 77388

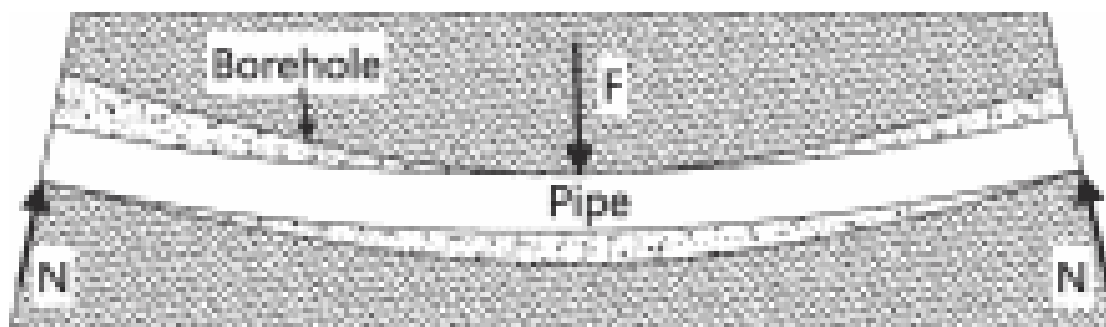
The result of damage from each cause can be numerous. For example, the overall design path of the HDD can cause abrasion damage, shearing of the coating, gouges in conjunction with the soil conditions, impacts to the elevated profiles, and cracking from excessive bending of the coatings. How does the design of a pipeline potentially cause abrasion damage? Even this one question has several potential sources of abrasion. First is the diameter of the bore hole, if it isn't sufficiently oversized, the pipe will travel along the surface of the hole as it is being pulled into place, this is clearly an abrasive issue. The second way that the design can abrade the pipe is by pulling it through sandy or loose soils that can mix with the drilling fluid. Having a sandy drilling fluid is similar to pulling the pipe through high grit sand paper. Another impact of the design that may lead to abrasion damage is from the angles within the drill. The angle of entry into the hole, or turning points within the hole can force the pipe to drag across the surface depending on the slope and length of the angle. In Fig 1 the curvature of the hole forces the pipe to slide along the sides at the points labelled F and N

Fig 1. Pipe in contact with bore hole surfaces

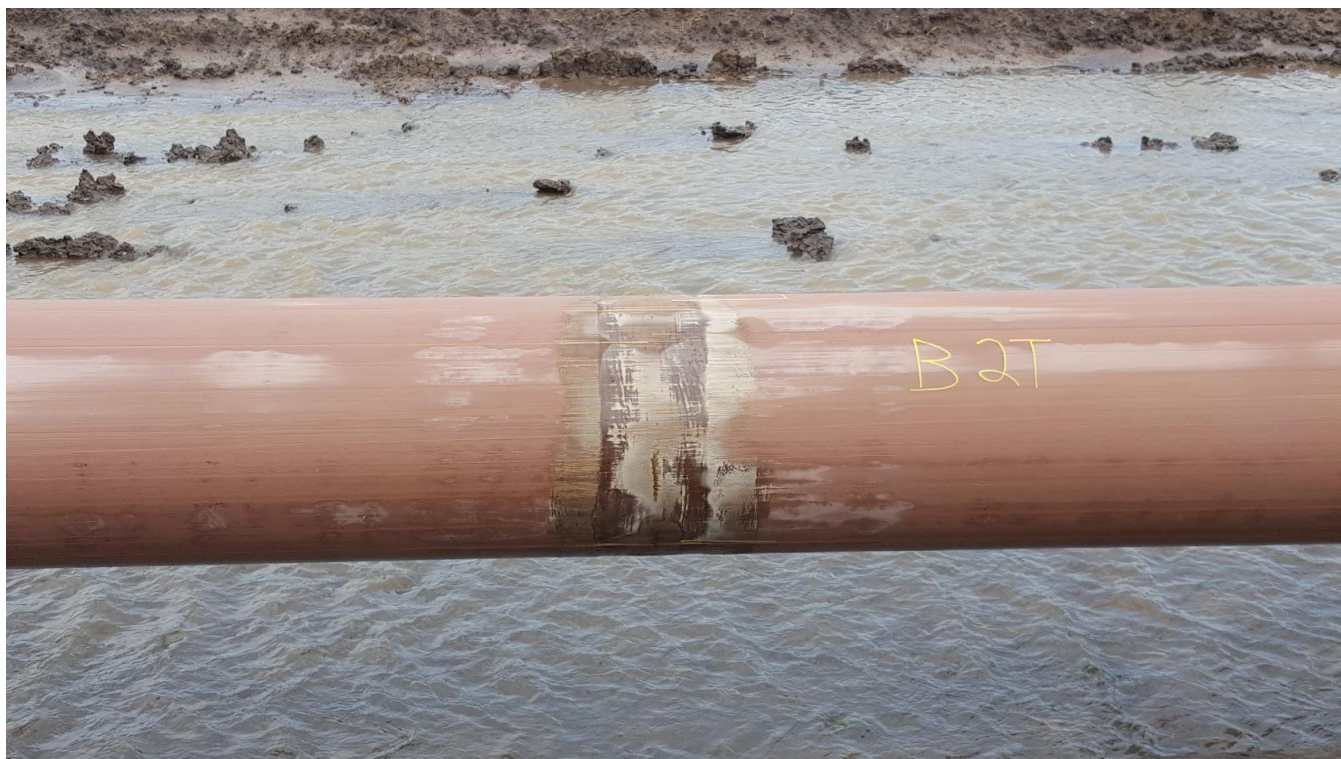
The results of abrasion in the hole look like Figure 2 where the coating has been smoothly sanded down. While there are multiple causes of abrasion from the HDD installation method, the good news is that industry wide, the generally accepted coating systems are well rated for abrasion specifically and in testing HDD coatings, a report from Hair<sup>1</sup> states:

Fig 2. Pipe with ARO showing abrasion wear
