**WHY HIRE AN INDEPENDENT, THIRD-PARTY INSPECTOR ON**

**HIGH PERFORMANCE COATINGS PROJECTS?**

Tim Bauman, Project Development Manager

### **CASE #1: "I Pressure Washed It"**

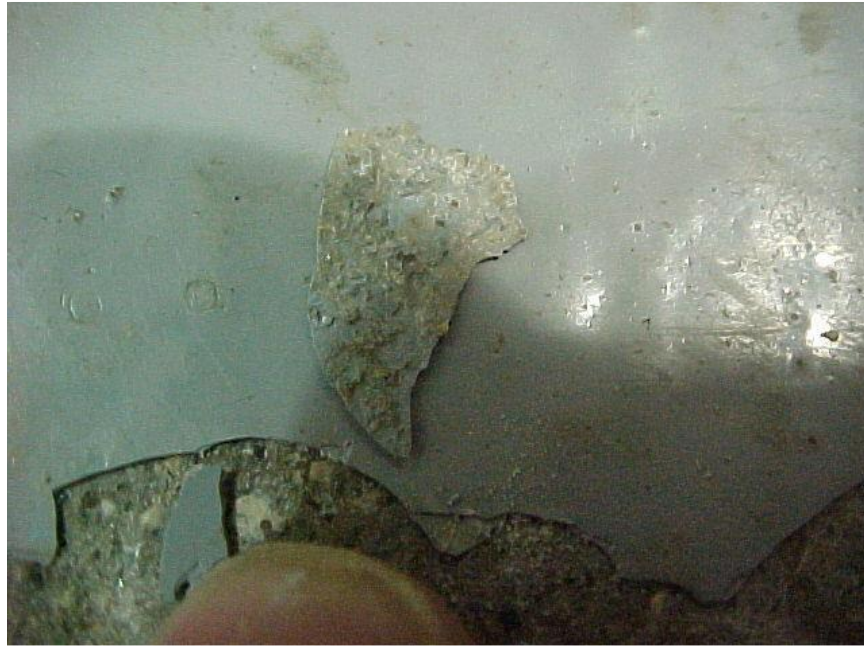
My first example take place in the hills of Pennsylvania at a rehabilitated water treatment plant where paint is delaminating from a below ground concrete wall. Twelve inches of concrete separate the failure from a lined filtration basin.

I was introduced to the painter by the sales rep and he could see I had a copy of the spec in my hands. I mentioned that the spec called for an SSPC-SP 13 and he looked at me realizing that I knew he did not abrasive blast the walls. He looked me in the eye and said, "I power washed the walls".

Now, because I have a lot of experience in this industry, I immediately – without even looking at the failed coating – knew what had happened.

We inspected the failed coating.
