# Seat Belt Restraint Evidence Generated in the Presence of Fractured Glass

Marie Moralde, Alan Dibb, Janine Smedley and Michael Carhart  
Exponent Inc

**CITATION:** Moralde, M., Dibb, A., Smedley, J., Carhart, M. et al., "Seat Belt Restraint Evidence Generated in the Presence of Fractured Glass," *SAE Int. J. Passeng. Cars - Mech. Syst.* 5(1):2012, doi:10.4271/2012-01-0084.

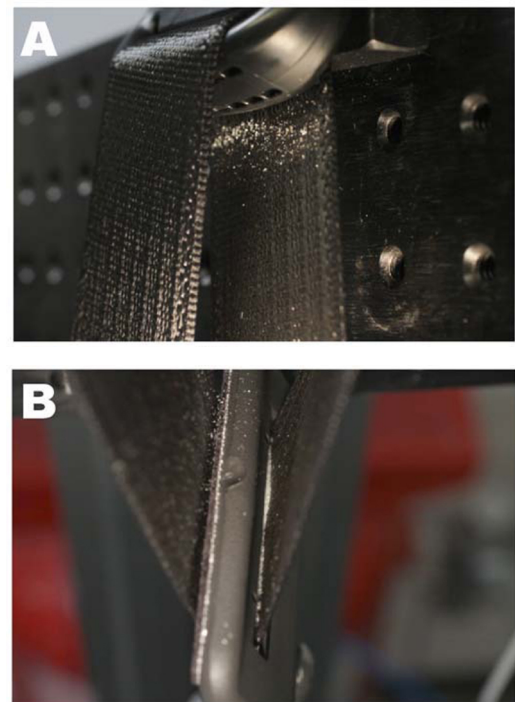
Figure 3. Photographs of glass fragments introduced on the webbing at D-ring (A) and latch plate (B).

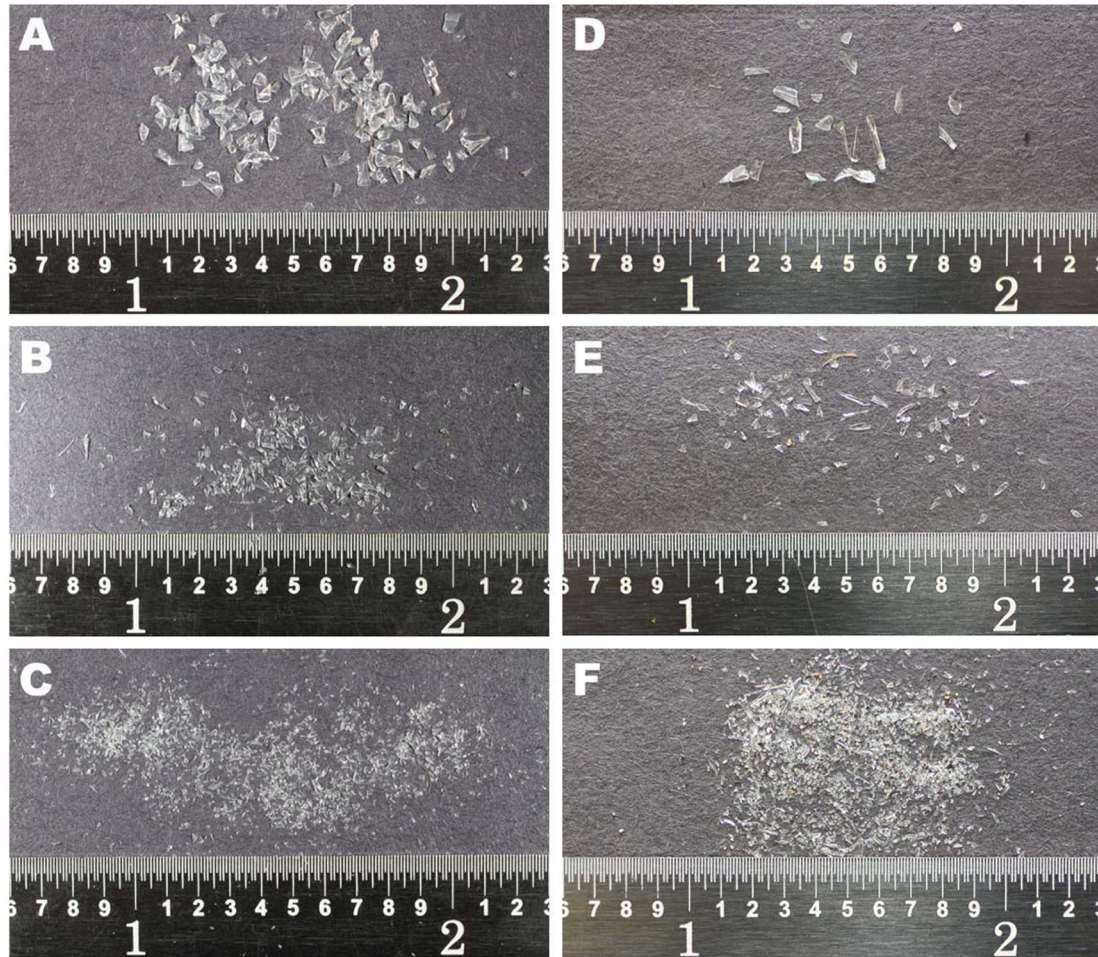
**Figure 5. Glass fragments (depicted scale in inches). Tempered safety glass (A) 425-850  $\mu\text{m}$ , (B) 250-425  $\mu\text{m}$ , (C) 106-250  $\mu\text{m}$ , and Laminated safety glass (D) 425-850  $\mu\text{m}$ , (E) 250-425  $\mu\text{m}$ , (F) 106-250  $\mu\text{m}$**

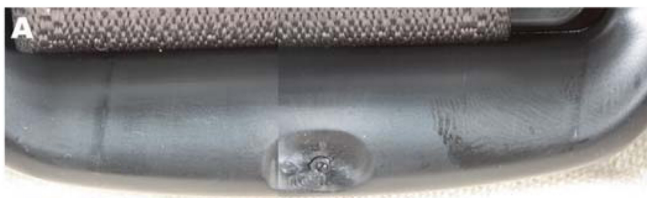
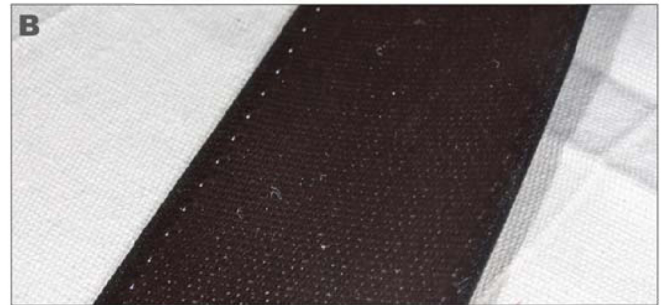
The SBLS pulse was of sufficient severity to produce loading evidence in the baseline test B1. The movement of the webbing across the D-ring produced abrasions from the webbing's finished edges at both ends of the D-ring's inboard load-bearing surface, and a few light abrasions between the edge striations (Figure 7A). No discernible abrasions or transfer of polymer were evident on the corresponding webbing surface that translated across the D-ring, although minor fiber disruption was seen (Figure 7B). Abrasions were observed on the body-facing side of the latch plate across the full webbing contact width. The abrasions were patterned in the form of the webbing weave, but did not exhibit any build-up (Figure 8A). No abrasions were observed on the non-body side of the latch plate. The corresponding webbing surface that translated across the latch plate exhibited linear abrasions and fiber disruptions (Figure 8B).

**Figure 7. Baseline test B1 results - inboard side of D-ring (A) and corresponding webbing (B)**

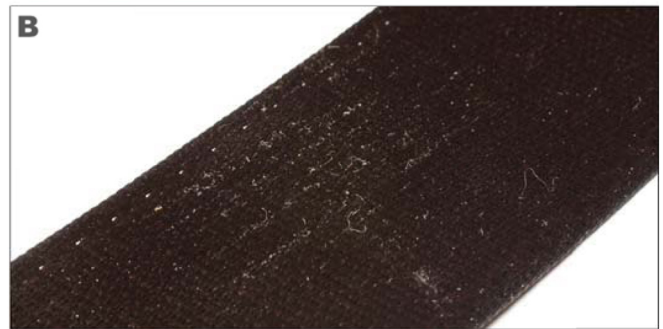
**Figure 8. Baseline test B1 results - body side of latch plate (A) and corresponding webbing (B)**

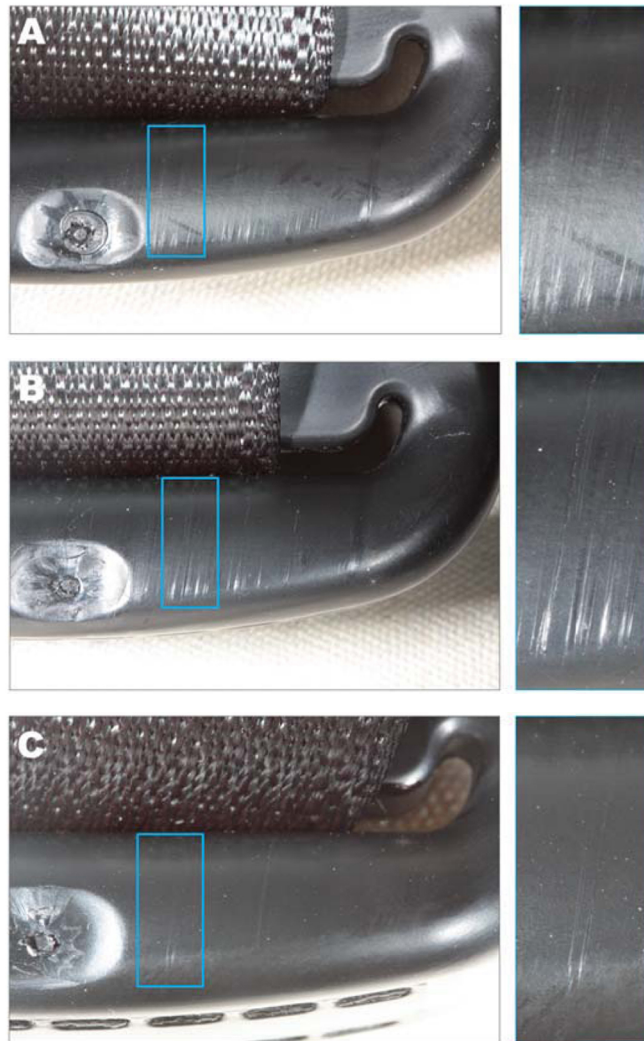
The tempered safety glass particles generated distinctive abrasions on the D-ring load-bearing surfaces, on both the inboard and outboard sides. The characteristics of the abrasions in the small and intermediate particle size tests

**Figure 9. D-ring abrasions generated by tempered glass fragments - (A) Small [Test G3], (B) Intermediate [Test G1], (C) Large [Test G2]**

were consistent with the size of the individual particles. The smallest particle size generated fine abrasions as compared to the slightly deeper and wider abrasions produced by the intermediate particle size. The correlation between the size of individual abrasions and the particle size was not observed in tests with the large particle size, which appeared lighter than even the small particle size abrasions. Figure 9 shows a comparison of the abrasions produced on the inboard load-bearing surface on the D-ring from the three glass particle sizes.
