# MAINTENANCE GUIDELINES FOR STEEL BRIDGES

Addressing Fatigue Cracking and Details  
at Risk of Constraint-Induced Fracture

G14.1-2021

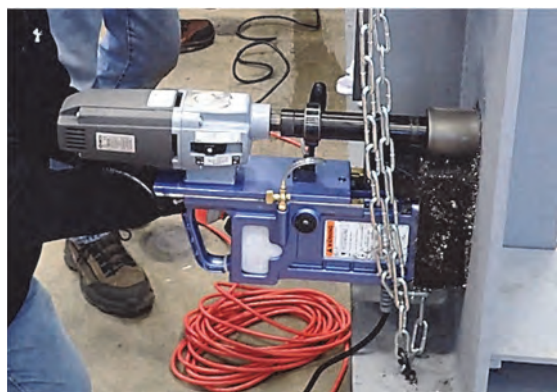
**Figure 3-1. (Left) Example of Magnetic-Based Drill, (Right) Annular Cutter Used for Hole Drilling**

The equipment recommended for hole drilling includes a magnetic-based drill and annular cutter, such as that seen in Figure 3-1. Although hand drills have been shown to be effective, even for larger diameter holes, when operated by trained and experienced crews, magnetic-based drills offer superb control and precision for a wide range of hole sizes. The greatest challenge can be positioning the drill in tight spaces where intersecting elements of a detail leave little room for the drill to seat properly.

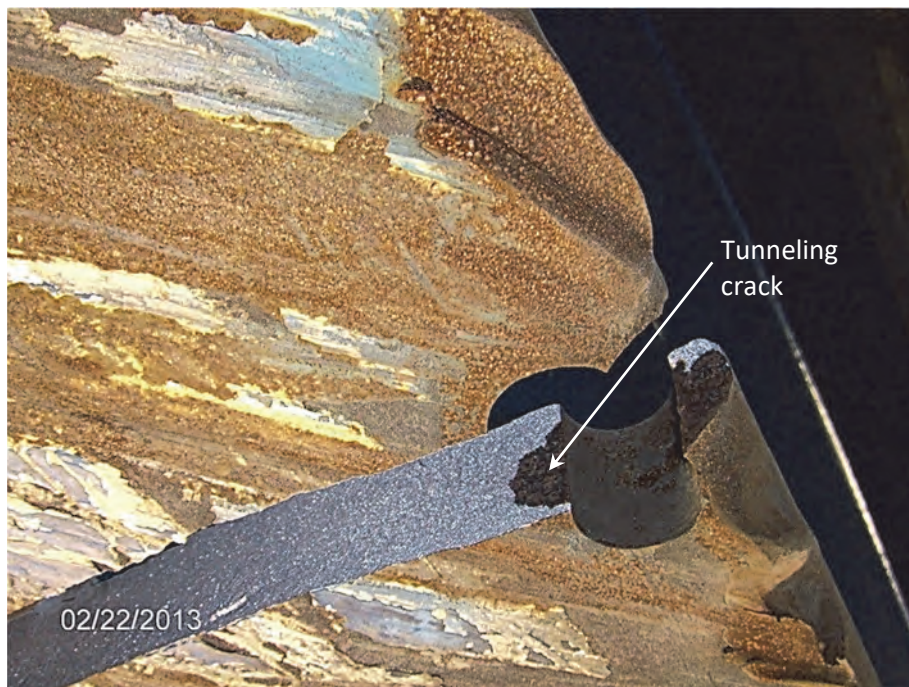
Figure 3-2. Crack Tip Tunneling Contributing to a Missed Crack Tip That Later Fractured

Crack tunneling can also contribute to missed crack tips if the engineer or technician is unaware of this phenomenon. Crack tunneling is the term used to describe the preferential advance of the crack tip at the center of a plate with the edges lagging behind. Additional triaxial restraint through the thickness of the plate can promote slightly quicker growth rates with a hidden leading edge, particularly in thicker plates. An extreme example of crack tunneling is shown in Figure 3-2, where a drilled hole was installed to attempt to arrest a crack caused during an impact event. The corroded surface indicates the extent of the previous crack, and the bright silver surface indicates the new fracture that propagated instantaneously during another impact event some months later. Notice that the previous crack tunneled ahead of where it breaks the surface of the plate. Furthermore, surface inspection methods such as MT or PT could not have detected the leading crack tip toward the middle of the plate thickness; UT could have been used to detect it, however.

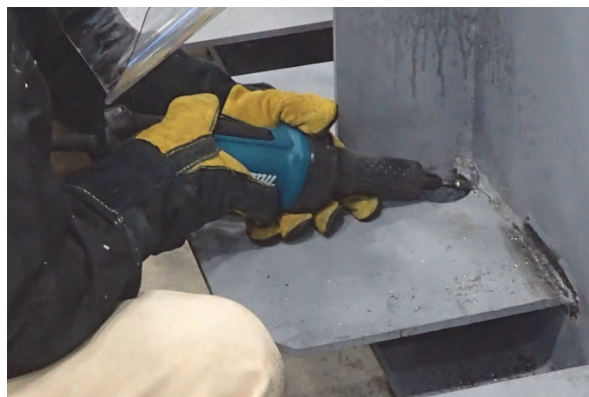
Figure 3-10. Typical Angle Grinder with Flap Wheel      Figure 3-11. Typical Die Grinder with Burr Bit

There are two main types of handheld grinders, angle and die. Grinding wheels for the angle grinder typically come in either 4.5- or 9-inch diameters and a wide range of types and grits. Also called a disc grinder, the angle grinder can also be used to quickly cut steel when using a cutting wheel. An example of an angle grinder is shown in Figure 3-10 paired with a flap wheel for sanding. A typical die grinder is shown in Figure 3-11 fitted with a rotary burr bit for rough grinding. The die grinder typically uses much smaller abrasive wheels and cutting wheels than the angle grinder, as well as carbide rotary burrs, allowing for access to smaller spaces. The angle grinder, although more difficult to get into tight spaces, has the advantage of faster material removal.
