# Erosion of Concrete in Hydraulic Structures

## Reported by ACI Committee 210

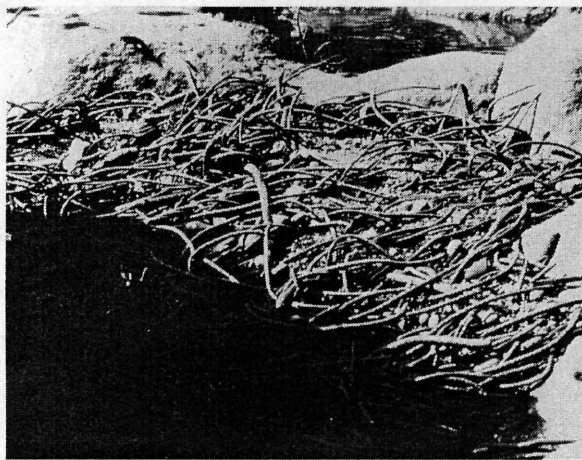
Fig. 3.3-Typical debris resulting from abrasion erosion of concrete

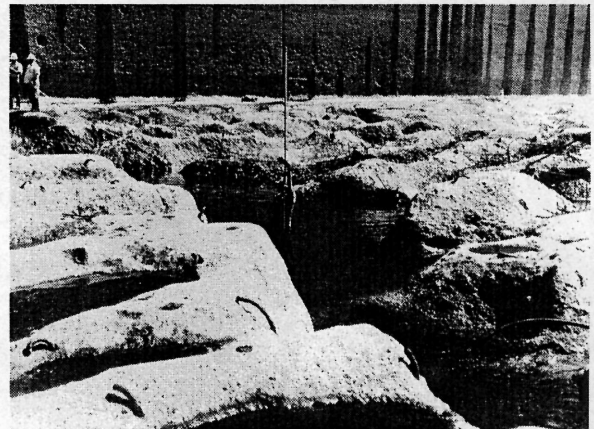
Fig. 3.4-Erosion of stilling basin floor slab, Dworshak Dam

A typical stilling basin design includes a downstream sill from 3 to 20 ft (1 to 6 m) high intended to create a permanent pool to aid in energy dissipation of high-velocity flows. Unfortunately, in many cases these pools also trap rocks and debris (Fig. 3.3). The stilling basins at Libby and Dworshak Dams, high-head hydroelectric structures, were eroded to maximum depths of approximately 6 and 10 ft (2 and 3 m), respectively. In the latter case, nearly 2000 yd<sup>3</sup> (1530 m<sup>3</sup>) of concrete and bedrock were eroded from the stilling basin (Fig. 3.4). Impact

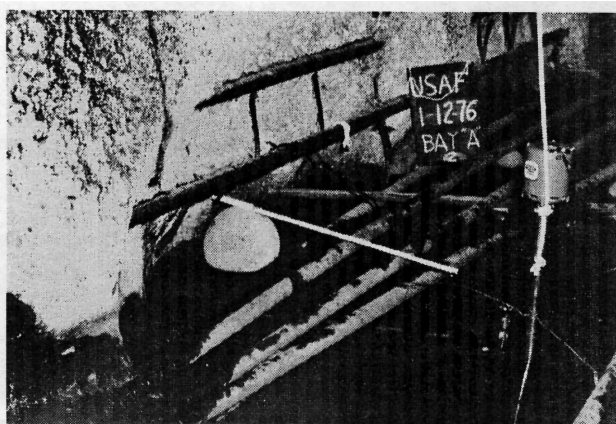
**Fig. 3.6-Abrasion erosion damage to discharge lateral: Upper St. Anthony Falls Lock**

Hydraulic structures other than spillways are also subject to abrasion erosion damage. When Upper St. Anthony Falls navigation lock was dewatered to repair a damaged miter gate, an examination of the filling and emptying laterals and discharge laterals revealed considerable abrasion erosion (Fig. 3.6). This erosion of the

concrete to maximum depths of 23 in. (580 mm) was caused by rocks up to 18 in. (460 mm) in diameter, which had entered the laterals, apparently during discharge of the flood of record through the lock chamber. Subsequent filling and emptying of the lock during normal operation agitated those rocks, causing them to erode the concrete by grinding.
