# Parking Structure Structural Maintenance—Guide

Reported by ACI Committee 362

ACI PRC-362.2-21

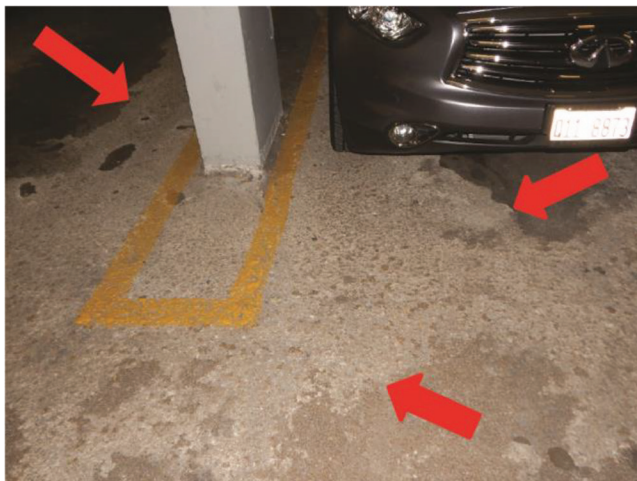
Fig. 2.1.1—Area of scaling on concrete surface.

**2.1.1 Scaling**—Scaling is the disintegration of cement paste at the surface of a concrete member or slab. It is commonly associated with saturated concrete that has inadequate air entrainment and experiences cycles of freezing and thawing. Scaling can result in progressive deterioration of a concrete structure or member. Severe scaling can result in a loss of concrete surface integrity to depths of more than 1 in. (25 mm). Scaling in deck slabs can create depressions that pose tripping hazards and create ponding areas that can lead to further deterioration (Fig. 2.1.1).

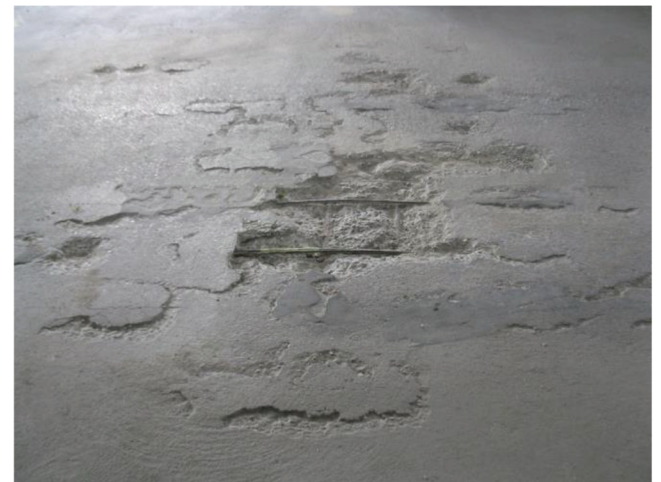
Fig. 2.1.2—Corrosion of reinforcement can lead to the formation of delamination and spalling of concrete.

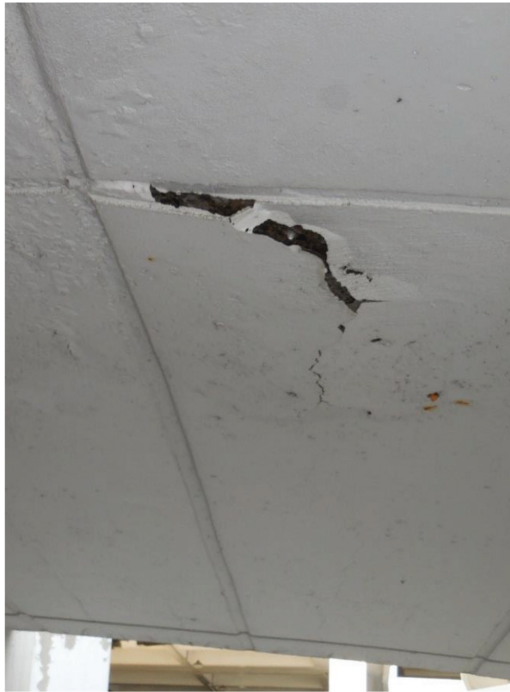
Fig. 2.1.3—Loose delaminated concrete on slab underside.

usually resulting from corrosion of the embedded reinforcing steel. Extensive concrete delaminations (greater than 5 to 10 percent of the surface area delaminated or spalled) are an indication of advanced deterioration. Delamination on the underside or soffit of a parking deck (slabs or framing members) can be a safety hazard due to the possibility of the delaminated concrete becoming loose and falling. Refer to Fig. 2.1.3.

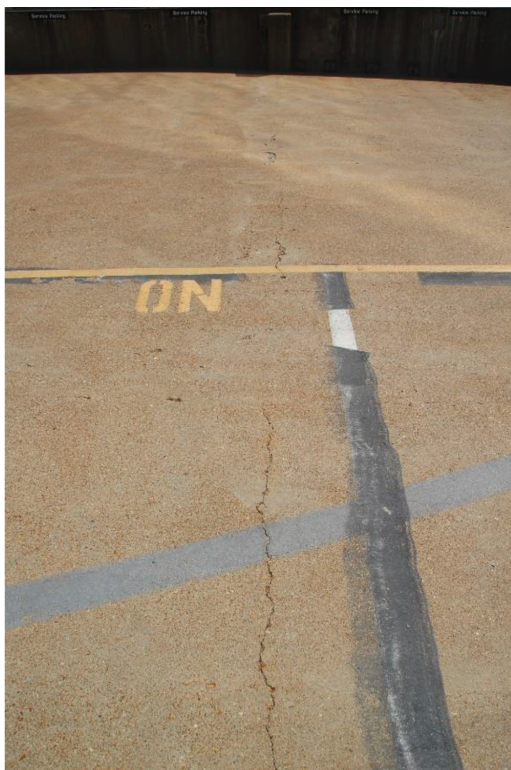
Fig. 2.1.5—Cracks in concrete allow accelerated absorption of water and chlorides.

Detrimental cracks can be construction- or service-related (Fig. 2.1.5). Construction-related cracks can be caused by rapid moisture loss due to improper curing, placing, or finishing practices. Cracking can also be caused by corrosion of embedded metal. Service-related cracks can result from thermal movement, structural loads, or differential settlement. Cracks can lead to leaking, leaching, corrosion, and delamination. Regardless of their cause, cracks should be investigated and, if necessary, repaired promptly, especially if they are leaking, to reduce the possibility of future deterioration. Refer to ACI 546R and ACI 562 for additional information.

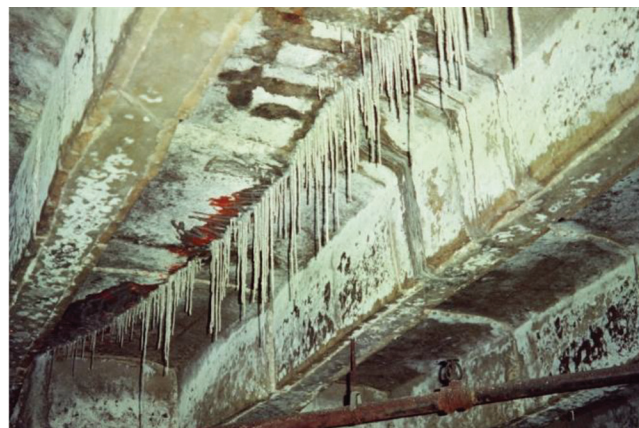
Fig. 2.1.7—Leaking and leaching can result in extreme deterioration conditions if cracks are not sealed.

**2.1.7 Leaching**—Leaching occurs when water passes through cracks or the concrete itself, dissolving the cement constituents and transporting them to the concrete surface where dripping or evaporation occurs. The dissolved constituents precipitate at the surface as the water evaporates, appearing as efflorescence or as calcareous deposits on the surface of the concrete. The dissolved constituents can combine with each other or with atmospheric chemicals. One common example is calcium carbonate, which is produced by atmospheric carbonation of calcium hydroxide leachate. Mineral deposits can also form along cracks as crystals, stalactites, or stalagmites below where water with dissolved minerals passes through slab cracks for extended periods. (Fig. 2.1.7).

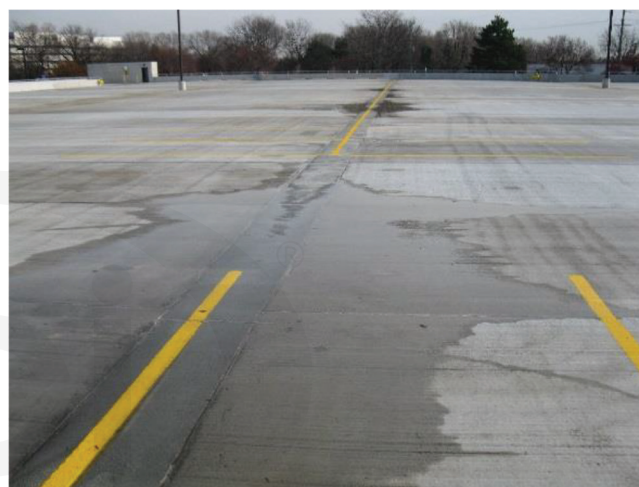
Fig. 2.1.8—Ponded water can contribute to leakage problems and lead to accelerated deterioration.

**2.1.8 Ponding**—Ponding (Fig. 2.1.8) can be a cause of deterioration because of the concentrating of water and deicing salts. The presence of standing water for extended

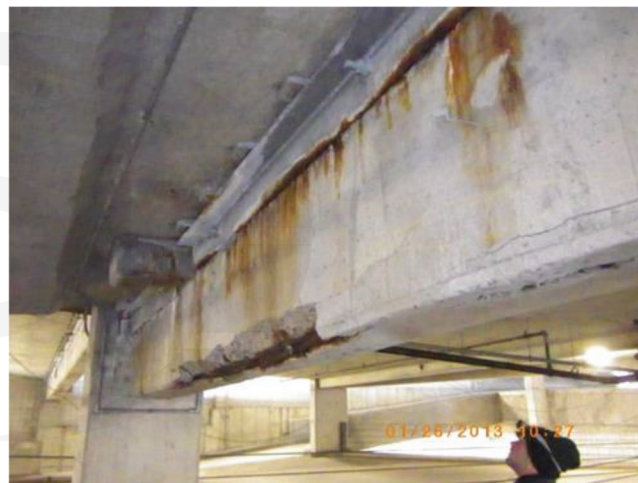
Fig. 2.2.2a—Delamination and spalling on beam beneath leaking expansion joint.

Beams and columns adjacent to and below expansion joints are especially susceptible to deterioration if the joint seals are not properly maintained (Fig. 2.2.2a). Failed joint seals allow water to run down the faces of beams and columns, which can result in delaminations and, potentially, a reduction in the member capacity. Beam and column deterioration can be minimized by maintaining joint sealant systems, and by applying sealers and elastomeric membranes on the deck surfaces above and on column concrete and bumper walls just above the deck surface. Connections of exposed steel elements and members containing embedded steel connections should be inspected regularly for corrosion and distress, and any protection provided for those connections should be maintained.
