# IN NON-DESTRUCTIVE TESTING OF CONCRETE

# **Innovations in Nondestructive Testing of Concrete**

**SP-168**

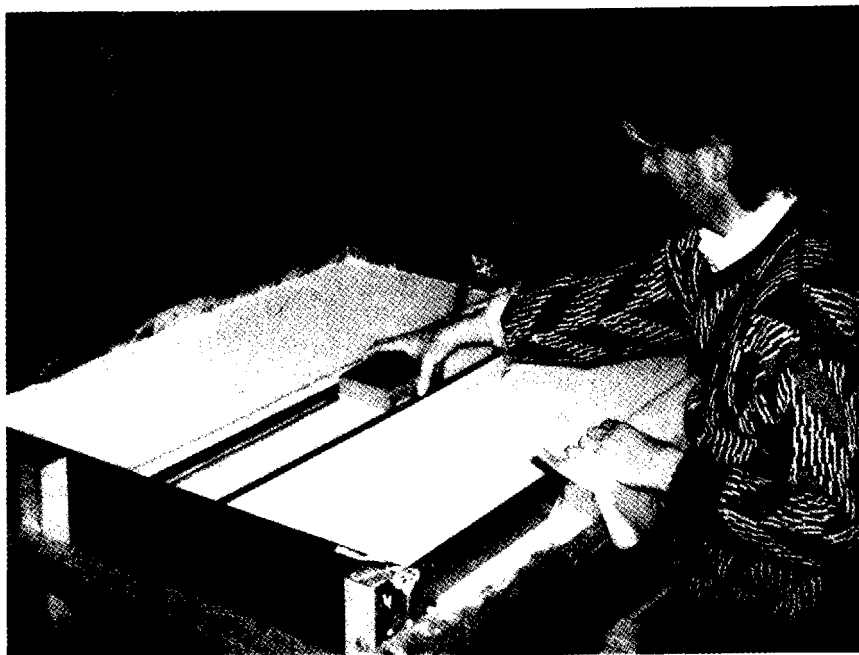
Fig. 1—Emulsion simulation tank with 1 GHz transducer

Changing the transducer orientation by  $90^\circ$  to that shown in figure 1 will significantly reduce the response obtained from transverse bars and is recommended if their effect is to be minimised when seeking other, deeper, features. Bars running parallel to the scan direction have also been demonstrated to have a constant and minor affect upon the ability to detect transverse bars even when directly under the antennas unless their diameter exceeds that of the transverse bars being sought. It is nevertheless recommended that scan lines should be located midway between bars if possible.
