# LARGE-SCALE STRUCTURAL TESTING

# Large-Scale Structural Testing

# **Fatigue Testing of Two Full-Size Pre-Cracked AASHTO Bridge Girders**

# **Full-Scale Testing of Wacker Drive Viaduct Prototype**

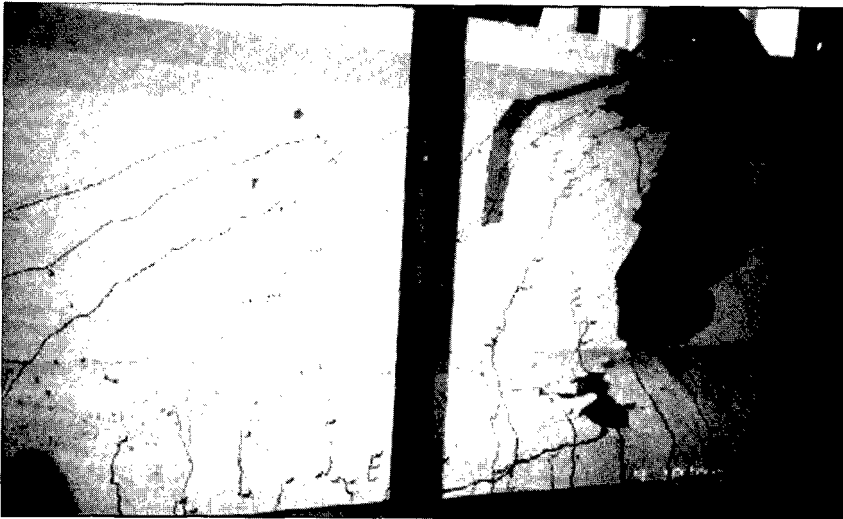
Figure 6 A View of Type V Girder after Failure

A similar behavior was observed for the Type V girder. As the ultimate load was reached at 1,680 kN (377 kips), the top flange failed in compression at about 0.91 m (3 ft.) from the midspan. Immediately following the crushing of the top flange, the web also crushed explosively. A view of the girder after failure is shown in Fig. 6.

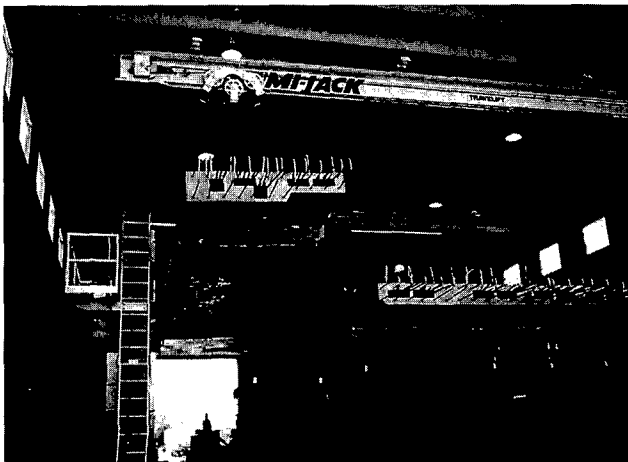
Figure 11. Positioning of segments by crane prior to bonding together

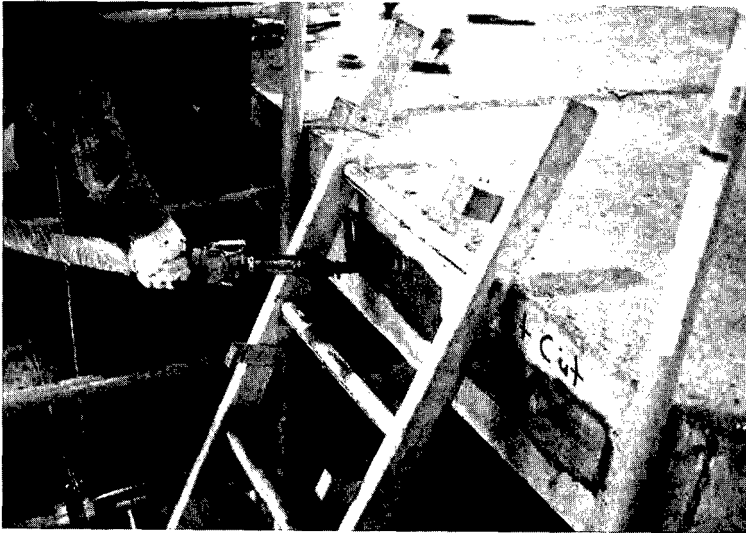
Figure 13. Grouting of post-tensioning ducts

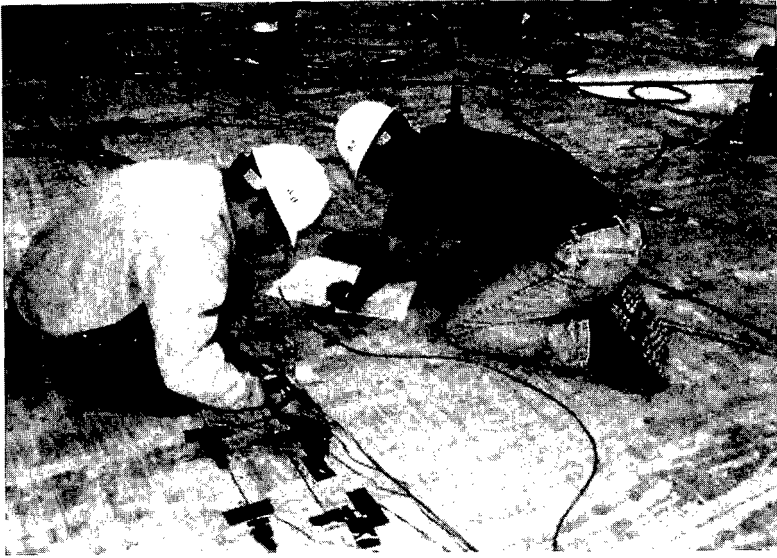
Figure 16. Whittemore gage locations for measuring strain by mechanical means
