# Seismic Retrofit of Reinforced Concrete Beam-Column T-Joints in Bridge Piers with FRP Composite Jackets

by C.P. Pantelides and J. Gergely

# Performance of an RC Corner Beam-Column Joint Severely Damaged under Bidirectional Loading and Rehabilitated with FRP Composites

# Experimental Evaluation of Noncircular Reinforced Concrete Columns Strengthened with CFRP

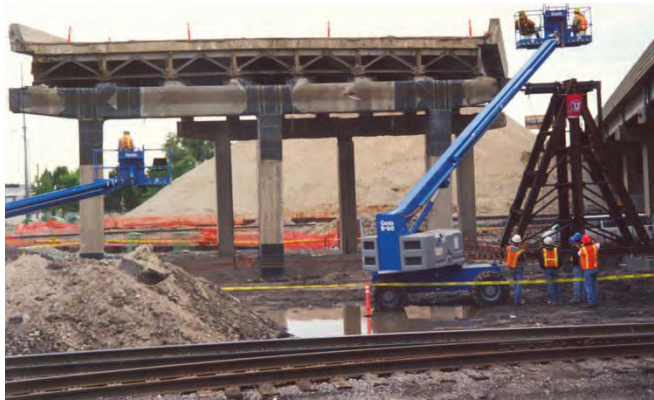
Figure 7 - In-situ lateral load test of bridge pier – 1998 tests.

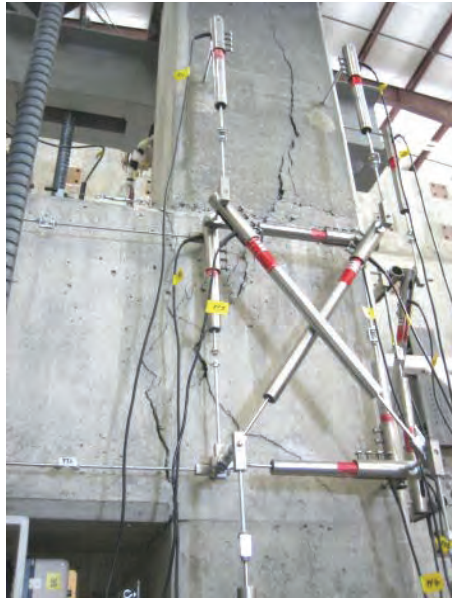
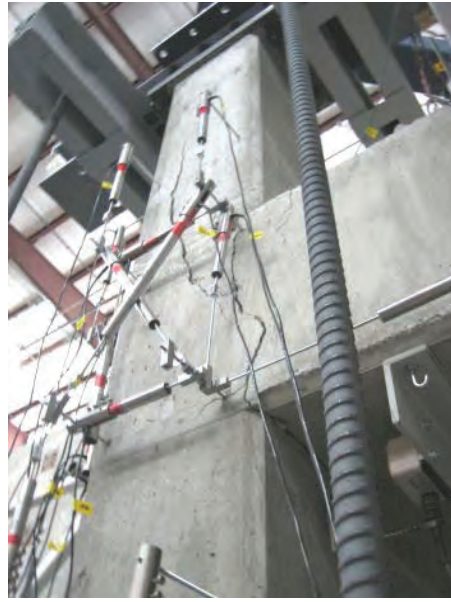
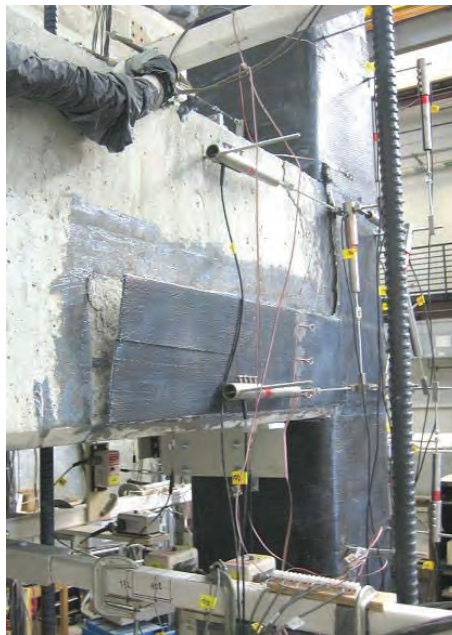
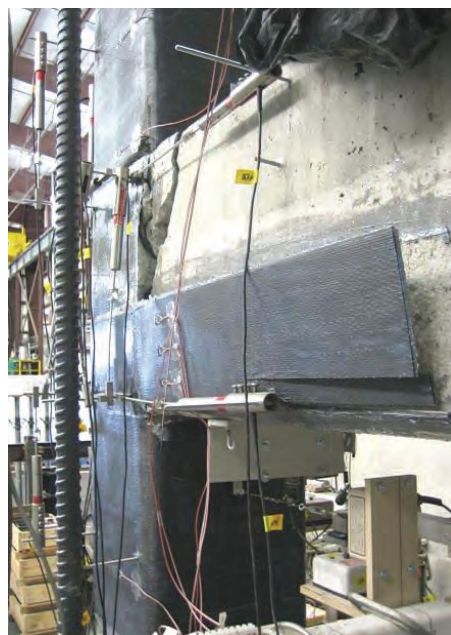
Figure 5 — Damage at the end of test: (a, b) before rehabilitation at cycle point 12a, and (c, d) after rehabilitation at cycle point 15a.

3. Joint shear cracking during the negative load steps. [Figure 5](#) shows that diagonal cracking in the joint occurred in one direction only and not in the often recorded "X" manner, because the loss of anchorage of the beam bottom bars prevented the formation of the other diagonal crack. The maximum width of the joint shear cracks was 0.04 in. (1.0 mm) during the unidirectional cycles. During the bidirectional cycles, they not only opened wider in the plane of the joint panel, but they also exhibited bulging in the direction perpendicular to the surface due to rotation of the hooked beam top bars. At the second peak at  $-0.93\%$  bidirectional drift, these cracks had joined those at the bottom of the beam and reached a width of 0.07 in. (1.8 mm) to 0.08 in. (2.0 mm).
