SP-282—1

## Measurement of TSS and Other Pollutant Removal by a Pervious Concrete System

# **Field Performance of Portland Cement Pervious Concrete Pavement in Cold Weather Climates**

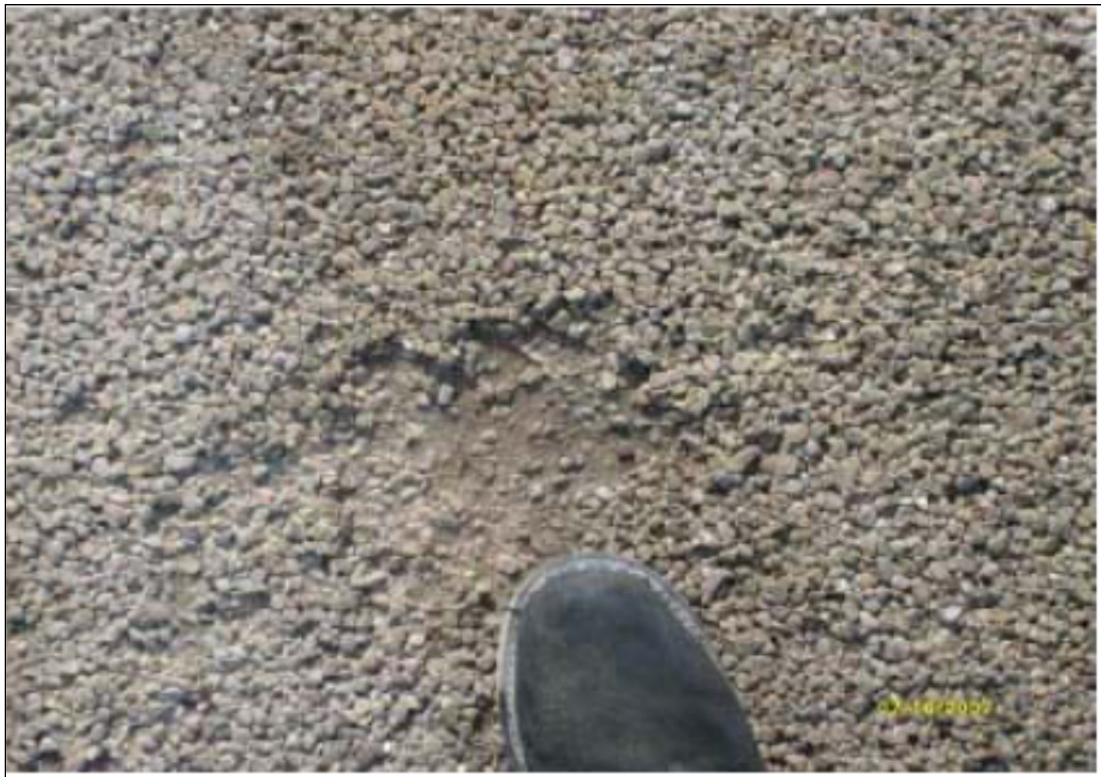
The extent of raveling on the surface and along joints was observed and described as minimal, medium (significant) or high (extensive). The surface was also examined for cracks and visual indications of clogging. Owners were questioned about maintenance. Raveling is shown in figure 1.

**Figure 1 – example of raveling**

Most of the sites had areas that were slightly deteriorated and had some missing aggregate. Raveling of aggregate occurs when the aggregate to paste bond is broken, and the aggregate is dislodged from the pervious concrete matrix. Raveling is shown in figure 1. There were few sites that did not show areas of raveling, and the site with the most raveling was at Indian Run Falls in Dublin, Ohio. This site also had the lowest water to cementitious materials ratio, which was 0.21. The w/cm ratio on the sites visited ranged from the 0.21 at Indian Run Falls, to 0.35 at Merry Lea Environmental Learning Center of Goshen College, in Albion, Indiana.

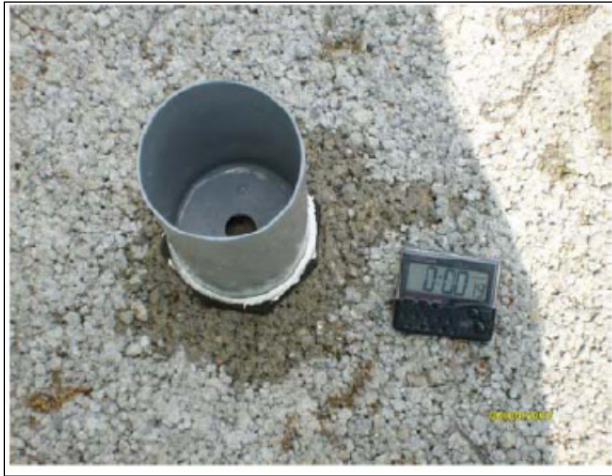
A simple surface hydraulic conductivity/infiltration apparatus for surface drainage was developed as part of this research. The equipment was made from a 4 by 8 inch (100 by 200 mm) plastic concrete cylinder mold. Foam rubber was attached to the bottom of the plastic mold to try to seal the cylinder against the pavement, and a hole was drilled for water to flow out with a diameter of 7/8 inch (22 mm). The time to drain the cylinder into the pavement

through the hole was measured. Care should be taken not to allow water to freely flow around the perimeter of the mold. Thus, constant pressure should be applied on top of the mold during testing. The test may be used before and after maintenance to quantify the effectiveness of a maintenance technique. The apparatus is shown in figure 2.

**Figure 2 – surface hydraulic conductivity/infiltration apparatus**

A smaller size diameter spot is observed if it takes less than a minute to drain the cylinder, and in some instances no water is observed around the cylinder. This phenomenon usually occurs with test times between 13 and 20 seconds. A small diameter spot is shown on the left side of figure 2.

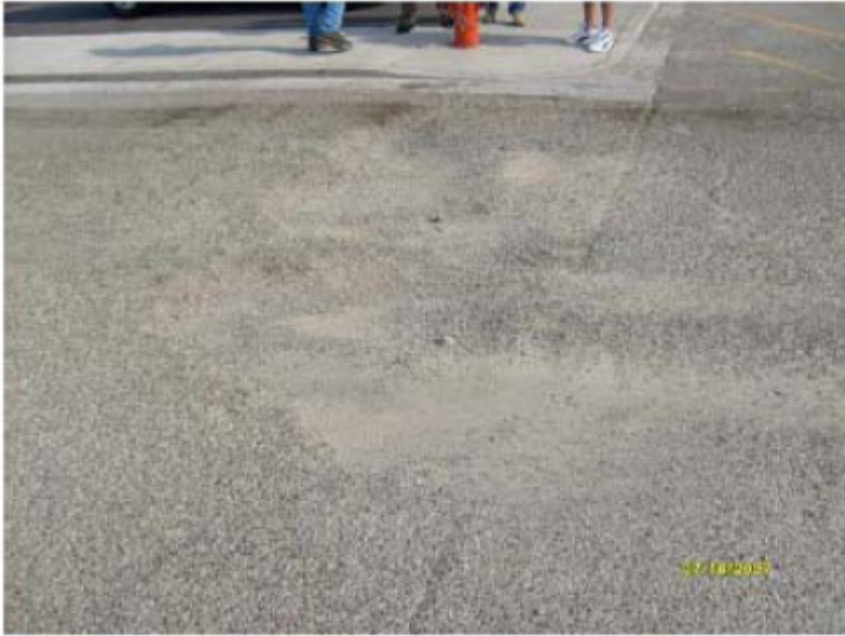
Major causes of cracking were heavy vehicle traffic, lack of contraction joints, or a large distance between joints. Joint spacing should probably follow recommendations for conventional concrete until rules for PCPC joint spacing can be developed. Figure 12 shows an example of heavy vehicle damage.

Figure 12 – Heavy Vehicle Damage

Six of the sites that were visited showed signs of cracking. The cracking in two cases came from heavy vehicular traffic. One case was in Gary, Indiana, at a Charter School where the local fire department fills the water tank on the truck at the hydrant, and food and other materials are brought in by delivery trucks and semi trucks. The second site

was located in Monroe, Ohio, at Ball Brothers Contracting. The pervious concrete was used as a storage area for large, heavy concrete forms. Heavy vehicles drive daily onto this pervious concrete to load and unload forms from the trucks. Skid steers and fork lifts are also used. At Boone County Farmer's Market in Burlington, Kentucky, a crack occurred due to small landscaping dump trucks and other vehicles parking for long periods of time. One other site had cracks due to a lack of construction joints along an 80 foot (24.4 meter) length (Kuert Concrete, South Bend, IN). Another crack occurred due to difficulty in placement and possibly an overly wet mixture (Merry Lea, Albion, Indiana).
