# **Serviceability and Safety: Core Aspects of Sustainable Structures**

**Andrea J. Schokker**

# Impact of Adjacent Lane Traffic on the Serviceability of Concrete Bridge Decks

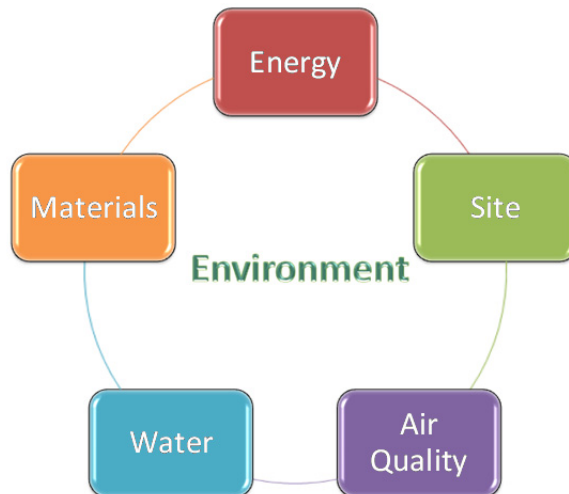
*Fig. 1—One representation of the environmentally related components for buildings (Schokker, 2010).*

Environmental issues related to sustainable building design and construction can be grouped in various ways. Fig. 1 illustrates a grouping that aligns with LEED (Leadership in Energy and Environmental Design) for building construction.

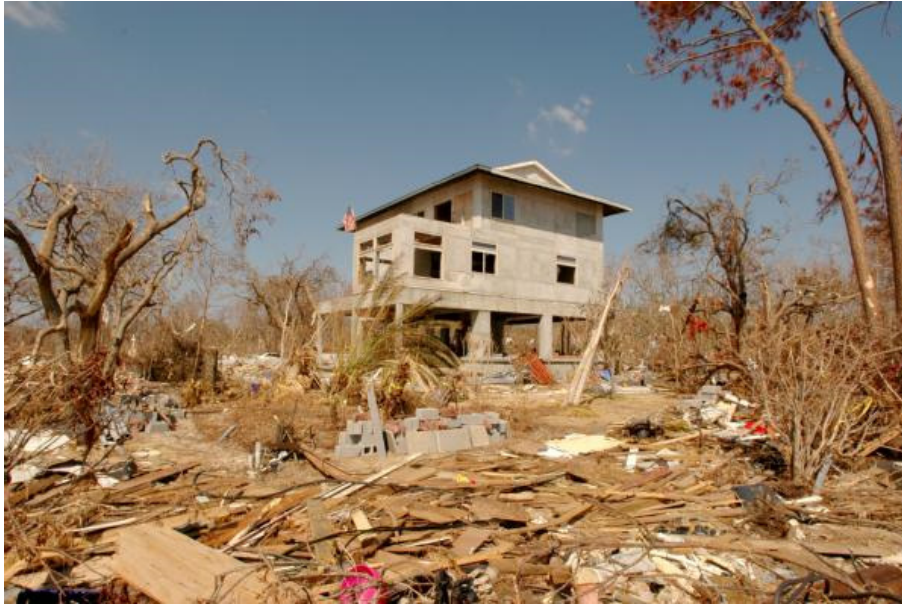
*Fig. 3—This concrete house (under construction during hurricane Katrina) was the only house left standing in the neighborhood (photo courtesy of John Fleck, FEMA)*

*Wind and Water*—Heavy rainfall events, wind storms, hurricanes and tornados can leave structures devastated. Concrete structures perform well under these conditions due to their ability to resist high winds. The concrete can also remain uncompromised even after submersion in water for extended periods of time. While mold and rot are a concern with many materials, concrete resists both and thus not only positions a structure to go quickly back into service, but also reduces health concerns related to the removal of molded or rotted materials. Fig. 3 shows a concrete house after hurricane Katrina. The high water mark on the house was 28 feet (8.5 m) above the base of the structure and the house was the only one left standing in the neighborhood. Fig. 4 shows a board impaled in a concrete wall after a tornado in Georgia. Concrete walls can be very effective in protecting occupants from flying debris.

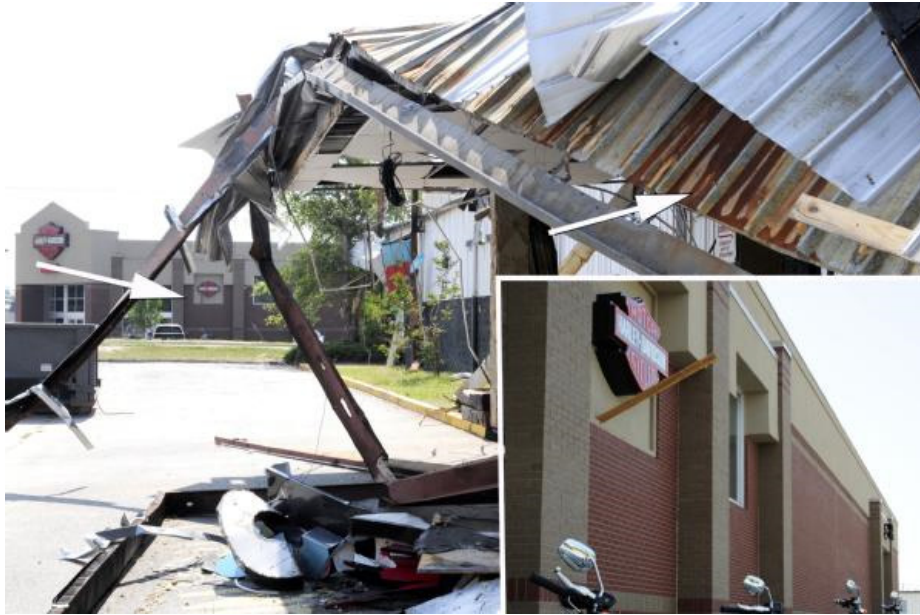
Fig. 4—During a tornado in Georgia, this awning was ripped apart and board was impaled into an adjacent concrete wall (inset) (photo courtesy of Mike Moore, FEMA)

**Blast and Impact**—Design for blast and impact loads has become more prevalent in the past decade as concerns rise about potential terrorist attacks. Mass concrete is a popular choice for barriers to resist blast and impact. Properly detailed concrete elements can effectively resist blast load damage as well as reduce the potential for shrapnel from failed portions of the structure. The “United Facilities Criteria: Structures to Resist the Effects of Accidental Explosions” gives details on blast resistant design (U.S. Department of Defense, 2008). Concrete spalls on the interior side of walls can also be resisted through the use of innovative fibers particularly for this purpose (Coughlin et al, 2010).

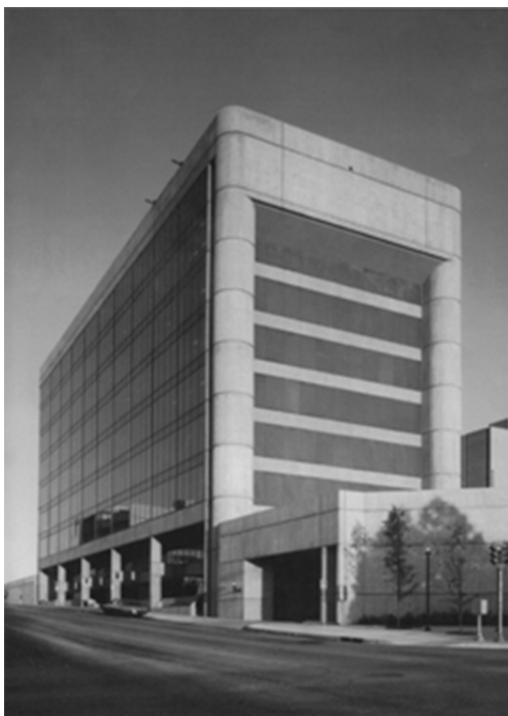
*Figure 1: Murrah Building prior to Attack*

The Murrah building project consisted of a nine-story office building (hereafter referred to as the Murrah building) along with one-story ancillary east and west wings and an adjacent multi-level parking structure south of the office building, partially below grade and partially above grade. This project was designed in the early 1970's and construction was completed in early 1976. Following the attack, the investigation focused on the nine-story portion of the Murrah building. Primary effects of the blast occurred along the north face, where the bomb was located at street level. The nine-story and one-story portions were demolished shortly after the blast and completion of investigations. The parking structure was barely damaged and was not demolished. Figure 1 shows the Murrah building prior to the attack.

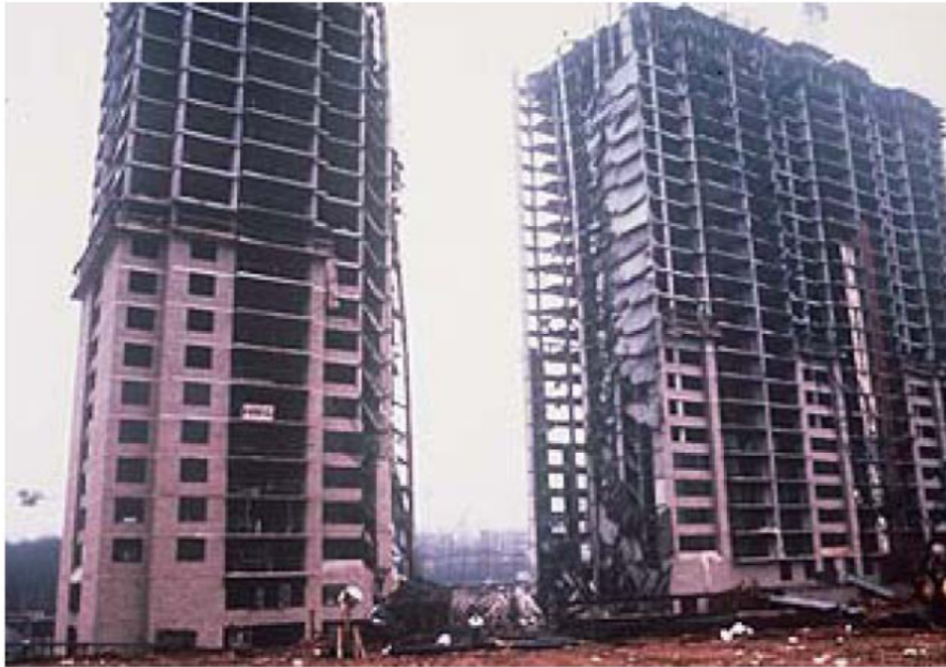
Figure 3 – Skyline Plaza/ Bailey's Crossroads Collapse (photo courtesy Nick Carino of NIST)

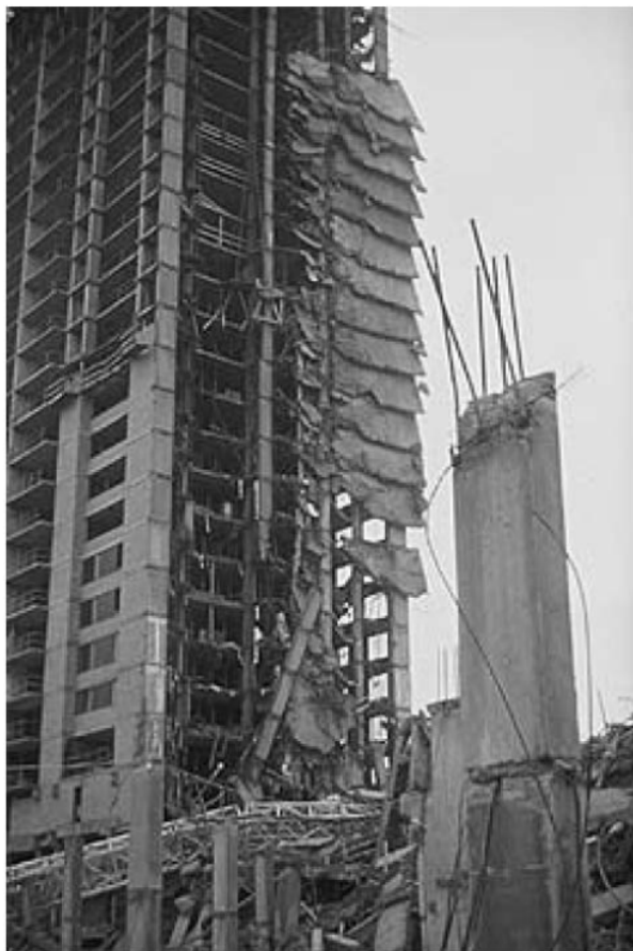
Figure 4 – Skyline Plaza/ Bailey's Crossroads Collapse (photo courtesy Nick Carino of NIST)

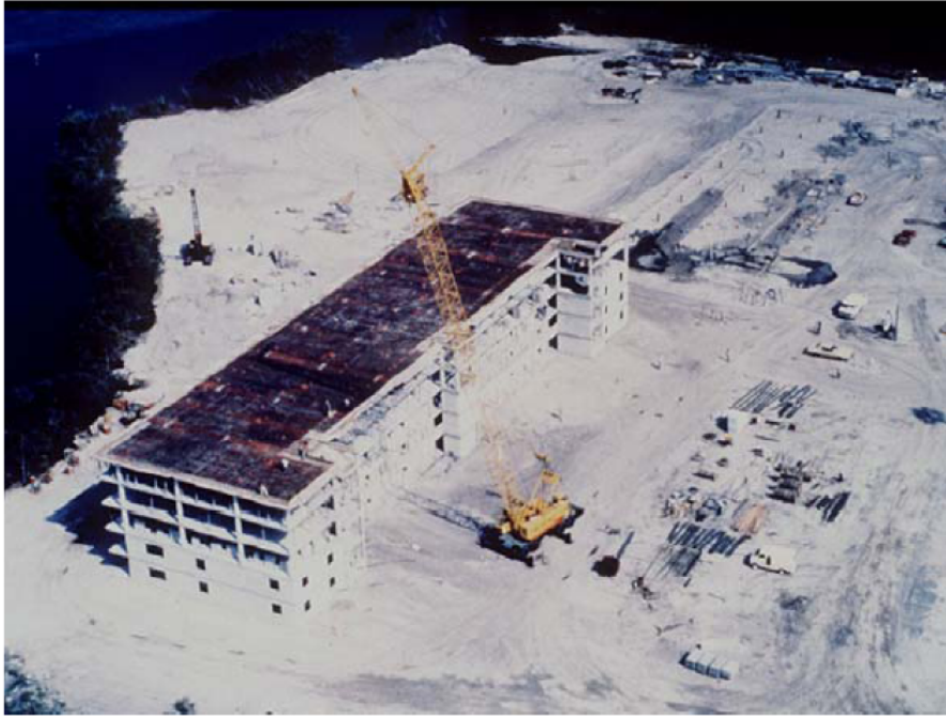
**Figure 5 – Harbour Cay Condominium before Collapse (photo courtesy Nick Carino of NIST)**

The third punching shear case study was the collapse of the Harbour Cay Condominium on March 27, 1981 in Cocoa Beach, Florida. Eleven workers were killed and 23 were injured. The condominium was five stories tall, with shoring at all levels (Fig. 5). When the forms were removed, the structure collapsed completely with all floors pancaking to the ground (Fig. 6).

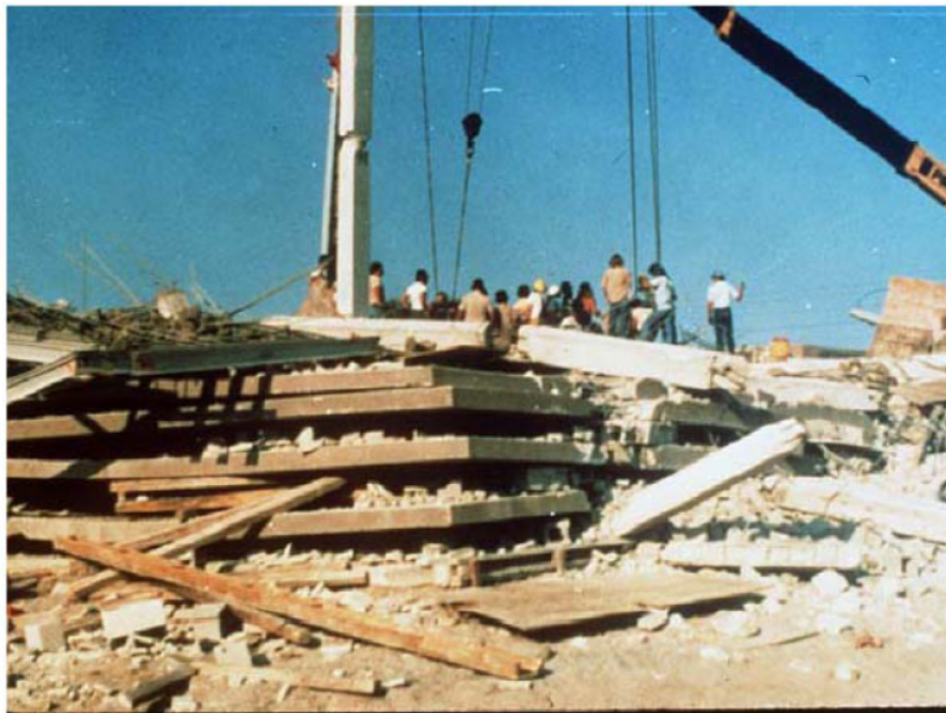
**Figure 6 – Harbour Cay Condominium Collapse (photo courtesy Nick Carino of NIST)**
