## Experimental Investigation of FRCM-Concrete Interfacial Debonding

Lesley H. Sneed, Tommaso D'Antino, and Christian Carloni

**Synopsis:** This paper presents the results of an experimental study conducted to understand the stress-transfer mechanism of fiber reinforced concrete matrix (FRCM) composites externally bonded to a concrete substrate for strengthening applications. The FRCM composite was comprised of a polyparaphenylene benzobisoxazole (PBO) fiber net and polymer-modified cement-based mortar. Direct shear tests were conducted on specimens with composite strips bonded to concrete blocks. Parameters varied were composite bonded length and bonded width. Results were analyzed to understand the effective bonded length, which can be used to establish the load-carrying capacity of the interface to design the strengthening system. The normalized load carrying-capacity was plotted against the width of the composite strip to study the width effect. Finally, strain gage measurements along the bonded length were used to investigate the stress-transfer mechanism.

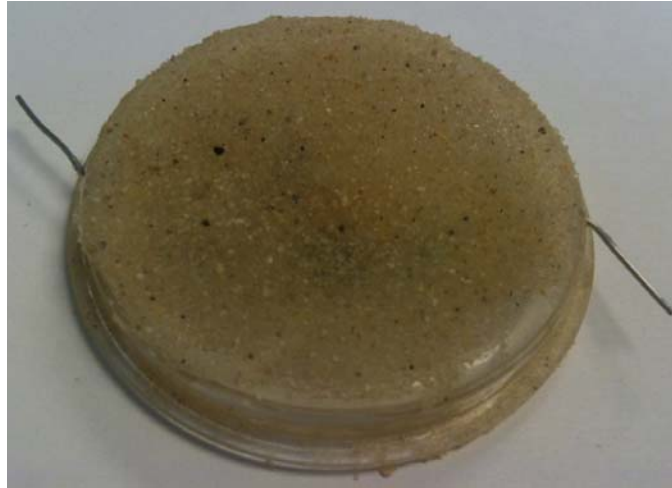
**Figure 1**—Moisture sensor

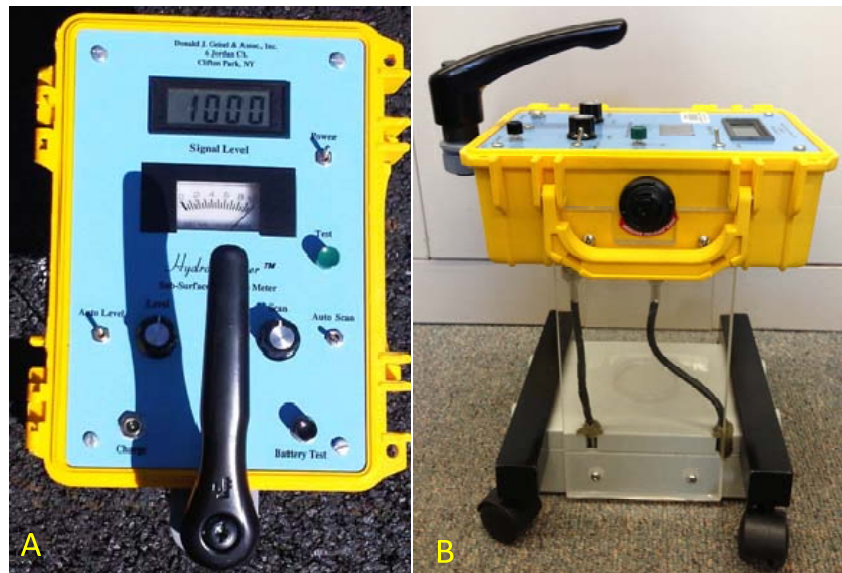
**Figure 2**—Scanning device A) Top view B) Profile view
