## Durability and Sustainability of Concrete Structures – Workshop Proceedings

SP-305

# Durability and Sustainability of Concrete Structures – Workshop Proceedings

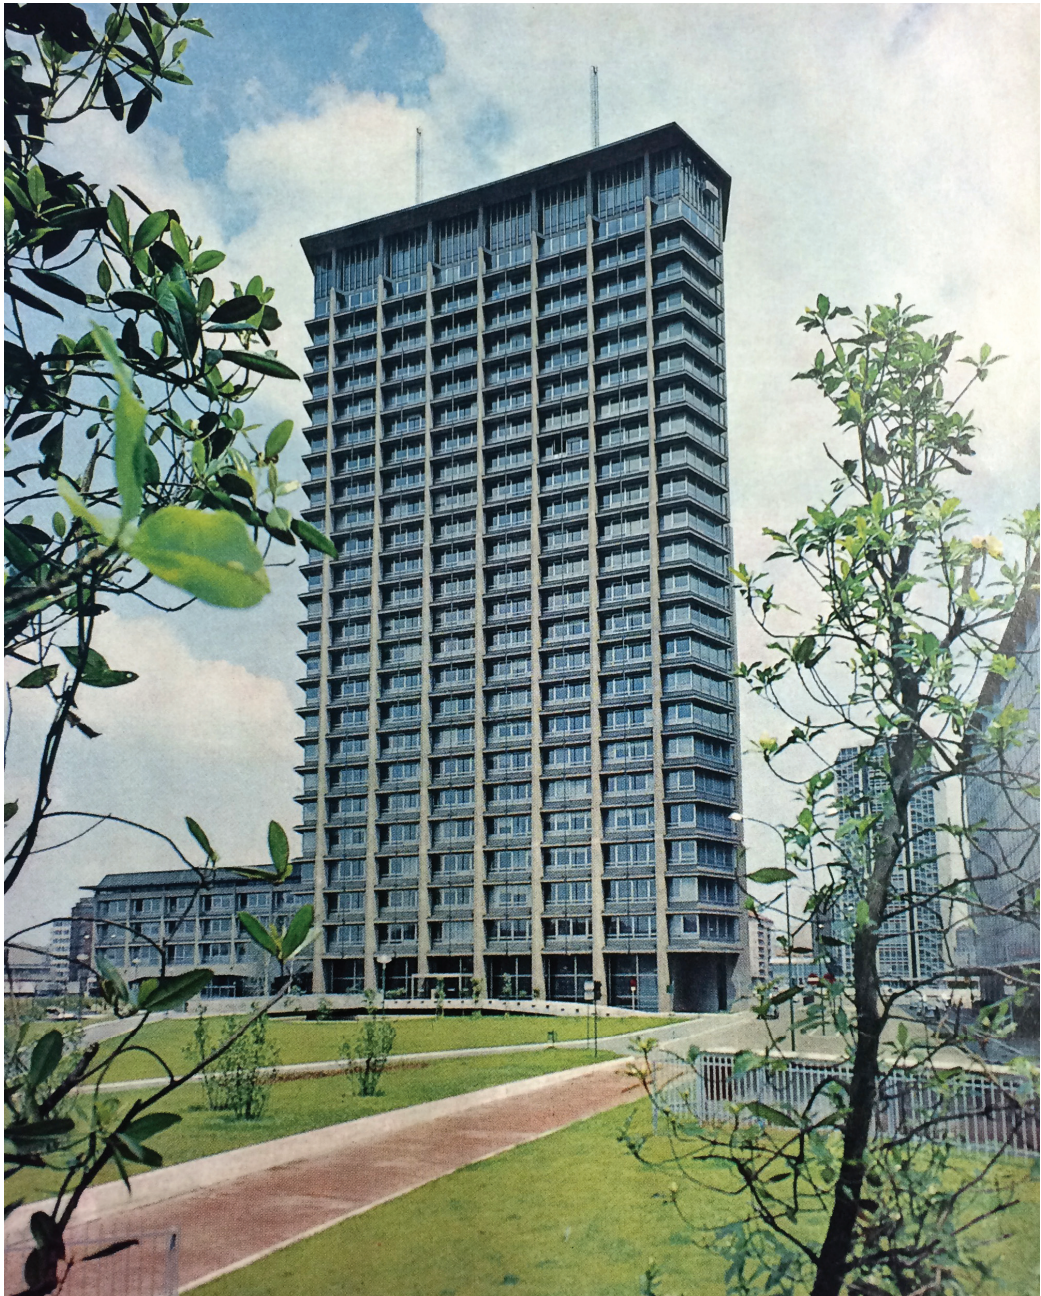
Figure 1–Photographic image of the tall building, housing the technical offices of the Milan Municipality [1].

The building, rising to one side of the main square of the *Centro Direzionale*, the large business center in Milan designed in the Fifties, houses the technical offices of the Milan Municipality (**Figure 1**). The tall building design begun in 1955 and lasted almost ten years. The architects involved in the design are Vittorio Gandolfi, Renato Bazzoni, Luigi Fratino and Aldo Putelli. The building consists of two bodies: a tall one (25 stories), containing all offices where public traffic is limited, and a four-story one with heavy-traffic offices. A glass-panelled body connects the bridge-building with the tall one. An interesting aspect is that the bridge-building has a span of about 25 meters (82 ft) as it has to surmount the entire Melchiorre Gioia avenue. The shorter sides of the two buildings are respectively 20 meters (65.6 ft) and 16 meters (52.5 ft). Both these structures are in reinforced concrete and have been designed by the engineer De Bernardinis.

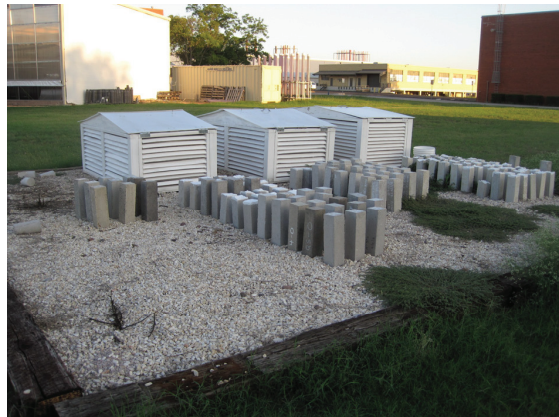
Figure 1—Outdoor natural carbonation exposure site located in Austin, TX.

This paper presents the creation of an outdoor natural carbonation site in Austin, TX, USA, to assess the carbonation resistance of concretes prepared with binders containing various replacements of SCMs by weight of cement. Several parameters were selected to be evaluated including mixtures with varying w/binder, varying

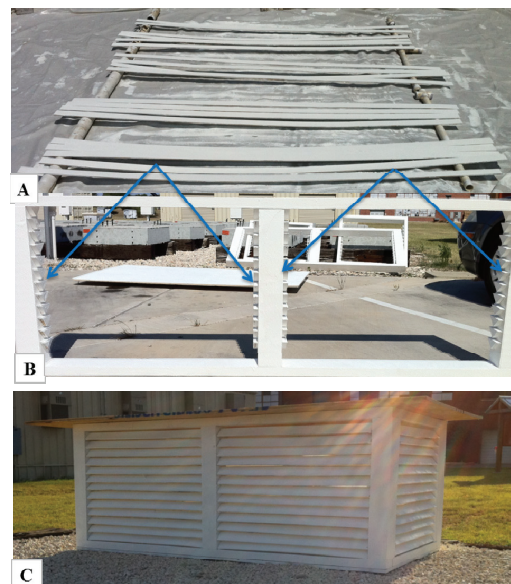
Figure 2—a) Wooden slat strips used in the long span of the Stevenson screen. Each slat was cut to fit inside each wall panel, b) long span wooden frame illustrating the isosceles triangles at the ends, c) final design of Stevenson Screen frame

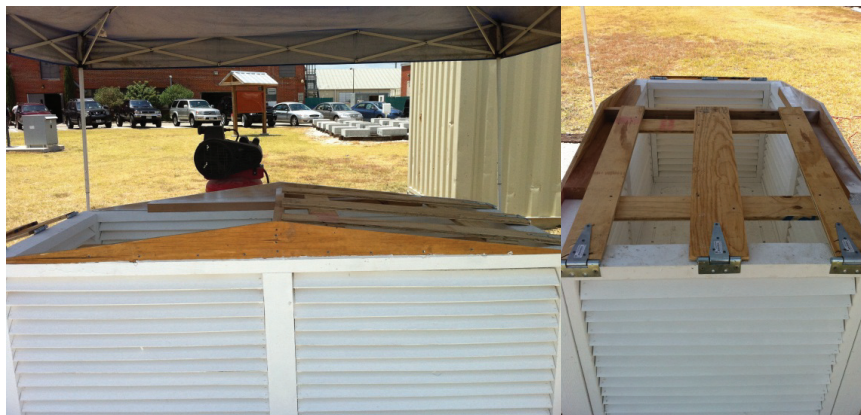
Figure 3: Design of roof system

**Design of Roof** - Sheets of 6.35 x 1219.2 x 2438.4 mm (0.25 x 48 x 96 in) High Density Polyethylene (HDPE) purchased at local plastic supplier in Austin, Texas were selected as part of the cover design. The sheets were selected to reduce maintenance and replacement costs from the long-term exposure to the high aggressive Texas

After attaching the wood panels to the frame, two sheets of HDPE were cut to cover the frames as well as provide a few inches of overhang similar to the slats. Each sheet was nailed to the three wood panels on each end as shown in the right photo in Figure 3. Each sheet had to be properly sized so that the door frames could fully open as well as not overlap with each other. To ensure that lids were not damaged from abruptly opening due to strong winds, each lid was securely tied to the middle of the Stevenson Screen using a steel cable. The cable was cut to a desired length allowing for enough room to access the inside.

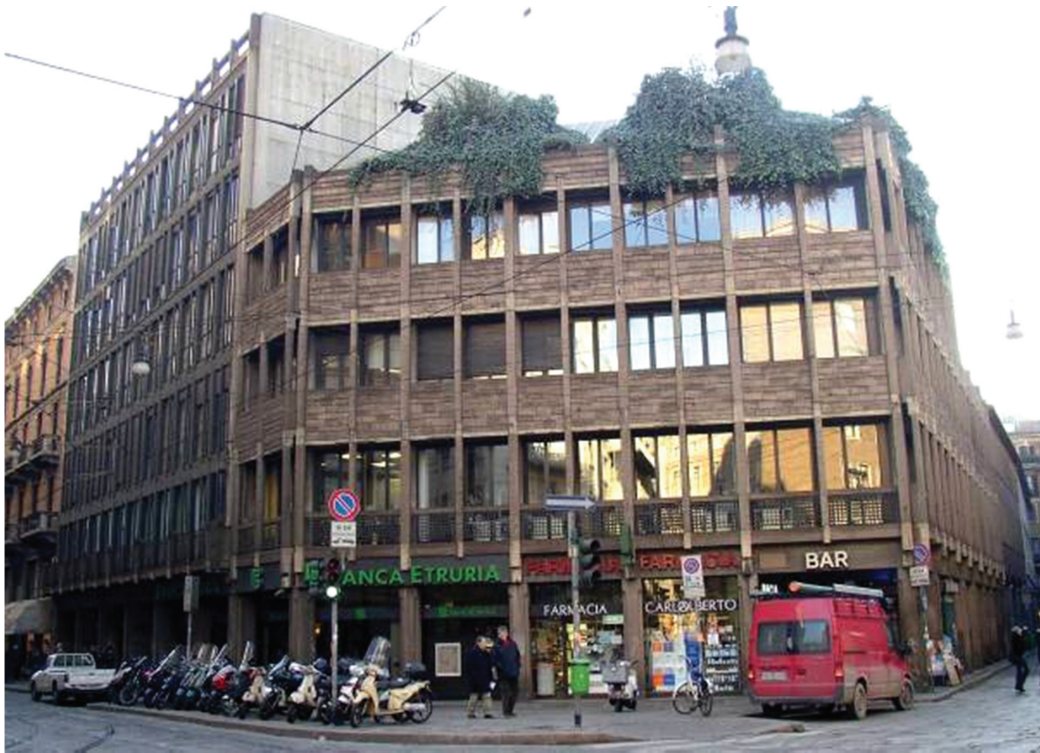
Figure 1–Figini & Pollini housing building before restoration, 2003

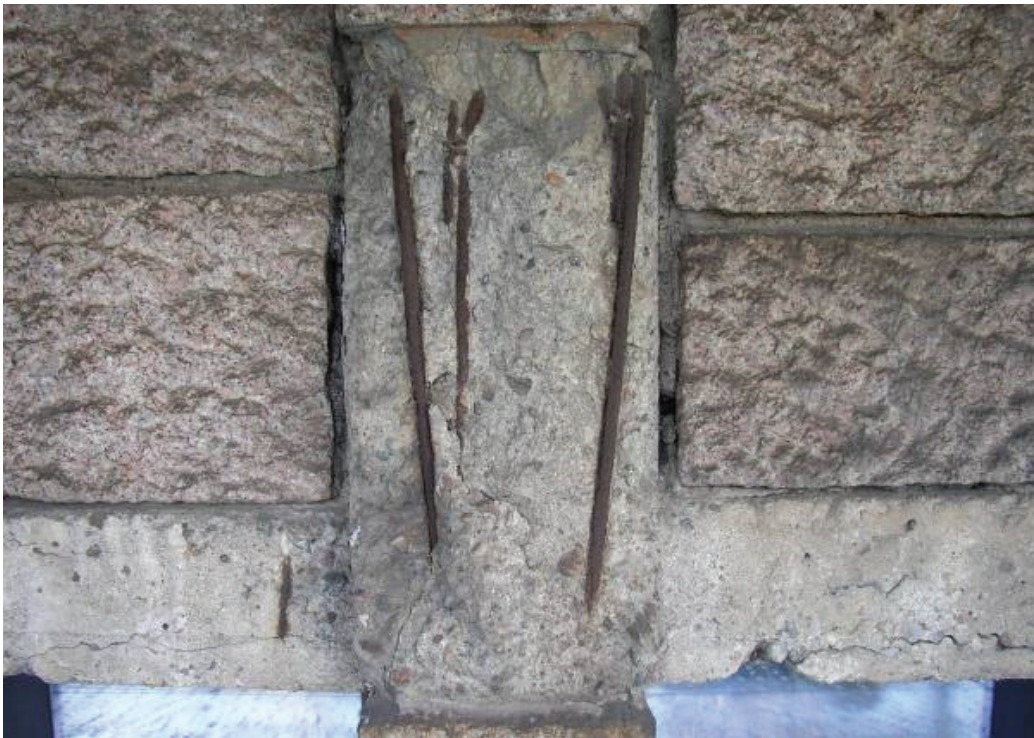
Figure 2–Thickness of concrete cover is less than 10 mm (0,39 in)

Because of falling fragments of concrete, in December 2003, work began on the restoration of the external façades<sup>18</sup>. Diagnostics in situ and in the laboratory concerned both the structure of the façade and the innermost main structure (position of the reinforcing rods, measurements of the thickness of the concrete cover, measurements of the potential of corrosion of the reinforcements, detection of ultrasound velocities, sclerometric surveys, phenolphthalein tests, analysis for the presence of chlorides). The tests by the Chemistry, Material and Chemical Engineering Department "Giulio Natta" of Politecnico di Milano indicated that the external structure, with obvious signs of degradation over about 90% of the structure, presented carbonation to a depth of 40-50 mm (1,57- 1,96 in) and the thickness of cover was from 5 to 29 mm (0,19 to 1,14 in)<sup>19</sup>.

In the specific case two problems emerged that led to the choice of the materials used. A first problem was the impossibility of reconstructing a concrete cover thick enough to ensure durable protection for the reinforcement bars, for reasons related to the need to preserve the geometry of the façade characterized by the co-planarity of the stone elements in relation to the concrete **showed in Figure 1**. In many areas the thickness of the concrete cover was less than 10 mm and therefore totally inadequate to guarantee an acceptable degree of durability. An example is showed in **Figure 2**. To cope with this problem a coating was applied to the reinforcement bars. Protection from corrosion was therefore entrusted to the coating itself and not to the repair mortar which, due to the small thickness of the concrete cover, would not have ensured lasting protection.

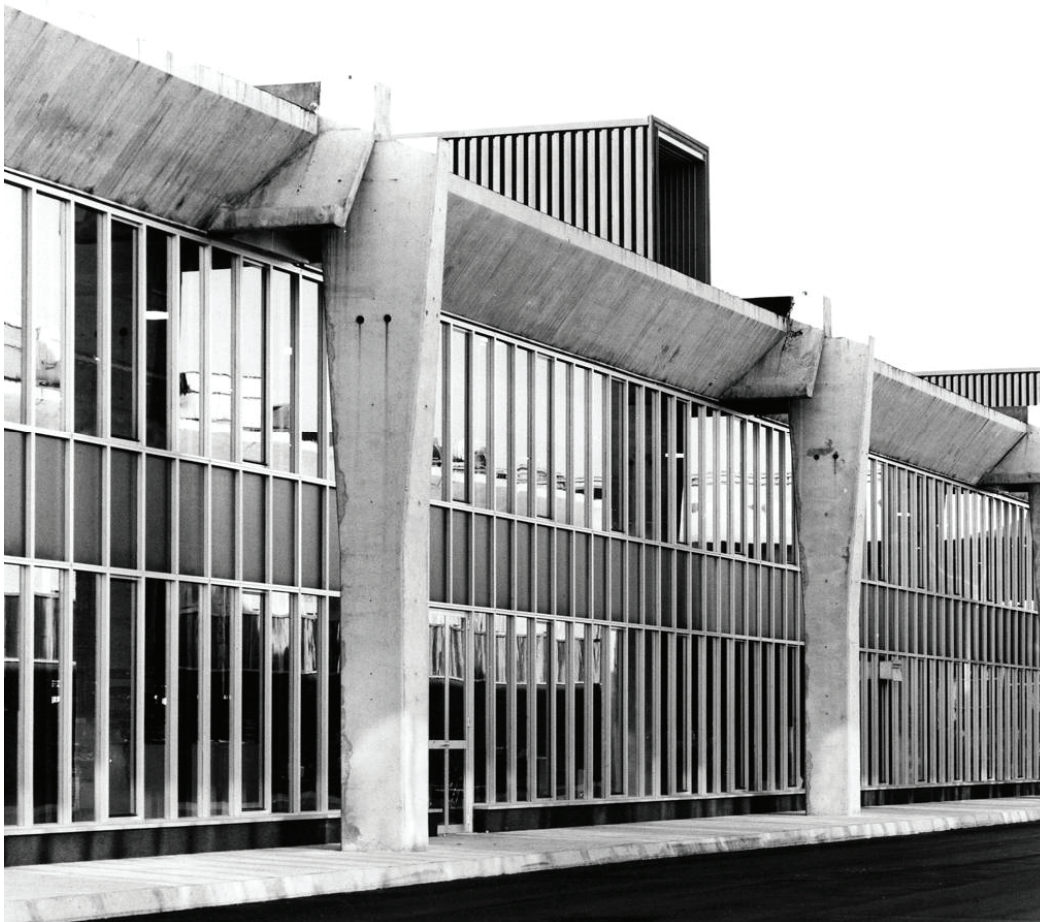
Figure 3—Olivetti factory in Crema in 1975 (Archivio del Moderno, Mendrisio)

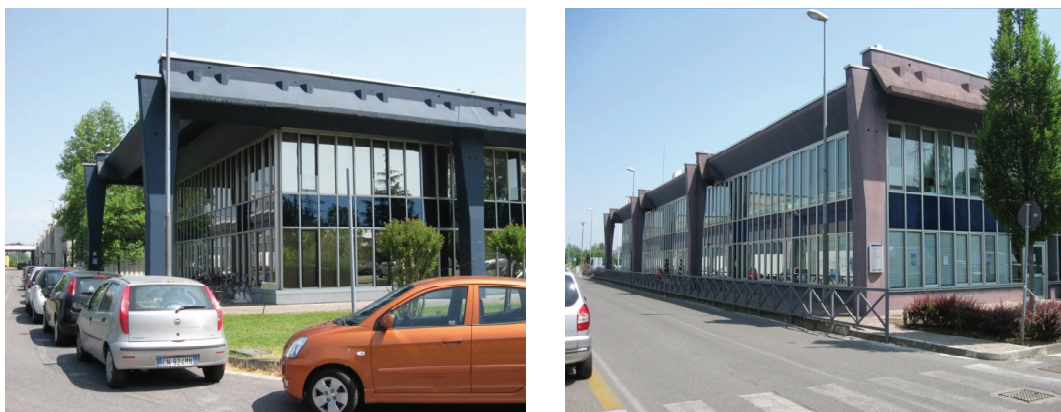
Figure 4, 5 -The parts of the complex with blue and pink colored coating

The restoration of exposed concrete was characterized from two different approaches. A part of the complex was restored with traditional method and techniques. After the demolition of the damaged or carbonated concrete and treating the reinforcing bars, the cover was replaced with an alkaline mortar. After, a pink or blue colored coating was put on the concrete surfaces with the purpose of protecting and making them uniform **showed in Figure 4 and 5**. This last operation permanently disrupts the sense of a structure that was conceived to be built out of exposed concrete<sup>23</sup>.

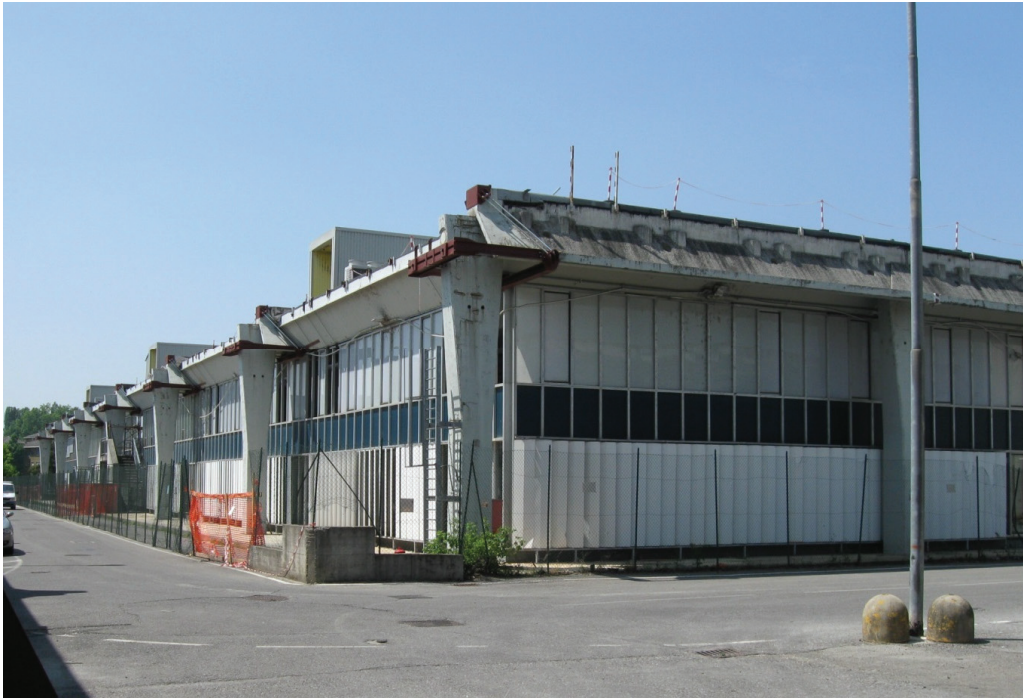
**Figure 6 –The part of the Olivetti factory with structural consolidation works**

In the other parts of the complex the restoration of exposed concrete was not realized and the priority was the structural consolidation **showed in Figure 7**. This consisted in the reinforcement of the secondary beams to prevent the side walls from sagging by installing a "hoop" and the strengthening of the principal walls, because the existing reinforcement bars have proved insufficient and allow slippage of the wings at the head of the beam **showed in Figure 8**. The intervention, with invasive effects in formal terms, proved capable of solving the structural problems. Moreover, this intervention is not capable of ensuring safety in case of an earthquake. The static structure of the factory, which consists of pillars embedded at the base and simply supported beams, if subjected to horizontal actions by an earthquake, will not be capable of preventing the structures from being free to slide over each other, regrettably, in compliance with the regulations still in force, which classify Crema as an area of low seismic risk.

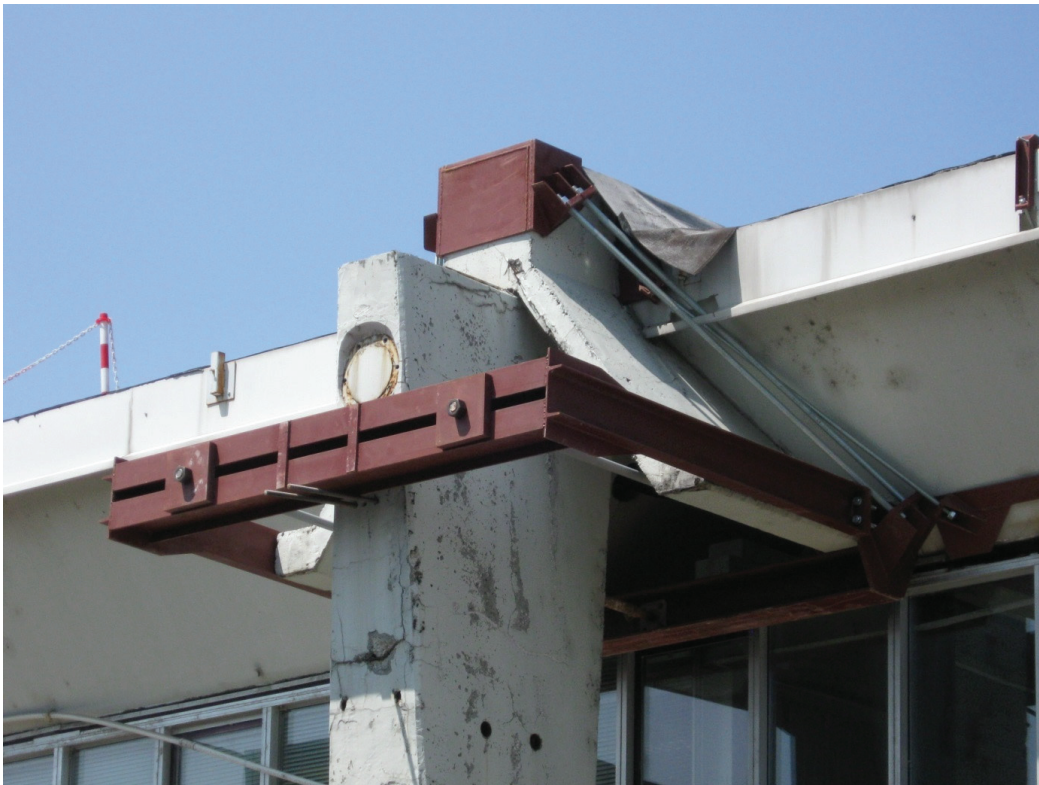
**Figure 7 – Connection between pillar and Y-shape beam. Detail of the decay of concrete structures**  
**CONCLUSIONS**
