SP-309

# Structural Integrity and Resilience

Editors:  
Mehrdad Sasani  
and Sarah Orton

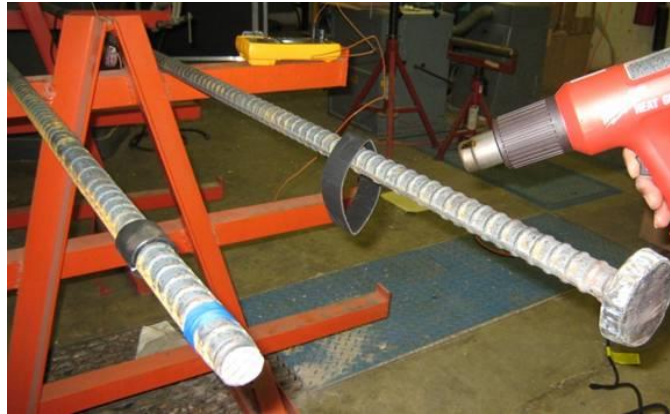
Fig. 5–Polyolefin shrink tube before (right) and after (left) heat treatment.

The polyolefin shrink tube was used to debond the reinforcing bars from the surrounding concrete at the desired locations. When heated, the polyolefin tube shrinks in the radial direction to fit tightly over the reinforcing bar. **Fig. 5** shows tube segments on reinforcing bars before and after exposure to a heat source. Circular high-strength paper tubes were used as formwork. Self-consolidating concrete was placed in the forms through circular holes on the top surface of the forms (**Fig. 6**).

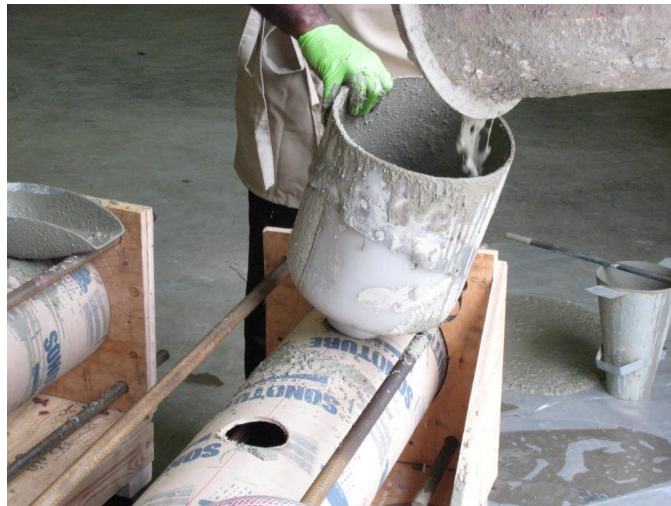
Fig. 6–Concrete placement in cylindrical forms.

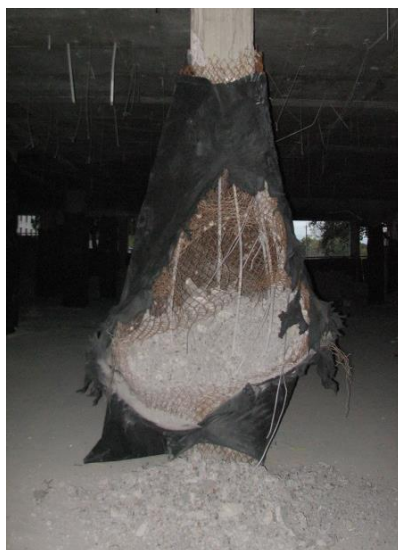
Figure 2 - a) Column D5 after explosion and undamaged top portion of column with deflected column reinforcement (adopted from Keyvani and Sasani, 2015), and b) diagonal potentiometers used in experiment to record the column displacement

Although the top portion of the removed column was undamaged (see Figure 2a) and the reinforcing bars of the lower half of the column remained in place with some lateral deformation, Keyvani and Sasani (2015) showed that the effect of reinforcement on the maximum displacement of the slab is negligible. Thus, analytically the column is removed suddenly and completely within the model. However, the weight of the undamaged portion of the column on the response is accounted for. To model the column removal, first its reactions under gravity loads and post-tensioning effects are found. Then the column is replaced with its reactions. In this case, the results of analysis under the gravity loads and post-tensioning effects are identical for the two models (with and without the column). Then, forces equal but opposite to the reactions plus the weight of the undamaged portion of the column are applied in 2 milliseconds (Sasani and Sagioglu, 2008), and a nonlinear dynamic analysis using time-integration method is performed. Hilbert-Hughes-Taylor (HHT) numerical damping is utilized to dissipate the effects of higher modes of vibration and improve numerical convergence.
