Durability of Concrete Structures  
Incorporating Conventional  
and Advanced Materials

SP-331

## Thermal Detection of Subsurface Delaminations in Reinforced Concrete Bridge Decks Using Unmanned Aerial Vehicle

## **Bond Behavior of Concrete Strengthened with FRP Laminates and NSM Bars Subjected to Accelerated Aging using Freeze-Thaw Cycles**

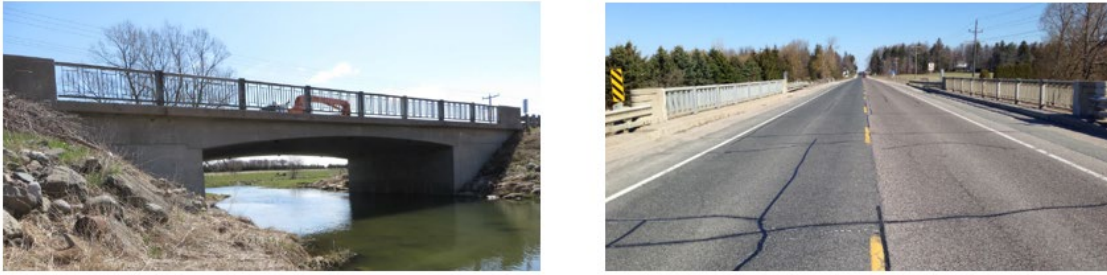
**Figure 1**-East elevation of the surveyed concrete bridge (2) and an overview of the deck condition.

The UAV-borne thermal survey for this study was conducted onsite in a real-world application on two in-service RC bridge decks located in the city of London, Ontario. The bridges were scheduled, by the Ministry of Transportation Ontario (MTO) for rehabilitation because delaminations, the extent of corrosion and high chloride ions content in the bridges were recently identified by a condition survey. Thus, the bridges were considered as good candidates and selected for the UAV survey. The two bridges, (named herein bridge (1) and bridge (2)) were constructed in 1965 as single span cast-in-place RC frames passing over a creek. The frames are supported directly on the abutments, and paved with about 100 mm (4 in.) asphalt wearing surface, as indicated in the structural drawings. The bridge structures have a north-south orientation and their outer limits have concrete curbs and steel handrails. The critical deck characteristics include a total length of 15.24 m (50 ft.) with a transverse width of 12.18 m (40 ft.), which supports one lane of traffic with one side shoulder in each direction. The structural drawings of both bridges indicate a deck slab thickness varying from 0.91 m (3 ft.) at the abutments to 0.48 m (1.6 ft.) at the mid-span of the deck with a parabolic soffit. Figure 1 illustrates the surveyed bridge (2) and a view of the condition of its deck. The utilized drone, thermal camera and the data collection methodology are briefly discussed below.

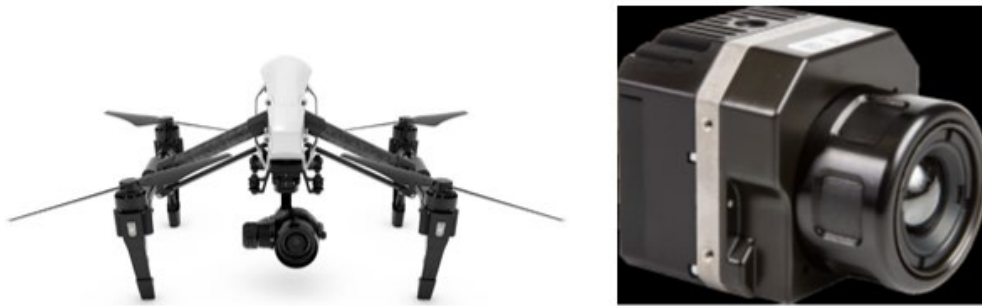
**Figure 2**-Aircraft (Inspire 1 Pro) and thermal camera (FLIR Vue Pro) utilized in this study.

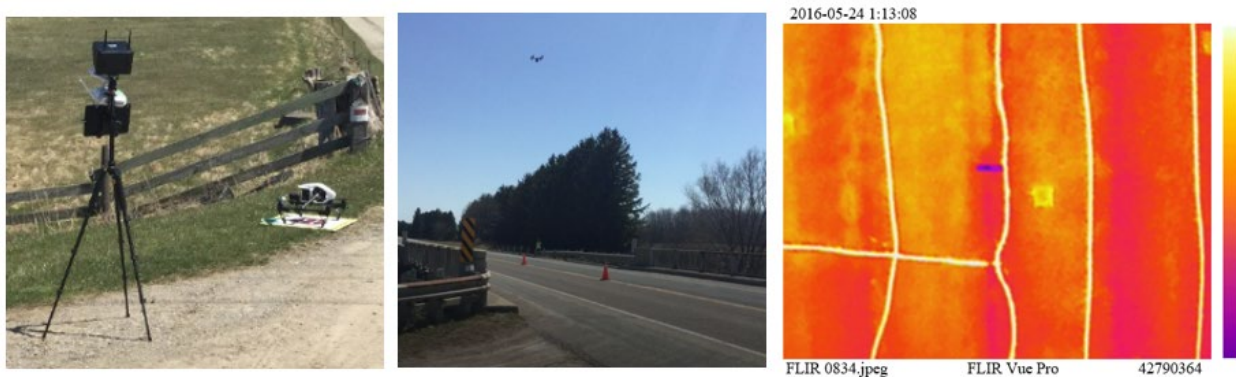
**Figure 3**-Setup of UAV-borne thermal system and a snapshot during flight over bridge (2).

Time of data collection is the most critical factor in a passive IR survey. In a study conducted by Washer et al [12] on concrete bridges, it was found that the effective time to perform a thermal IR test depends on the depth of the delamination. The most contrast appears on the thermal IR image approximately 4 hr after sunrise for a 50 mm (2 in.) deep delamination and 7 hr after sunrise for a 75 mm (3 in.) deep delamination. Therefore, the surveys were conducted on May 24<sup>th</sup>, 2016 at 1 PM, six hours after sunrise. During the survey, the ambient temperature was 26° C (79° F), relative humidity was 22%, and wind speed was 8 km/hr (5 mi/hr.). Bridge deck dryness was considered during data collection since surface moisture can reduce the thermal contrast on thermal IR images. Road traffic was not closed during data collection of the two bridges. While the total time taken to complete a bridge deck inspection from setup to tear-down was approximately 20 minutes, the total flight time was about three minutes for each bridge deck. A calibrated 9 mm (0.35 in.) focal lens (69 x 56) was utilized, which allowed a FOV of 13.74 m (horizontally) x 10.62 m (vertically) (45 ft. x 34.8 ft.) for each image taken at a constant 10 m (32.8 ft.) altitude and resulted in 2.5 cm (1 in.) spatial resolution. Hence, a total of four thermal images, at spacing of 5 m (16.4 ft.), were collected with an overlap of 50% to cover the entire deck length. Each image covers the entire deck width and shoulders, in addition to the sidewalks at both sides. The still images were taken at the center of each bridge deck. Figure 3 illustrates the UAV hovering process and a captured thermal image.

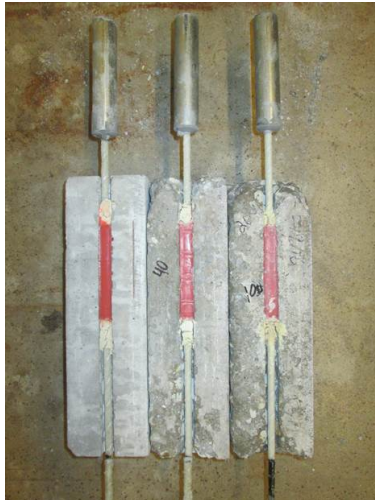
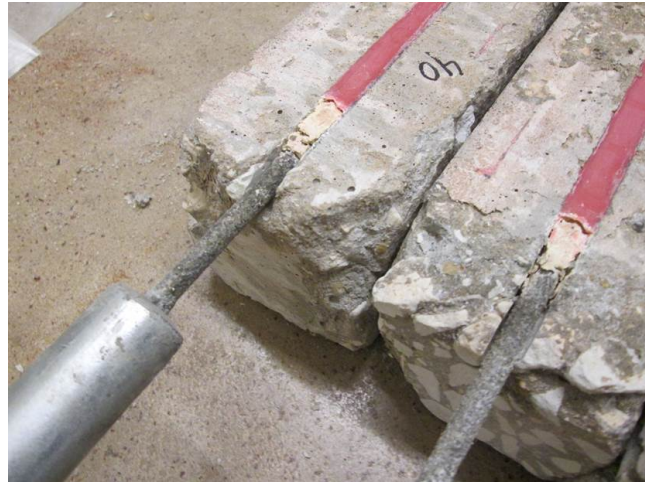
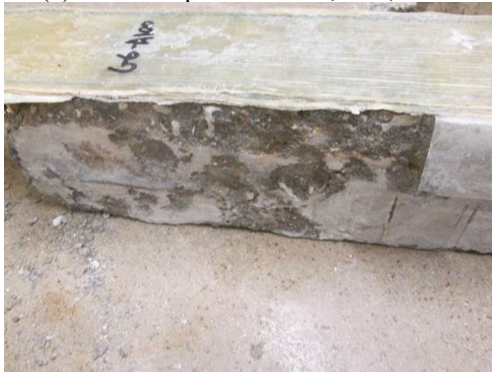
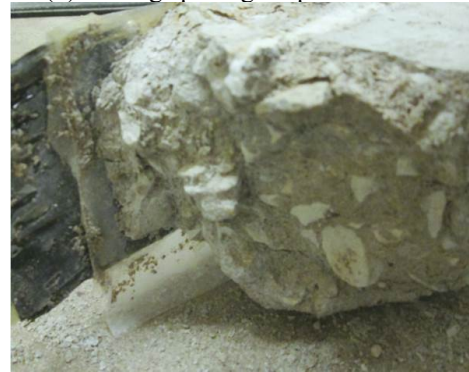
(a) G-b-102 specimens: A0, A40, A100

(b) Scaling/spalling at specimen ends

(c) Scaling induced loss of bonded area

(d) Severe end damage on C-152-A100

Fig. 3—Effect of accelerated aging on concrete specimens

Compared to the 40 cycle specimens, the 100 cycle specimens showed increased scaling of the concrete (moderate to severe), and in many cases coarse aggregate had been exposed and/or completely spalled off. Fig. 3(a) compares a set of concrete specimens with no aging, 40 freeze/thaw cycles, and 100 freeze/thaw cycles. The most severe of concrete damages occurred mainly at the ends of the specimens (Fig. 3(b)), which generally left the bonded portions of FRP intact. One laminate specimen (G-152-A100) had scaling on one side that resulted in loss of a minor portion of bonded area, as shown in Fig. 3(c). There were also two 100 cycle CFRP laminate specimens that had severely damaged ends that rendered the specimens untestable due to lack of bearing area against the plates in the test fixture, one of which is shown in Fig. 3(d). For this reason, the results for the 100 cycle CFRP laminates are omitted. Other than some salt depositions on the laminates, the FRP laminates, bars, and epoxy filler had no visible signs of deterioration.
