## Advanced Analysis and Testing Methods for Concrete Bridge Evaluation and Design

SP-342

Sponsored by  
ACI Committees 342, Evaluation of  
Concrete and 343, Concrete Bridge  
Design (Joint ACI-ASCE)

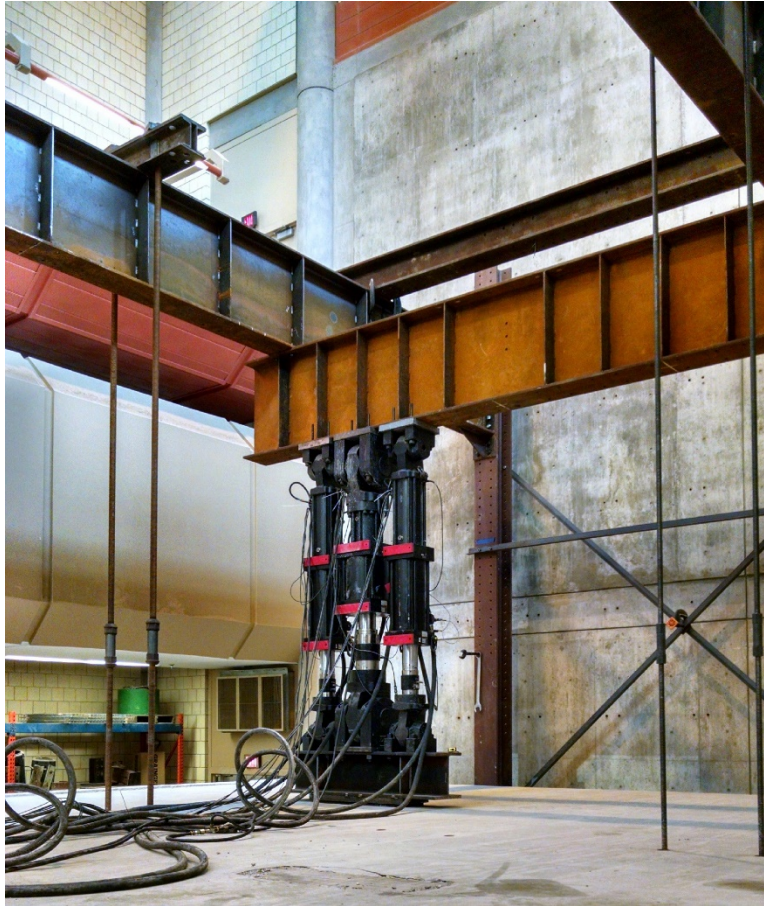
Fig. 7—Load frame and actuator setup above the deck in the northeast quadrant
