## Field Applications of Non-Conventional Reinforcing and Strengthening Methods for Bridges and Structures

SP-346

Sponsored by  
ACI Committee 345

ACI Virtual Concrete Convention  
October 25-29, 2020

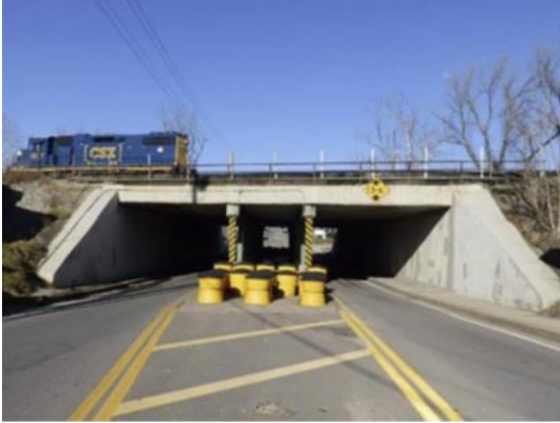
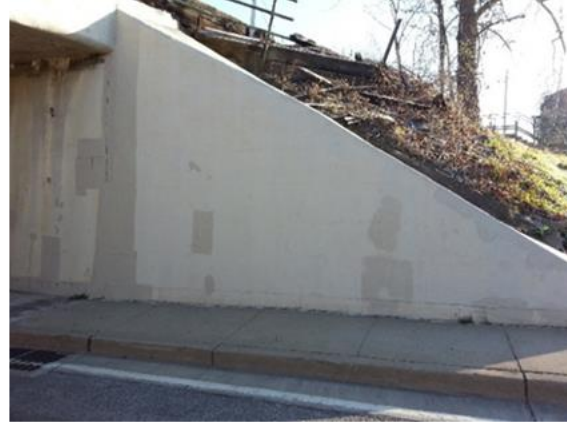
(b) GFRP wrapping on a wing wall

**Fig. 1**—Details of East Street Viaduct bridge (WVDOT bridge inspection reports 2012 and 2017)

This section briefly introduces two aging bridges in West Virginia retrofitted by the FRP composites. The FRP wraps externally bonded to the concrete surface to compensate for strength loss due to corrosion, deterioration, or fire/impact damage. The use of FRP wraps allows the rehabilitation of the existing concrete, resulting in an economic repair as substructure replacement generally requires replacing the entire bridge. These repairs have saved the WVDOT thousands of dollars compared to conventional repairs.

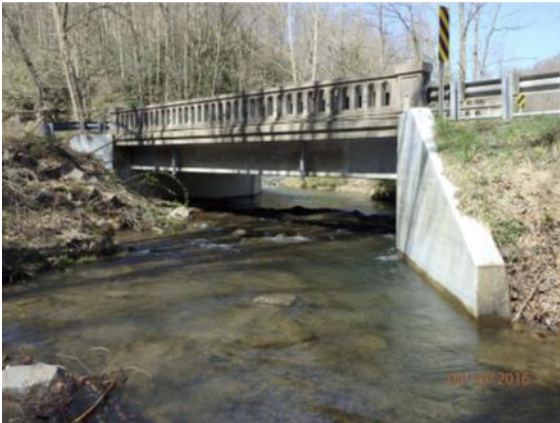
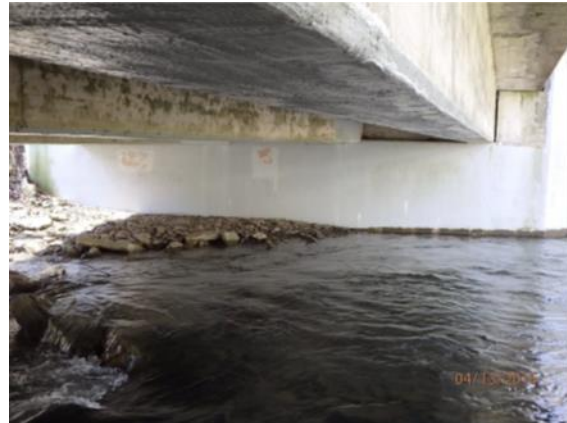
(b) CFRP wraps in underside of a T-beam and  
abutment #1

**Fig. 2**—Details of Flag Run bridge (WVDOT bridge inspection reports 2016)
