The first part of this paper covers mass concrete practices that have been employed in dams in the United States during the past 75 years. The second part describes in some detail the concrete construction operations during that period.

# Historical Account of Mass Concrete

Raymond E. Davis

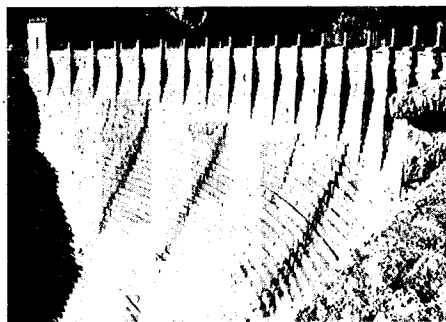
Fig. 6 — Downstream face of Roosevelt Dam built of cyclopean rubble masonry faced with rough ashlar blocks

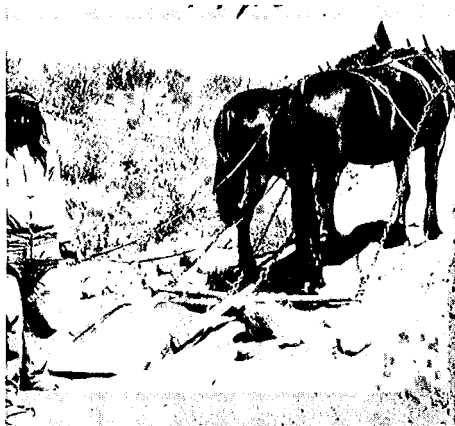
Fig. 9 — Construction methods used on Roosevelt Dam illustrates the notable engineering achievement of these early dams

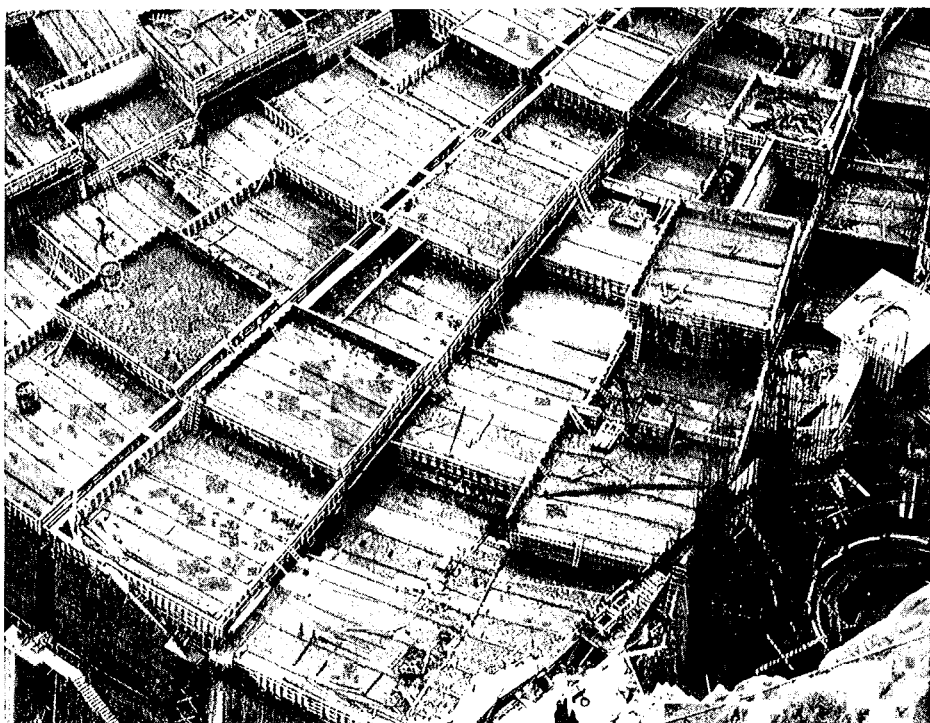
Fig. 14 — Hoover Dam was constructed of columnar blocks with horizontal section as large as 50 x 60 ft

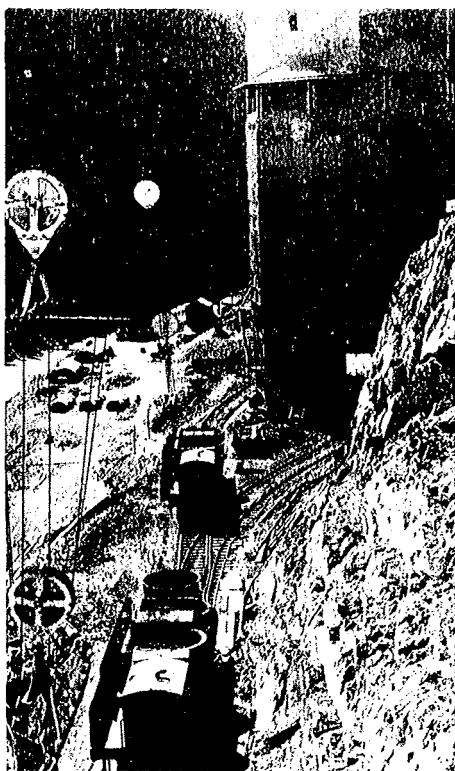
Fig. 16—Concrete cars on trackway along bucket loading dock at Hungry Horse Dam

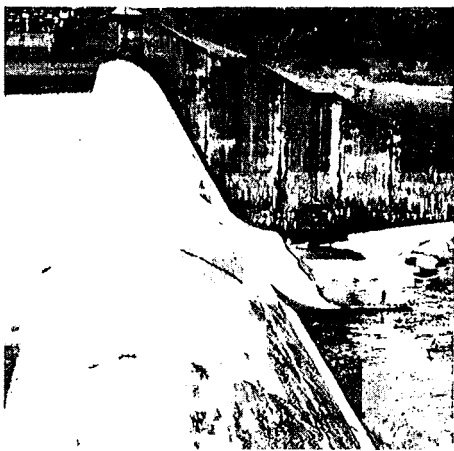
Fig. 4 — Spillway crest and south abutment wall of Hinckley Dam (1948)
