# **Longtime Studies and Field Experiences with Sulfate Attack**

**By Edward M. Harboe**

# Longtime Study of Concrete Durability in Sulfate Soils

by David Stark

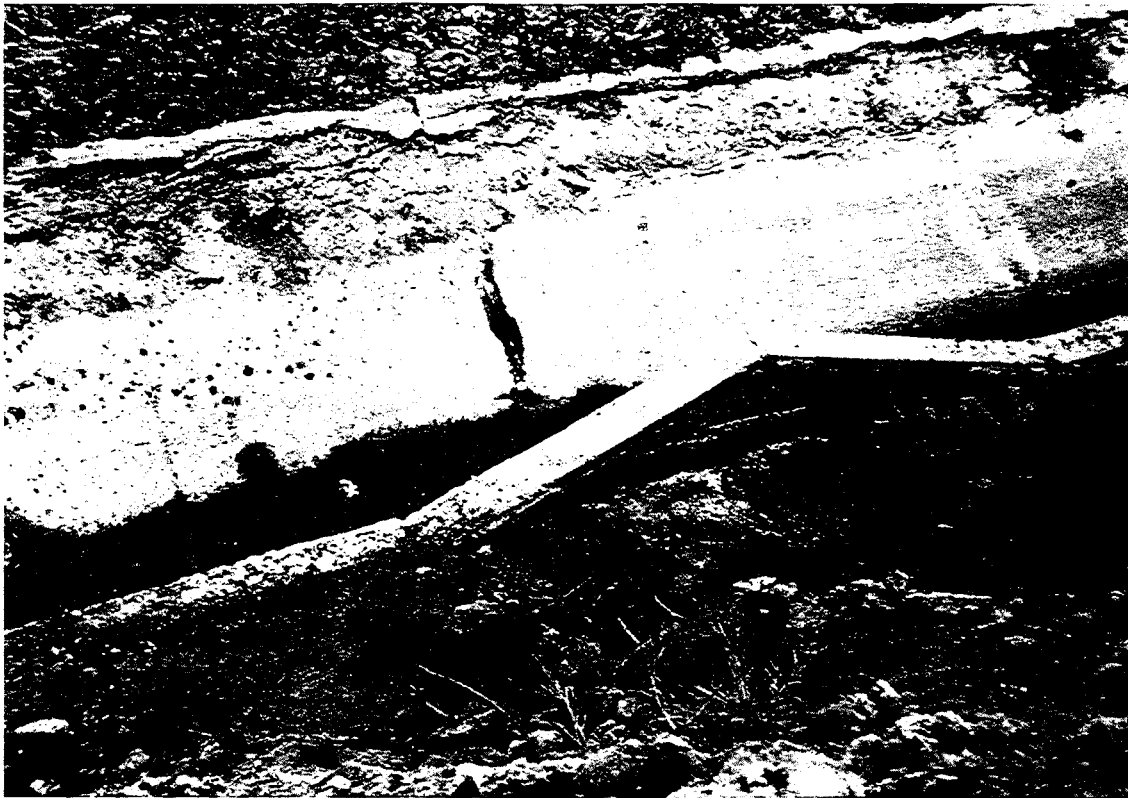
Figure 2 shows a concrete-lined irrigation ditch on our San Luis Unit of the Central Valley Project in California. The concrete is in an extreme state of deterioration due to sulfate attack. The concrete was made with Type I cement and was 5 years old when the photograph was taken.

Fig. 2--Sulfate attack on concrete canal lining. San Luis Unit, Central Valley Project, California

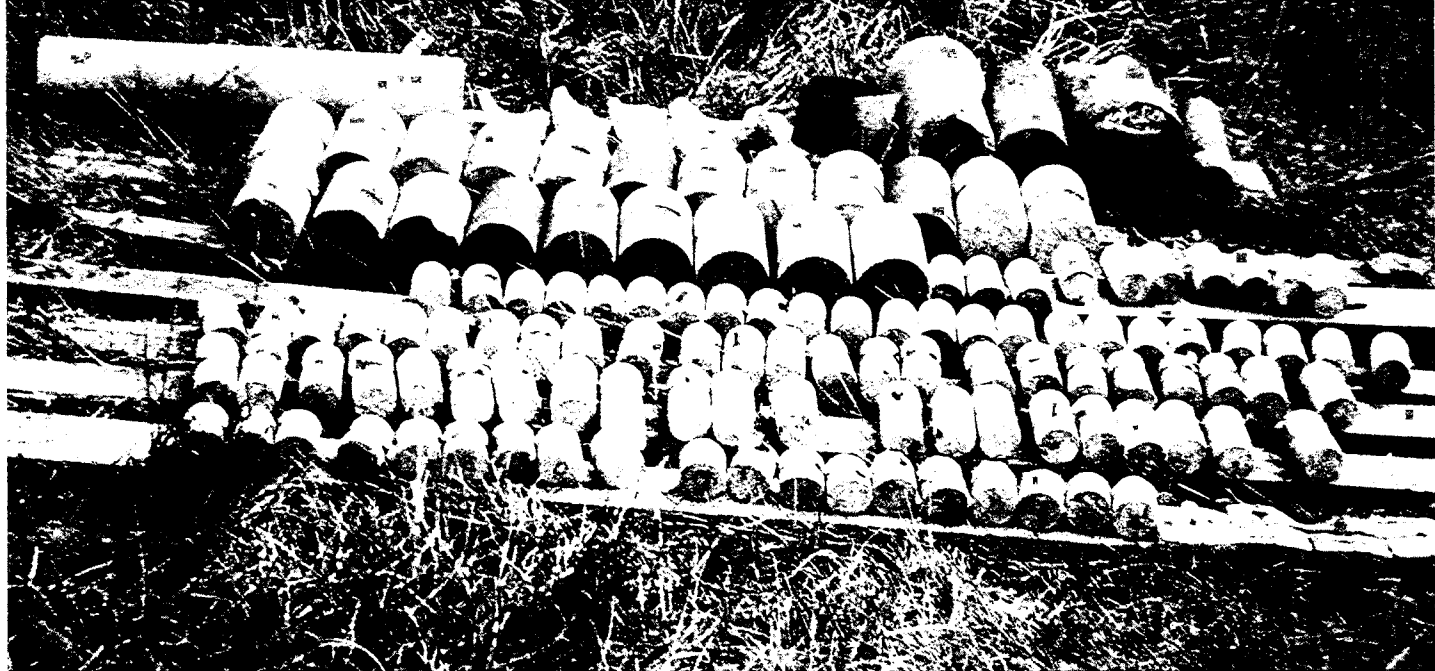
Fig. 11--Test specimens after removal from test plot and washing

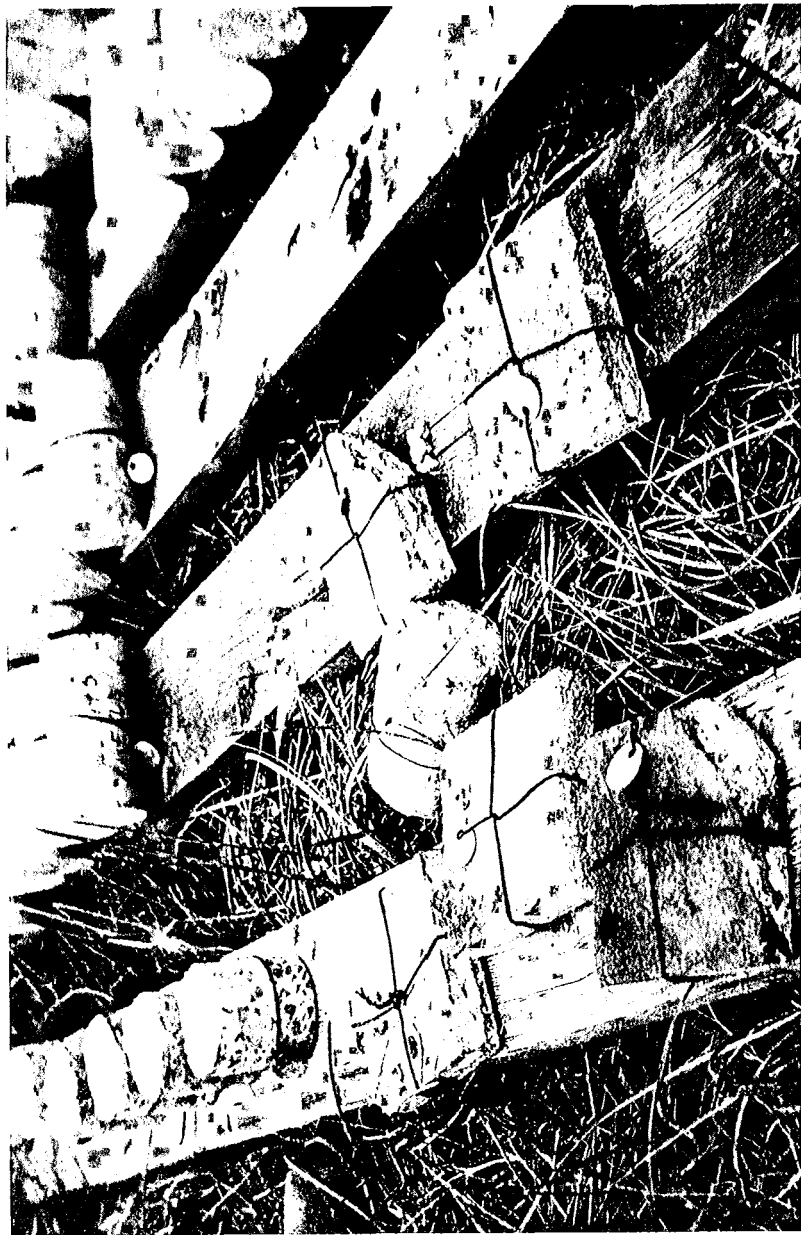
From 1951 to 1971, Interpace Corporation maintained a field exposure test plot near Fort Collins, Colorado (7). This site was selected because of severe sulfate attack on a concrete pipeline in this area. We had a great interest in this test plot and, since it was convenient to our laboratory and remote from Interpace's laboratory, it was to our mutual benefit that we participate in all the evaluations. Figure 10 shows the beginning of excavation to retrieve test specimens. The ground water in this area is high so that at all times there was enough moisture present to sustain sulfate attack. Figure 11 shows some of the test specimens removed from the pit after they were washed and brushed. Test specimens included cast cylinders, concrete pipe sections, irregular pieces of larger diameter concrete pipe, and even a few pieces of metal pipe. Figure 12 shows mortar lining and coating specimens from the test plot.
