# Design, Construction, and Performance of Four Experimental Concrete Pavement Sections in Ontario

by T. J. Kazmierowski, G. A. Wrong, and W. A. Phang

Synopsis: Recent innovative developments in concrete pavement design methodology, material specification, construction techniques, and pavement drainage systems prompted Ontario's Ministry of Transportation and Communications to consider alternative rigid pavement designs.

In order to evaluate the relative performance of several concrete pavement designs, a 15.6 km (9.7 mi) long experimental rigid pavement was constructed in 1982 incorporating four different pavement designs, three shoulder designs and two types of surface textures.

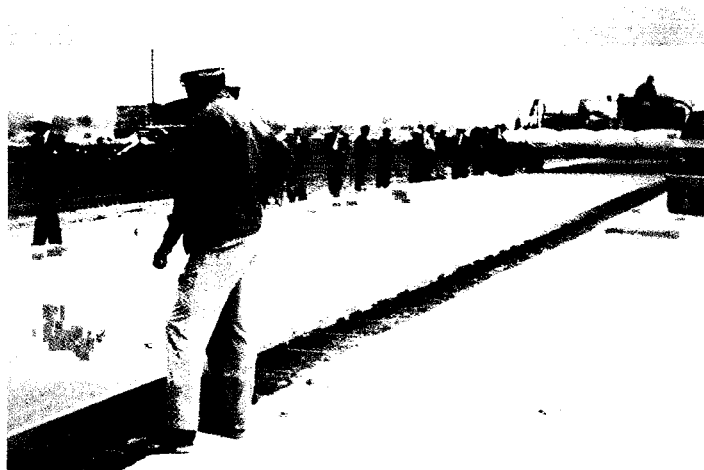
Photo 2—Slipformed W.B.L. and shoulder on lean concrete base  
(note longitudinal epoxy coated tie bars)

sections with tied-in concrete shoulders were slipformed in one lane plus shoulder (3.7 m + 0.6 m) width, starting with W.B.L. travelling westerly and then shifting to the E.B.L. and travelling easterly.

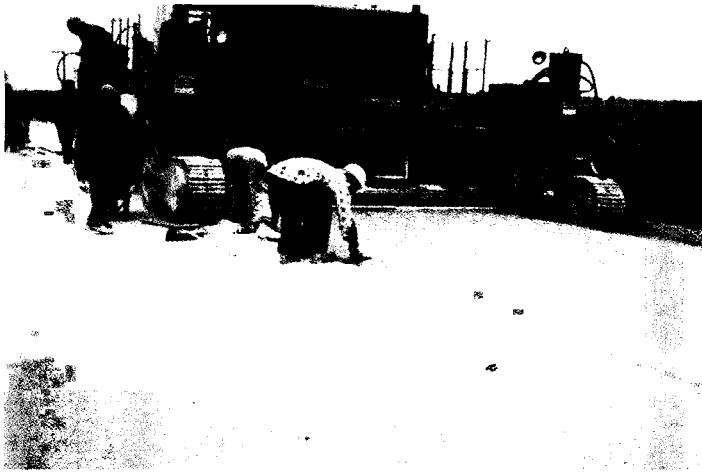
Photo 3—Slipforming E.B.L. and shoulder (sections III & IV)

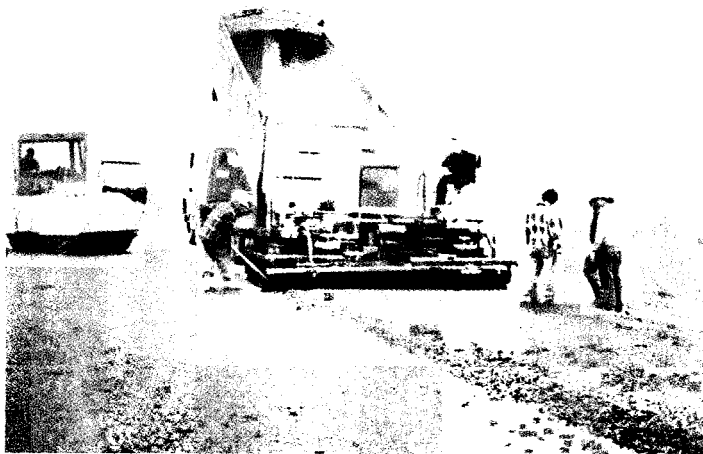
Photo 4—Paving 100 mm of bituminous treated permeable base (O.G.D.L.)

The O.G.D.L. is basically an open textured, uniformly graded coarse aggregate with 2% A.C. content which was placed in a 100 mm (4 inch) lift directly on the clay subgrade using conventional paving techniques. This free draining bituminous treated permeable base course material is designed to expedite internal drainage of the pavement structure while providing sufficient stability to resist densification and shear distortion under construction traffic.

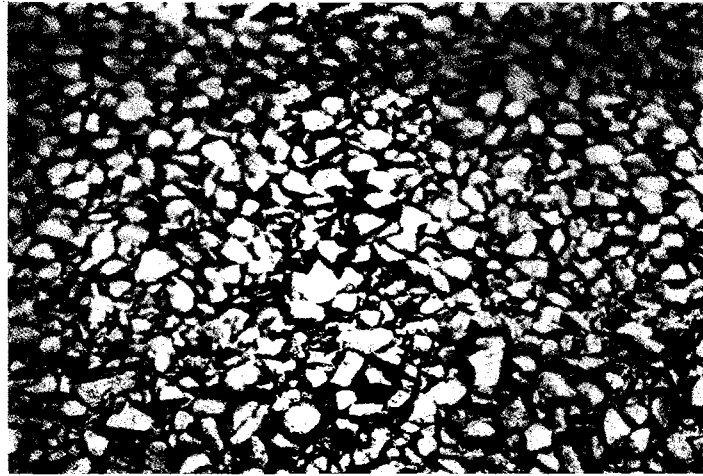
Photo 5—Open permeable texture of O.G.D.L.

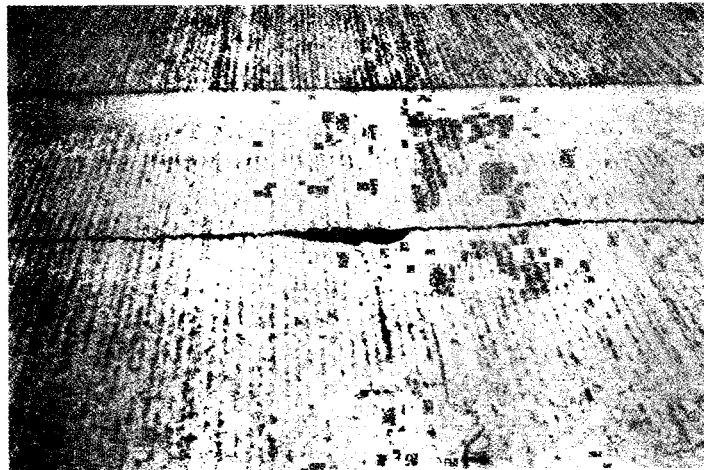
Photo 10—Spalling at intersection of transverse and longitudinal crack (section IV)
