# Crack Length and Depth Determination in an Integrated Carburized Gear/Bearing

by: J.S. Kachelries, Materials Engineering  
and R.J. Drago, Gear Technology

## TECHNICAL PAPER

## Abstract

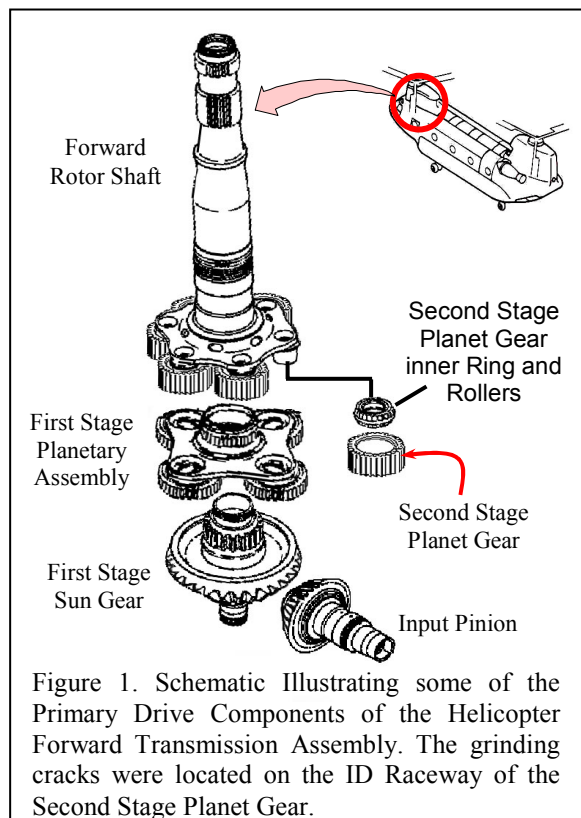
Both the Forward and Aft Chinook Transmissions contain six of these Planetary/Gear Bearing Assemblies comprising the Second Stage Planetary System. A schematic illustrating the location of the Second Stage Planet Gear/Bearing in the Forward Transmission Assembly is shown in Figure 1. A photograph showing the magnetic particle indication on the spherical raceway of the Planet Gear returned from service is shown in Figure 2.

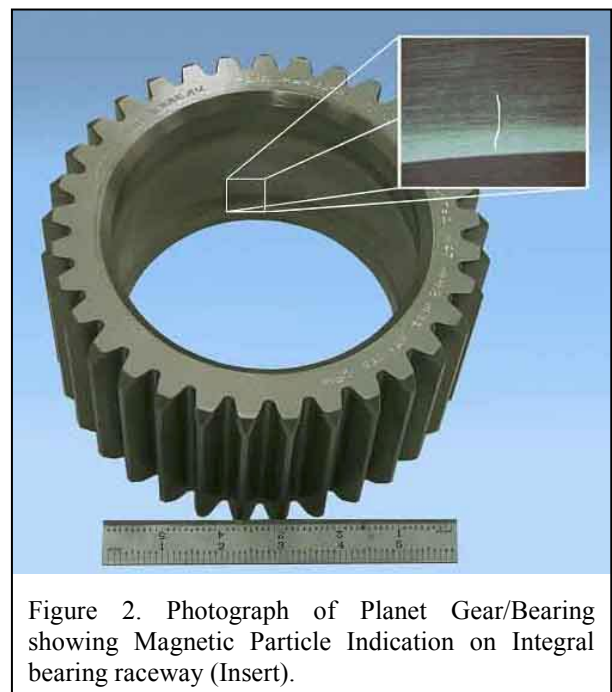
During a scheduled overhaul of a military helicopter transmission, magnetic particle inspection revealed an approximately 0.30 inch long crack indication on the outer raceway of an Integrated Planetary Gear/Bearing Assembly. In this integral design, the gear manufacturer carburizes an approximately 7-inch pitch diameter spur gear (4 inch tooth width), including an approximately 5.7 inch diameter spherical bore. The gear manufacturer completes the gear teeth portion of the spur gear, and the spherical bore is subsequently ground by the bearing manufacturer. The raceway of this Gear/Bearing Assembly is carburized to a 50 HRC effective case

During overhaul of a primary drive helicopter Spur Gear, which also serves as the outer race for an integral spherical bearing, magnetic particle inspection detected an approximately 0.3-inch long crack indication on the raceway surface. Subsequent metallurgical evaluation disclosed that the indication was a 0.028-inch deep, pre-existing grinding crack that had not been detected by the manufacturer during final inspection. A sample re-inspection of product that was currently in storage that had been shipped from this manufacturer revealed that additional components with grinding cracks. In an effort to determine if the processing cracks posed a safety of flight concern, several gears that contained cracks were designated to undergo a rigorous dynamic bench test. However, in order to insure that the bench test produced the maximum amount of relevant test data, it was necessary to document, nondestructively, all of the grinding crack dimensions (location, lengths, and depths) prior to the start of the test. The locations and lengths of the cracks were determined using a specially modified magnetic rubber inspection technique, which could reliably document crack lengths as short as 0.006 inch. A fixture was developed that made it possible to produce a magnetic rubber casting of the gear raceway, while simultaneously performing up to thirty, one second central conductor shots. To nondestructively estimate crack depths, a unique, highly sensitive, laboratory eddy current inspection technique was developed. Using a limited number of data points, a “response-to-depth” curve was generated that predicted the maximum crack depths to  $\pm 0.002$  inch. Using these two techniques, the “status” (i.e., growth) of each crack was monitored at various stages of the bench test. At the completion of the bench test, a detailed destructive metallurgical evaluation of each of the test gears was conducted and documented. The post-test data confirmed the accuracy of the nondestructive eddy current estimates, and provided additional data that will make future crack depth predictions more accurate.
