## **Sticking Phenomena at the Brake Pad – Disc Interface: An Open Call for Electrochemists**

### **ABSTRACT**

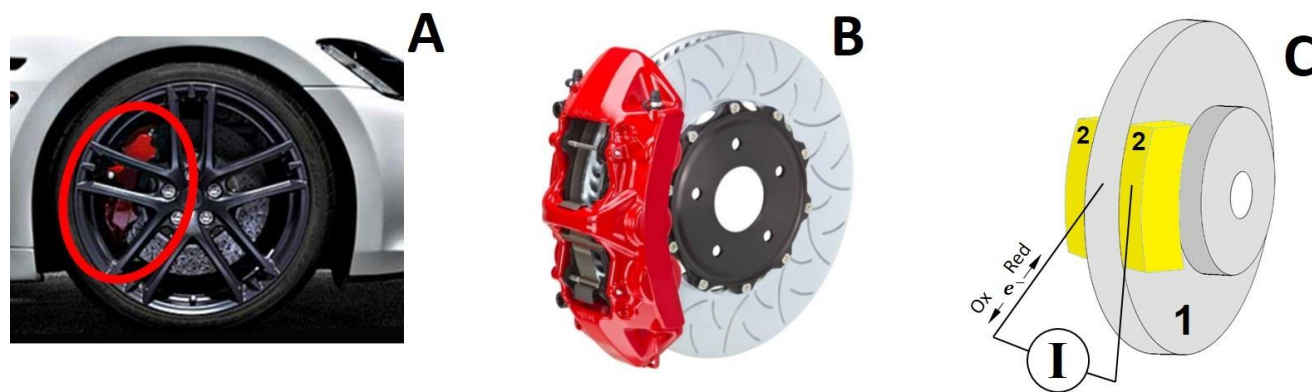
**Figure 1: A) Car wheel comprising a disc brake system; B) Disc brake system for high end cars; C) Schematic illustration of disc (C1) and braking pads (C2); the galvanic current (I) between the two and the associated electron flow are represented by the means of black lines. Considering the used experimental setup, oxidation of the disc is associated with positive currents while negative currents are associated with the oxidation of friction material comprised in the braking pads.**

Top-notch disc brake systems are complex multi-material devices. Most typical configurations include at least three elements,<sup>1,2</sup> namely: a) an anodized aluminum caliper; b) a cast iron brake disc; and c) a couple of composite braking pads (see Figure 1). During car driving, all these components can be exposed to several environments including rain, snow, chloride-rich conditions (e.g. presence of road salt), heavy traffic (SOx, NOx) and face severe corrosive phenomena.<sup>3</sup>
