## Effect of Laser Marking on Corrosion Performance of Metallic Materials in Different Environments

### ABSTRACT

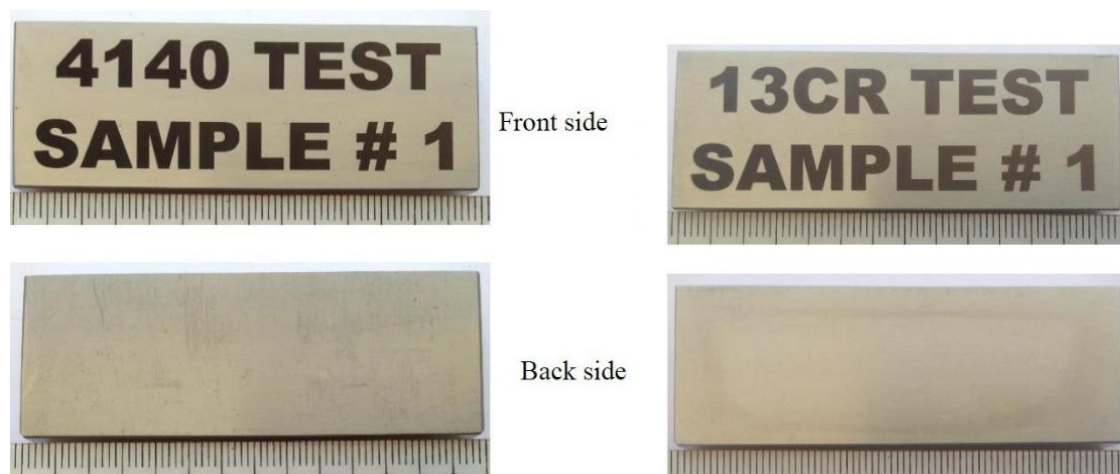
**Figure 1: Front side and back side of the marked specimens.**

The pitting corrosion resistance test was conducted in accordance with ASTM G48 (Method A). Multiple test specimens of 4140-80 (Heat A) and 13Cr-80 (Heat B) were tested in ferric chloride solution at 25°C and then decreased to 5°C for 72 hours. All the test specimens have the same dimension (Figure 1) with one surface marked and the others unmarked. After 72 hours, all surfaces were cleaned by flowing water, photographed, and weighed. Pit depth was also measured when pitting was observed.
