**Paper No.**  
**16671**

## **Pipe Preservation During Trenchless Installations: There's No Need to Take Unnecessary Risks**

Cristian Grecco  
TDC International AG  
Alpenstrasse 6  
6004 – Luzern  
Switzerland

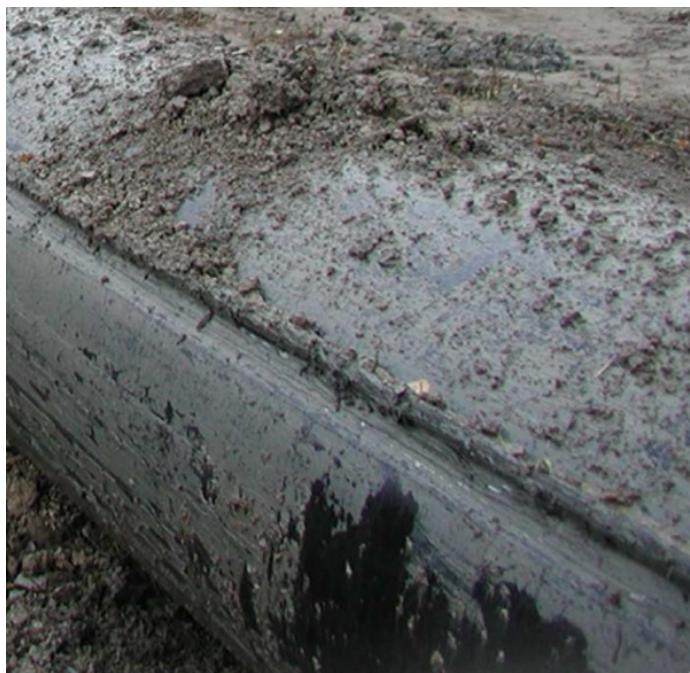
**Figure 1: Deep scratch damage during an HDD project**

At the same time, the trenchless industry has made sustained progress at achieving longer and larger crossings and therefore, most of these pipeline operators tried to install pipelines protected by three-layer coatings with varied results. In some cases, a reinforced layer of its outer layer was specified with the expectation of compensating losses due to abrasion. Many operators studied the use of polyolefin coatings exposed to high cutting and abrasive loads typical of trenchless installations and concluded that to obtain a suitable protection it is required to double or triple the coating thickness. However, other problems are created by such a simplistic approach. An image of a damaged polyethylene coated pipes is shown in Figure 1.

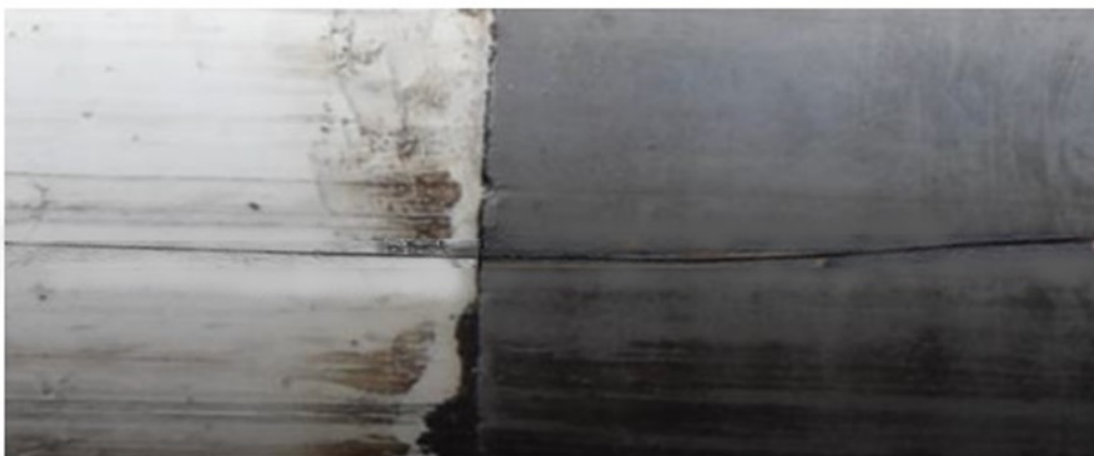
**Figure 2: Propagated crack due to release of internal stresses on a 3LPP coated pipe**

The application process of three-layer coatings is primarily achieved by sleeve or side extrusion of the polyolefin topcoat, where the material is brought to a fluid state achieved by friction between plastic particles and external heating. Immediately after the fluid thermoplastic film is laid onto the pipe surface, water jets cool the material back to its solid state. The consequence of the sudden change of state is the creation of internal stresses that are released as soon as the pipes are subjected to additional stress during installation. These residual stresses increase with an increased coating thickness. Adeniran et al.<sup>[1]</sup> explained the mechanisms involved. Figure 2 shows a crack through the coating reaching the base steel, which occurred during a HDD crossing.

These internal stresses are the root cause of cracks in the PE/PP anticorrosion coating that appear when pipe is bent to accommodate the shape of the crossing. They are also responsible for disbonding the coating at the pipe ends when pipes are exposed for a few months to the environment and the bare steel at the end of the pipes (cutbacks) starts to corrode.

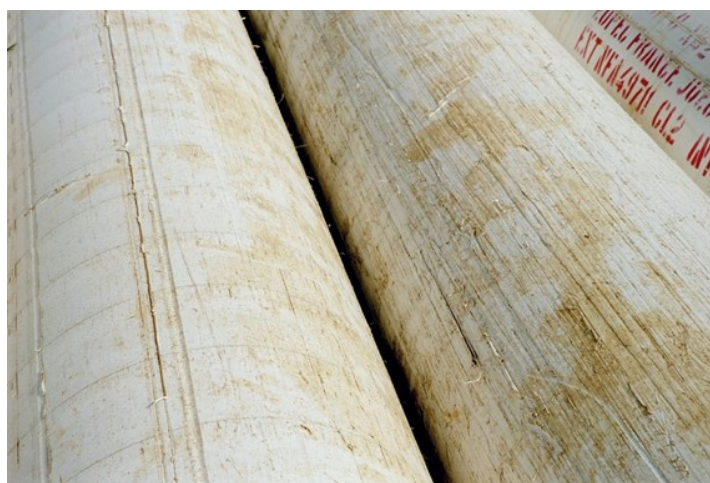
**Figure 3: Deep scratches occurred due to gouging of polypropylene coating**

A. Dam extensively tested polyolefin topcoats for resistance to sharp objects as part of Gasunie efforts to determine the most suitable coatings for trenchless installations<sup>[2]</sup>. The most interesting conclusion was that polypropylene showed ca. 25% higher resistance to scratches when compared to polyethylene, but the former is drastically damaged by very sharp shapes, which is consistent with field experience in France as seen in Figure 3. In this case the crossing was done through a geological formation of 80% chalk and 20% basalt rock that destroyed the polypropylene.
