## **Case Study: Foreign Operator DC Interference on An Existing Pipeline System**

Jessica Jaskolka  
EN Engineering LLC  
28100 Torch Pkwy Ste. 400  
Warrenville, IL 60555  
USA

Close Interval pipe-to-soil Surveys (CIS), Alternating Current Voltage Gradient (ACVG), and In-Line Inspection (ILI) data suggested corrosion activity on a buried gas transmission pipeline. An analysis of the survey results and additional testing in the field determined a foreign operator was responsible for static DC interference on the pipeline. This paper is a case study for the testing, analysis, and design for the interference.

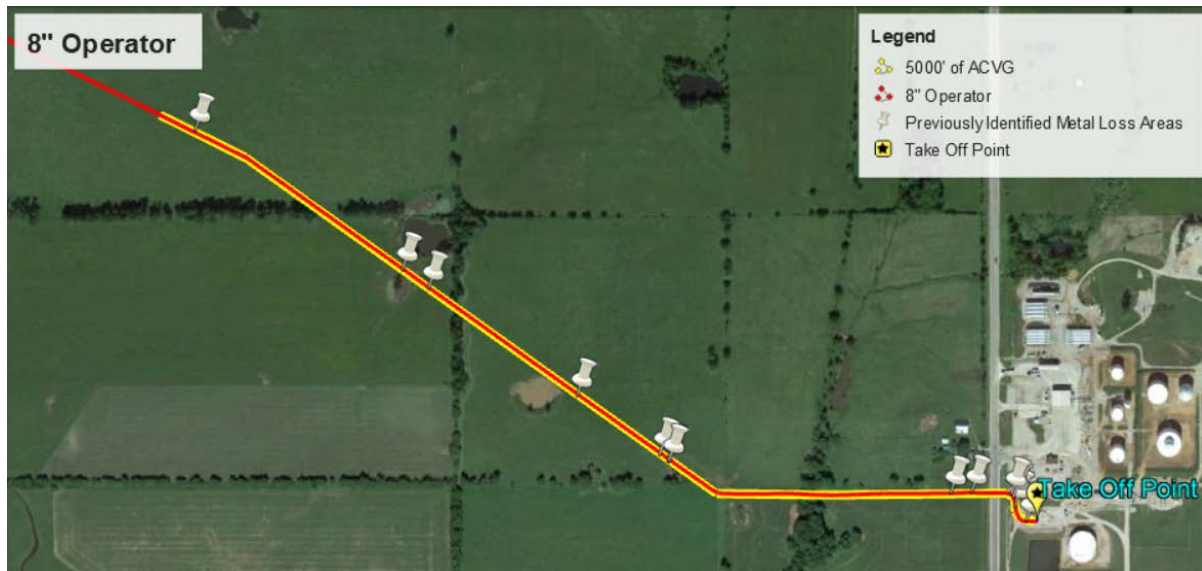
EN Engineering (ENE) completed an AC interference study over 68 miles of an operator's transmission line. In addition, an ACFG survey of approximately one (1) mile of the pipeline was conducted at the take-off point of the 8" line. The first 5000' surveyed via ACFG can be seen in **Figure 1**.

**Figure 1: Additional 5,000' segment surveyed**

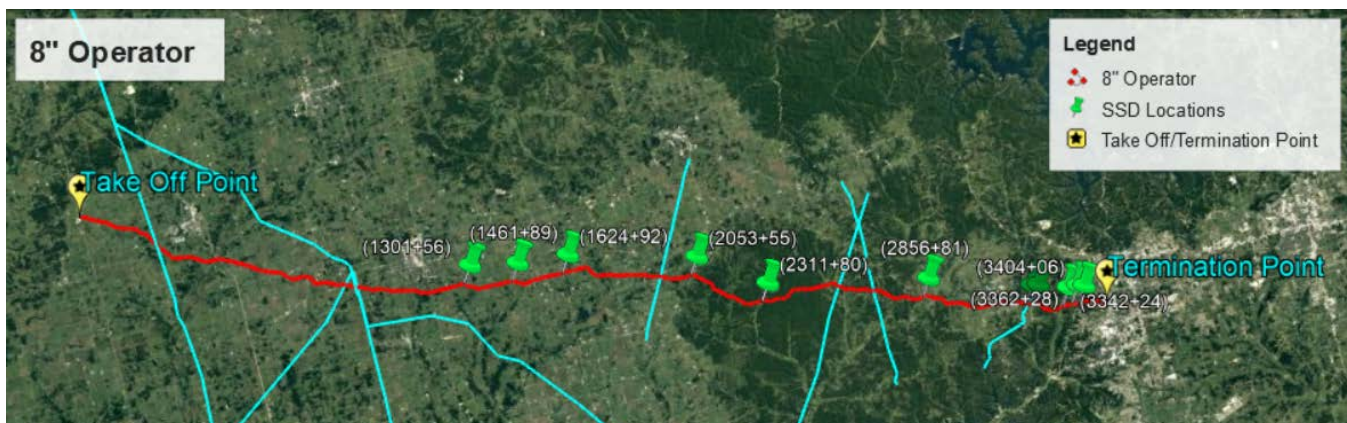
Previous annual test point surveys completed by the operator along the pipeline have shown AC potentials of up to 8 V<sub>AC</sub>. These readings are located near powerline crossings. Mitigation measures were designed by a third-party and have been installed. These mitigation measures include galvanic anodes connected to the pipeline through solid-state decouplers (SSD). These locations can be seen in **Figure 2**.

**Figure 2: Solid-State Decoupler (SSD) locations and powerline crossing locations**

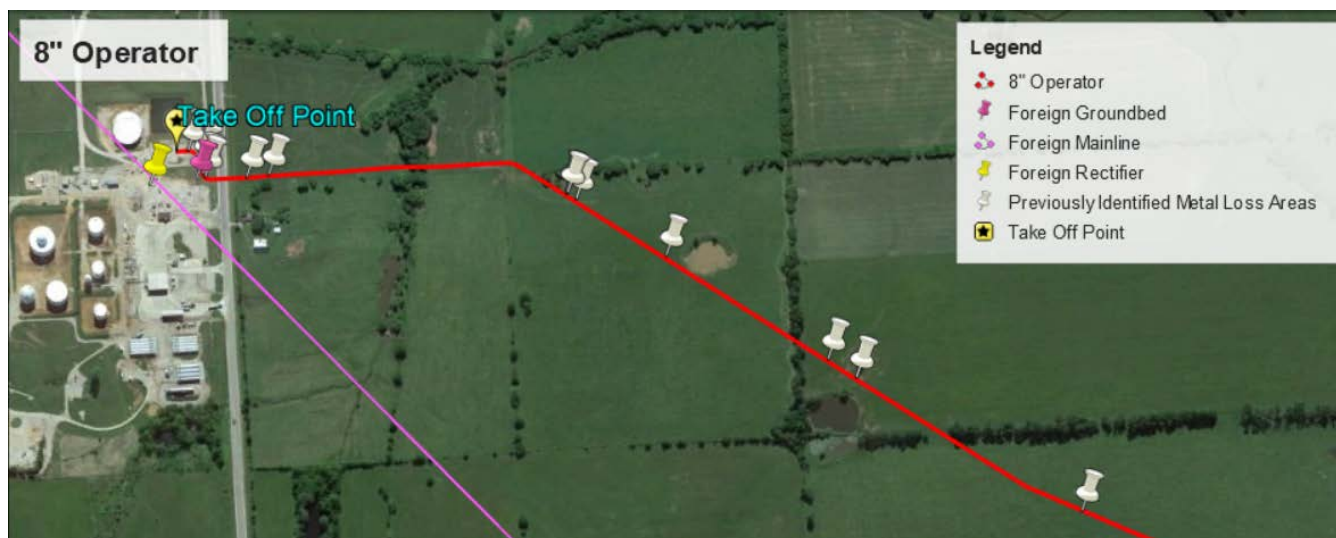
Within operator's station at the take-off point of the 8" line, there are seven (7) foreign rectifiers with one (1) previously identified as influencing the operator's line. There are two (2) rectifiers which protect the foreign mainline; one (1) also protects the station piping. The groundbed for this rectifier was installed by HDD method as a conventional horizontal arrangement. It is located within 70-ft of the operator's pipeline. An aerial image of the foreign mainline, rectifier groundbed. An aerial image of the foreign mainline, rectifier groundbed, operator's line, and ILI metal loss locations can be seen in **Figure 3**.

**Figure 3: Operator pipeline near take off showing metal loss areas**

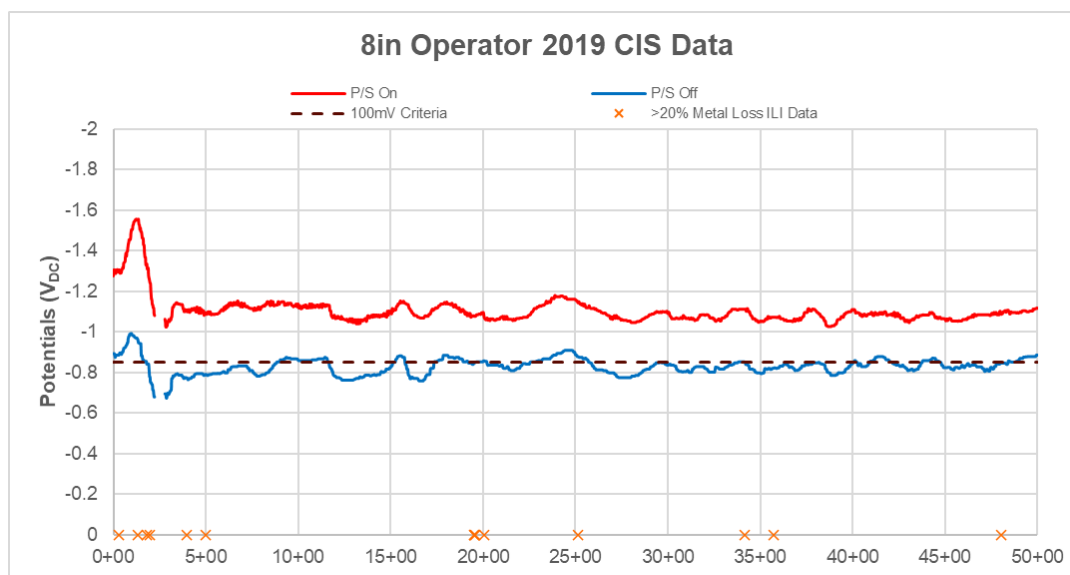
**Figure 4: 5000’ area of interest from the ON/OFF 2019 CIS**

The ON/OFF CIS plot shows the areas of ILI determined metal loss noted with “X” marks along with the “ON” and “OFF” potential reads. The “OFF” potentials dip below the -850mV requirement from stationing (0+00) to (20+00) and slowly move back into minimum requirement criteria beginning at stationing (20+00) to the end of the area at stationing (50+00). However, there are severely depressed areas noted at approximately (1+00), (37+50) and (45+00). These areas appear to have positive ON and OFF Readings.

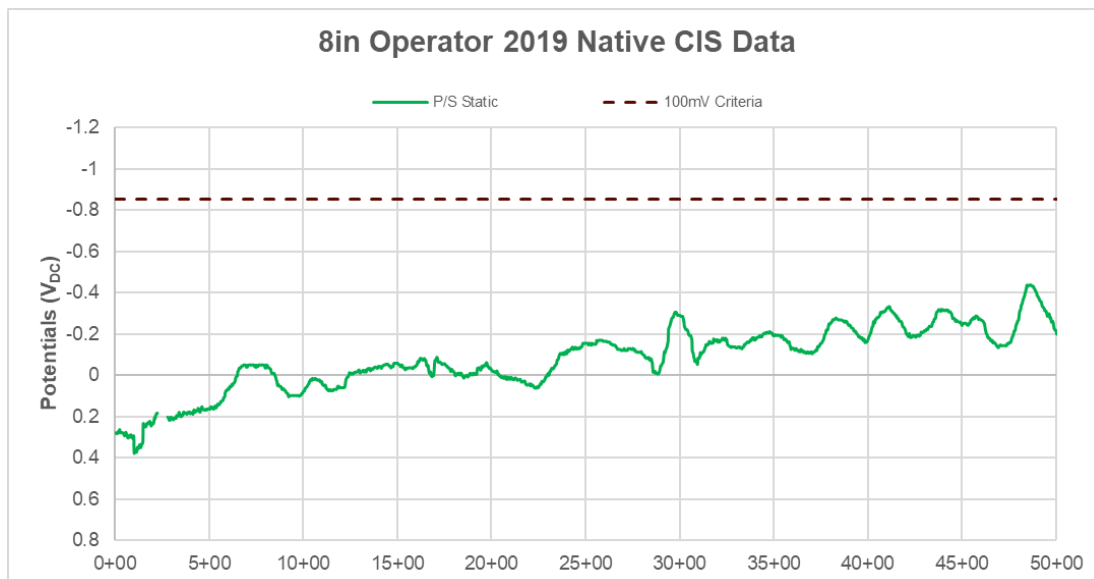
**Figure 5: 5000' area of interest from the 2019 Native CIS**

The native CIS graph shows the native potentials are positive from stationing (0+00) to (5+00) and slowly become more electronegative from stationing (5+00) to the end of the area of interest at stationing (50+00). From both the CIS and metal loss data provided, there is a strong suggestion of interference from the foreign operator; however, at the time, the cause was uncertain.

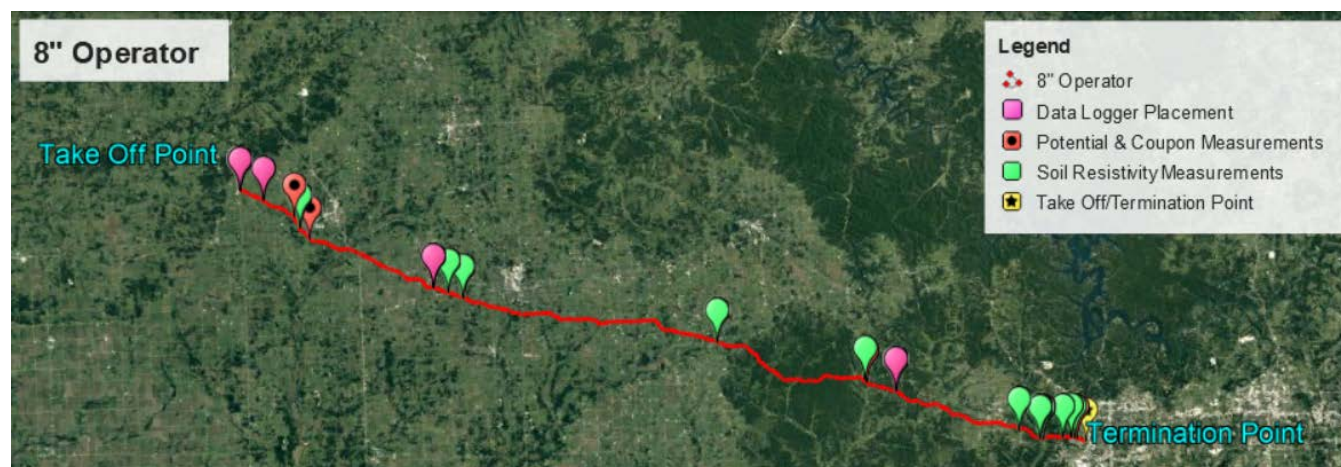
Data loggers measuring AC and DC potentials, were placed on the take off point of the pipeline in areas with the highest number of metal loss areas, foreign line crossings, and at powerline colocations. AC and DC current density and potential measurements were taken along the pipeline using a temporary AC coupon probe at various test stations. Soil resistivity measurements were taken in areas of foreign line crossings, powerline colocations, waterbody crossings, and areas where changes in topography occurred. Locations in which data loggers were placed, AC/DC current density and potential measurements were taken, and areas where soil resistivity was measured can be seen in **Figure 6**.

**Figure 6: Field data measurement locations**
