## Laboratory and Full-Scale Qualification of an Abrasion Resistant Overcoat Wrap

David B. Futch  
ADV Integrity, Inc.  
28246 FM 2920 Road  
Waller, Texas 77484  
United States of America

### ABSTRACT

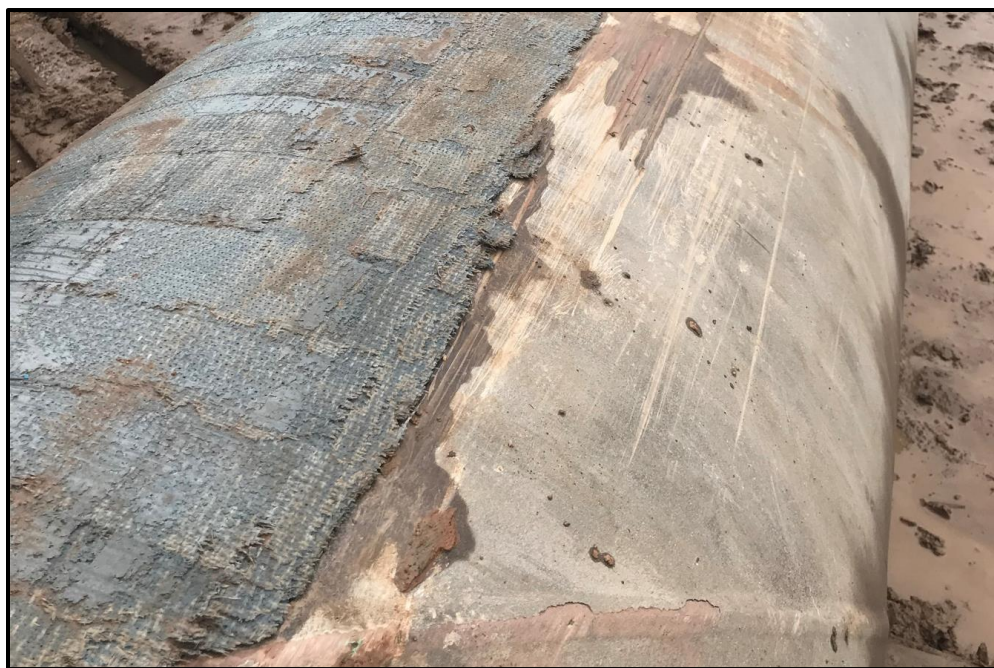
**Figure 1: Photograph of representative coating damage during an HDD.**

As onshore pipeline rights-of-way become more congested and urban sprawl increases, the number of horizontal directional drills (HDDs) will likely increase. HDD is a trenchless pipeline installation method that requires drilling a larger pilot hole where the mainline pipe can be subsequently pulled through the drilled hole. However, HDDs have an increased probability for coating damage, even when coated with traditional mill or field applied abrasion resistant overcoat (ARO). This coating damage includes abrasion, impact, gouging, denting, tearing, bending, etc. and that damage may exist for the life of the pipeline due to an HDD being inaccessible for future maintenance. Therefore, there remains a need for a high quality, sacrificial overcoat to protect the underlying coating, both on the mainline and field joints. A representative photograph of coating damage occurring during an actual HDD is shown in Figure 1. In this example, gouging occurred along the length of the pipe, both to the FBE+ARO base coating and sacrificial overcoating.

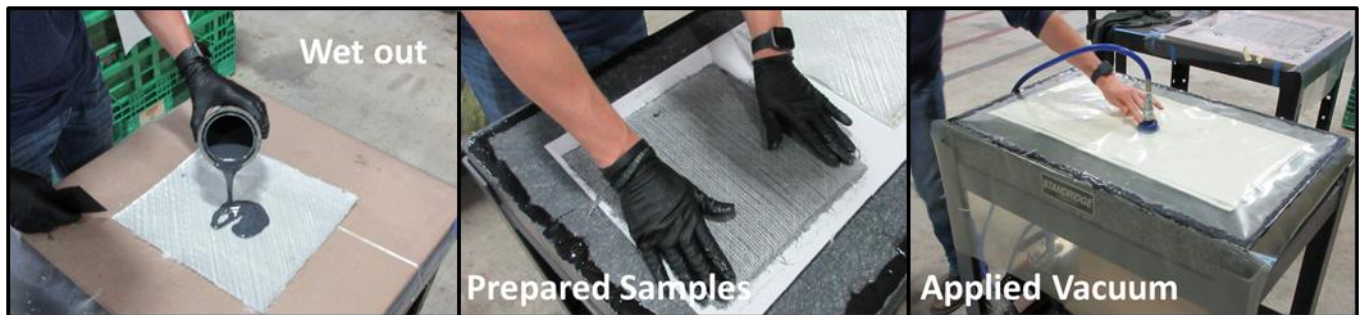
Figure 2: Preparation of composite panels.

Several laboratory bench-top tests were performed to qualify the ARO overcoat system. This included tensile tests, Taber Abrasion, and sub-scale gouge testing of the polymer matrix. Representative panels, 12-inches x 12-inches x 0.25-inch (0.3-m x 0.3-m x 6.4-mm), were fabricated using a vacuum table during the curing process, shown in Figure 2. This vacuum table helps to debulk composite materials by ensuring a consistent wet-out and cure under the application of a vacuum.
