## **On The Performance Of UNS S32100 vs N08825 Expansion Compensator Materials In Geothermal Applications**

### **ABSTRACT**

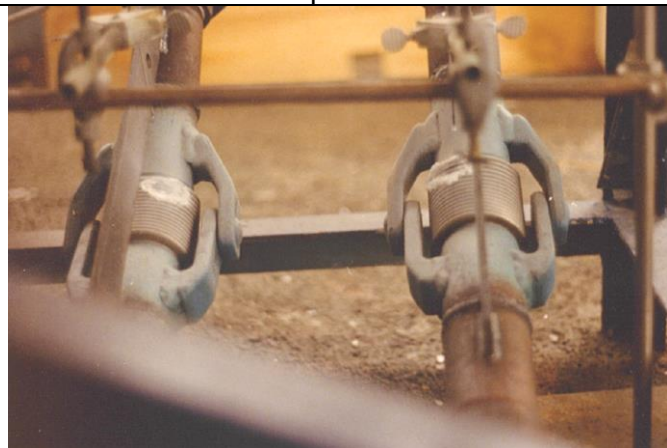
N08825 (left) and S32100 (right) with brine drip.

**Figure 1: Prestressed expansion compensator bellows units shown as received and in the 1<sup>st</sup> test arrangement with brine dripping onto the external surfaces.**

The initial drip of brine at 160 °C was near the bellows inlet end as shown in Figure 1 with heavy silica scales as shown in Figure 2 and was on opposite sides of the stressing bars for the two bellows units tested. The deposited silica was easily cleared from readily exposed surfaces, but some scale was left between the bellows convolutions at the start of the 2<sup>nd</sup> test. The 2<sup>nd</sup> test with condensate + 1% brine at 150 °C was also done with the solution dripped in the same location. Figure 3a shows the bellows at the end of the 2<sup>nd</sup> test. The 3<sup>rd</sup> and 4<sup>th</sup> tests at 105 °C were done with the drip solution near the bellows exit and on the opposite sides of the stressing bars than for the first two tests, but at the same locations for both the 3<sup>rd</sup> and 4<sup>th</sup> tests. Figure 3b shows the appearance of the bellows after the 3<sup>rd</sup> test.

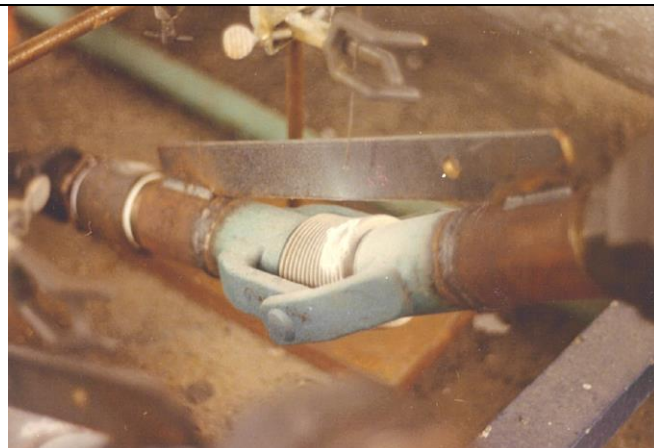
1<sup>st</sup> test of N08825 with brine drip.
