**A Novel Methodology for Addressing Corrosion Under Insulation (CUI) Utilizing Corrosion Inhibitor Impregnated Self-Amalgamating Silicone Based Tape**

Phillip Low  
Zerust Oil & Gas  
23900 Mercantile Road  
Beachwood, Ohio, 44122  
USA

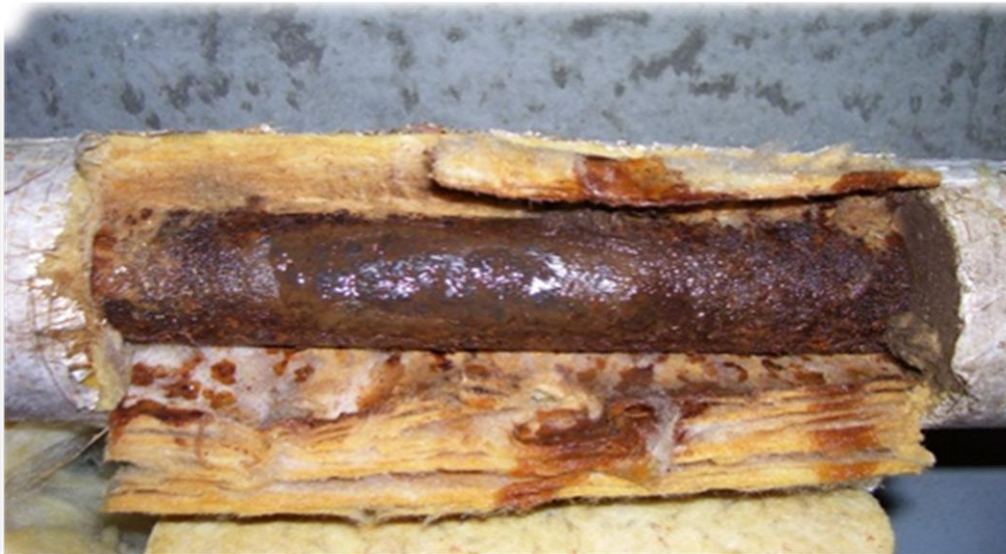
Coating failures, which can lead to holidays within the coating, can occur as a result of many factors such as: mechanical and ageing damage, cissing or contaminants, cratering, where solvent or surface chlorides, pinholes within the coating creating pathways for moisture and contaminants entering, coating damage due to the skill set of the applicator such as overcoating or undercoating potentially creating rash corrosion. Trying to create factory conditions in the field is a difficult task and trying to achieve an industrial blast cleaning<sup>4</sup> or a near white blast cleaning profile<sup>5</sup> in harsh environmental conditions is all known issues relating to coating failures. Environmental impact can play a large part in the CUI system breakdown as many assets are located coastal or offshore resulting in harsh climatic conditions. An example of CUI damage is shown below in Figure 1.

**Figure 1: CUI example**

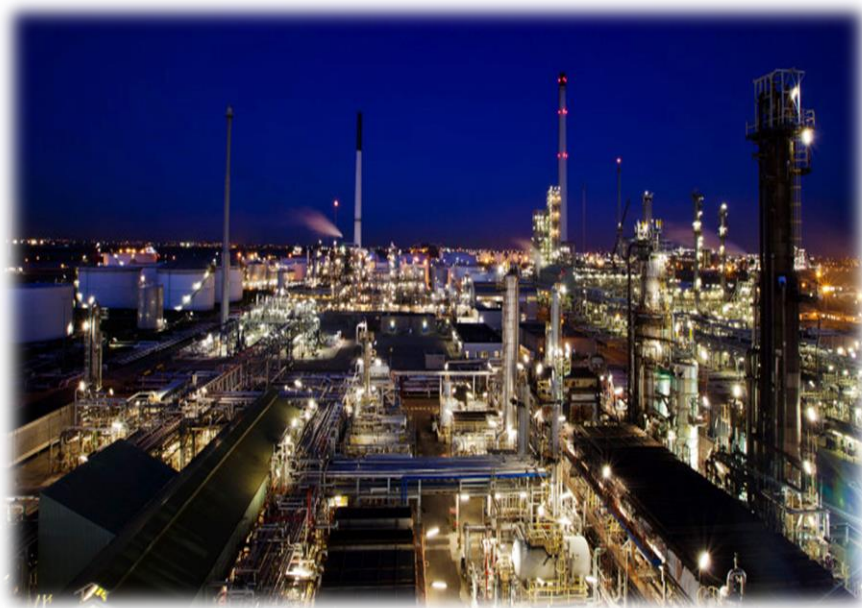
**Figure 2: Central European Refinery**

Two separate trial locations were utilized for conducting simple atmospheric corrosion protection case studies for the Tape. Asset 1, as seen in Figure 2, is a large refinery close to the climatic North Sea region., The refinery processes and stores multiple products petrochemical products.
