## Thinning of Inlet Piping to Reactor Effluent Air Condenser [REAC] Of Gas Oil Hydrotreating Unit - Case Study

Sudharsanan Soundararajan  
Abu Dhabi National Oil Company -Refining  
Al Ruwais, Abu Dhabi, PO Box 11885  
United Arab Emirates

### ABSTRACT

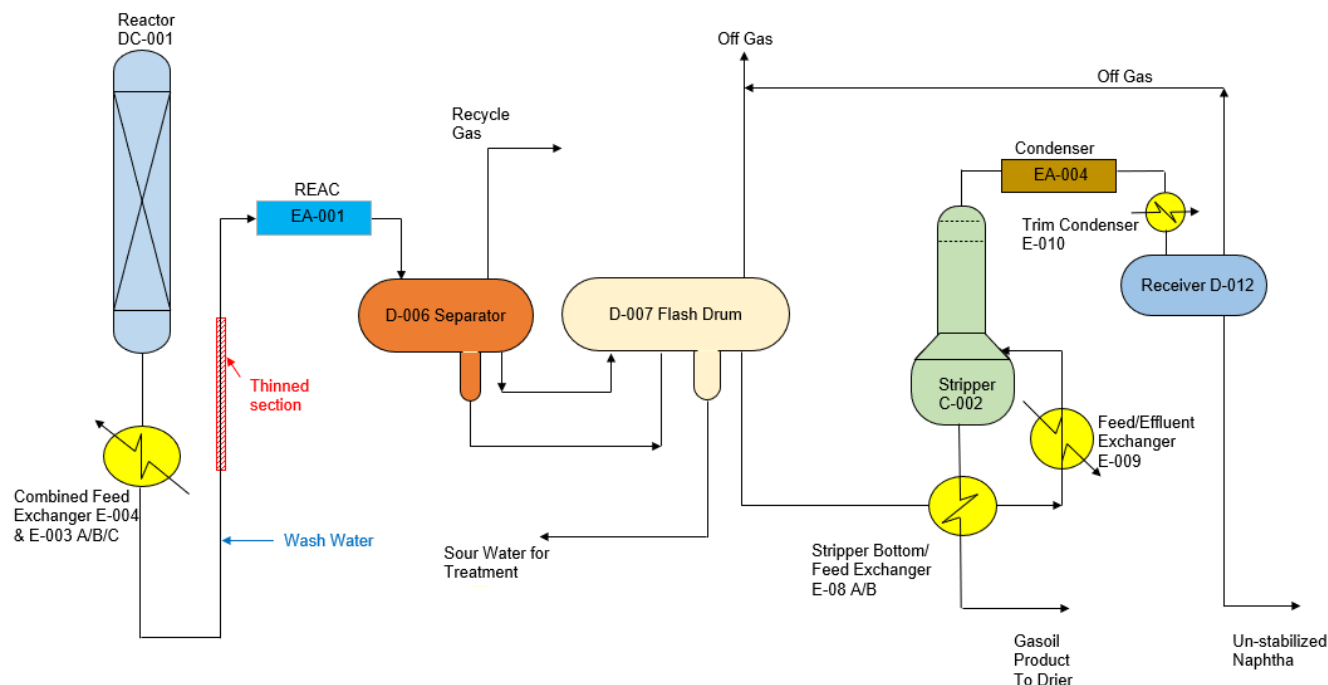
**Figure: 1 Process Flow Diagram of Reactor Effluent and Product separation system**

In this Gasoil Hydrotreater unit, the feed is a blend of Gasoil from Crude/Vacuum Distillation unit and Condensate splitting unit. The feed is mixed with hydrogen and it is preheated in series of Combined Feed Exchangers (CFE) followed by a Charge Heater and fed into Reactor, where denitrification and desulfurization reaction occur. The hydrotreated gasoil is cooled in CFEs to recover the heat for preheating and the final cooling of the reactor effluent is obtained in air fin coolers i.e., REAC. Water is injected into the stream before it enters the coolers in order to prevent the deposition of salts. In the stripper section, Sour gas and the Naphtha is separated from the Gasoil product. Refer Figure 1 for process flow of the Reactor effluent section.

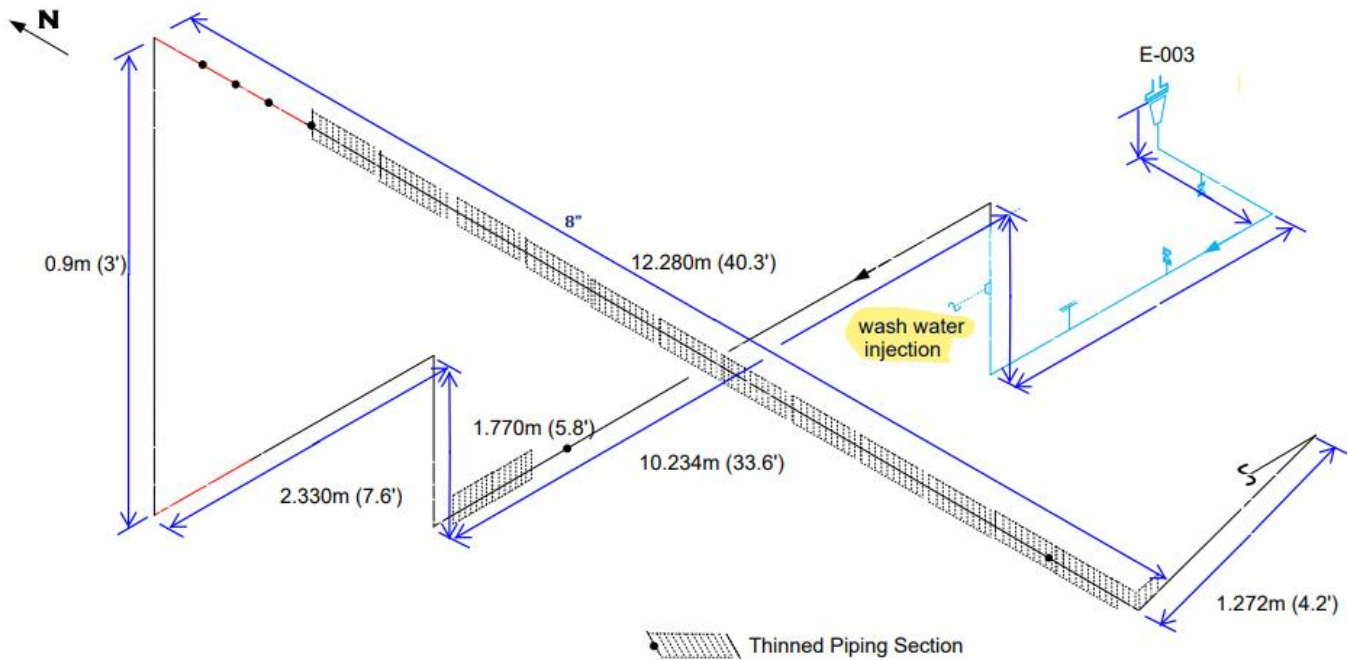
**Figure: 2 Isometric drawing of the E-03 outlet piping highlighted with thinned section**

During a turnaround inspection, as a part critical piping system, an extensive Ultrasonic Thickness (UT) survey was carried out on inlet piping to REAC. The metallurgy of the piping is ASTM<sup>(1)</sup> A 335<sup>2</sup> Gr P11 i.e., 1.25Cr-0.5Mo. The diameter and thickness of the pipe is DN200 (NPS 8") and 15.09mm (0.594"). The operating pressure & temperature of the pipe is around 60kg/cm<sup>2</sup> (865 Psi) & 150°C (275°F) respectively. The inspection coverage was over and above of recommendations for injection point inspection in API<sup>(2)</sup> 570<sup>3</sup>. Severe metal loss was observed on the piping downstream of wash injection. Thinned location is highlighted in Figure 1. The unusual observation was that there was no significant thickness loss at point of water injection or immediate downstream piping, but loss was predominantly on straight portions after 5 directional change, Refer Figure 2. The thickness loss was on the horizontal

piping portion downstream of continuous wash water injection point. Corrosion rates in excess of 1mm/year was noticed. However, no metal loss was observed on the subsequent vertical portion of piping up to REAC. All the thinned piping was replaced with same metallurgy. The removed pipe sample was split opened, and it was observed that metal loss is confined to top portion i.e., 10 to 2 o'clock position of the pipe only. Refer Figure 3 & 4 for photographs of the split opened pipe section. The morphology of failure is similar to that of acidic under deposit corrosion. Internal deposit from top section of the pipe was analyzed using Wavelength Dispersive X-ray Fluorescence method (WD XRF). The analysis revealed the deposit is predominantly an iron (Fe) based corrosion product with Sulfur (S), Chlorine (Cl) and Oxygen being the other contributing elements. The results are tabulated in Table-I.

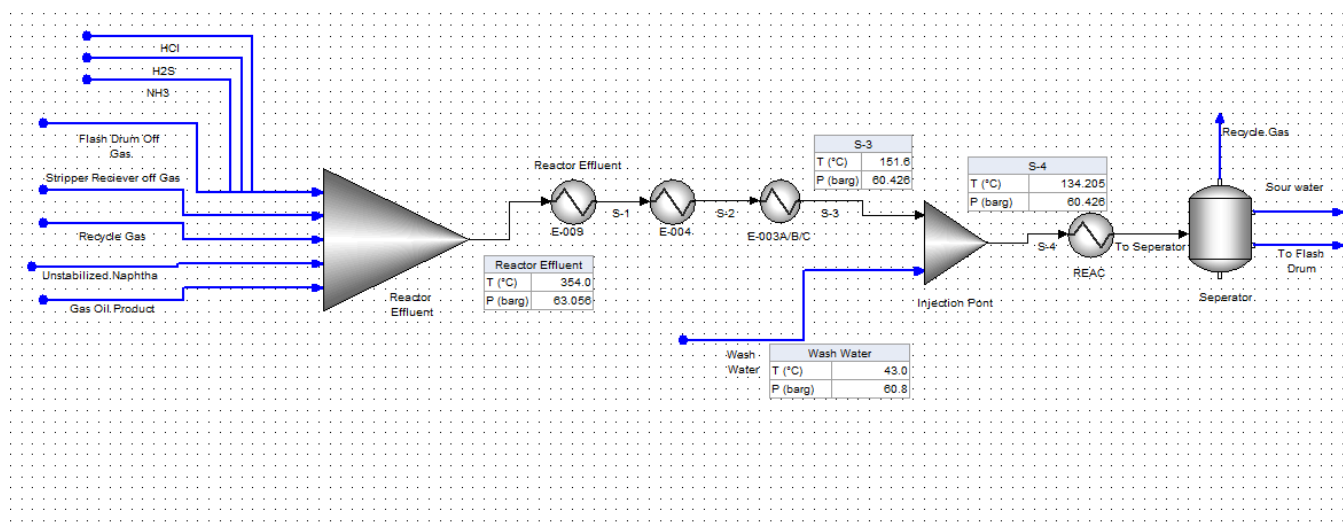
Figure: 5 Process Simulation Model

The process calculation to estimate the stream composition of reactor effluent was carried as per guidelines in Annex A3 of API 932B<sup>7</sup>. The reactor effluent is separated into Diesel Product, Unstabilized Naphtha, Recycle Hydrogen and Off gas. These streams were back blended to simulate the reactor effluent stream and the chemistry was analysed using Mixed Solvent Electrolyte (MSE) model of OLI<sup>†</sup> Systems. As per simulation, the quantity of injected water that remains in the aqueous phase after equilibrium flash is 76%. The estimated ammonium chloride ( $\text{NH}_4\text{Cl}$ ) precipitation temperature is 180°C (356°F) and there is no precipitation of ammonium bisulfide salts ( $\text{NH}_4\text{HS}$ ). The temperature survey of stream S-4, refer Figure 6, revealed that conditions are not favorable for precipitation of salts and pH is above 6.2 at the region of interest.
