# Corrosion and Mitigation Techniques for Fire Protection Piping Systems

2022-09-04: Developed by AMPP Standards Committee (SC) 18, Water/Wastewater

AMPP TR21544-2022

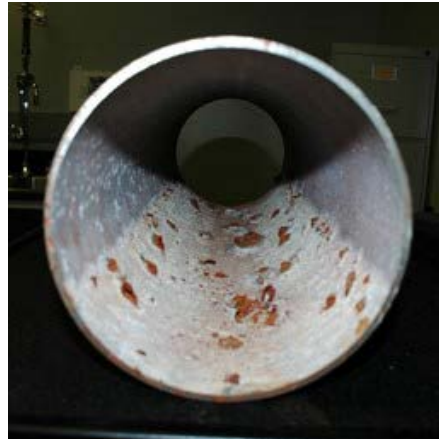
**Figure 1: Photograph Showing Corrosion of Galvanized Steel Pipe (NPS 6, Schedule 10) Where Residual Water Filled Approximately 40% of the Pipe's Volume in a Dry Pipe System (Image Courtesy of FM Global. Used with Permission. © 2014 FM Global. All Rights Reserved).**

Figure 1 shows corrosion of galvanized steel pipe (Nominal Pipe Size [NPS] 6, Schedule 10) where residual water filled approximately 40% of the pipe's volume in a dry pipe system.<sup>4</sup> Experience shows that galvanized pipe in dry and preaction systems with residual water (originating from initial hydrotesting or subsequent flow testing) can develop through-wall corrosion leaks within as little as 2-3 years after installation, due to residual water within such systems.

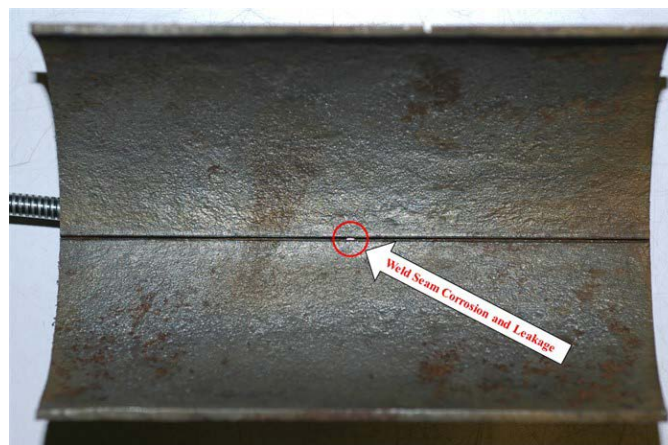
**Figure 3: Photograph Showing Preferential Grooving Corrosion on Pipe Weld Seam with a 1 mm Pinhole Leak in a Wet Pipe System, after Removing Corrosion Products inside an NPS 3 Pipe**  
(Image Courtesy of FM Global. Used with Permission. © 2014 FM Global. All Rights Reserved).

Figure 3 shows an example of preferential grooving corrosion on a pipe weld seam inside an NPS 3 carbon steel pipe (after removal of corrosion product deposits) in a wet pipe system with a 1 mm pinhole leak located in the weld seam. In addition, the grooving corrosion of a longitudinal through-wall leakage in a galvanized steel pipe along its weld seam in a preaction system is shown in [Figure 4](#). The leak occurred beneath a large tubercle along the pipe’s approximate 6 o’clock installed position.
