# RECOVERY OF FOUR OILED WETLANDS SUBJECTED TO *IN SITU* BURNING

Regulatory Analysis & Scientific Affairs  
Publication Number 4724  
September 2002

## **RECOVERY OF FOUR OILED WETLANDS SUBJECTED TO *IN SITU* BURNING**

Jacqueline Michel, Zach Nixon, and Heidi Hinkeldey  
Research Planning, Inc.  
Columbia, South Carolina 29202

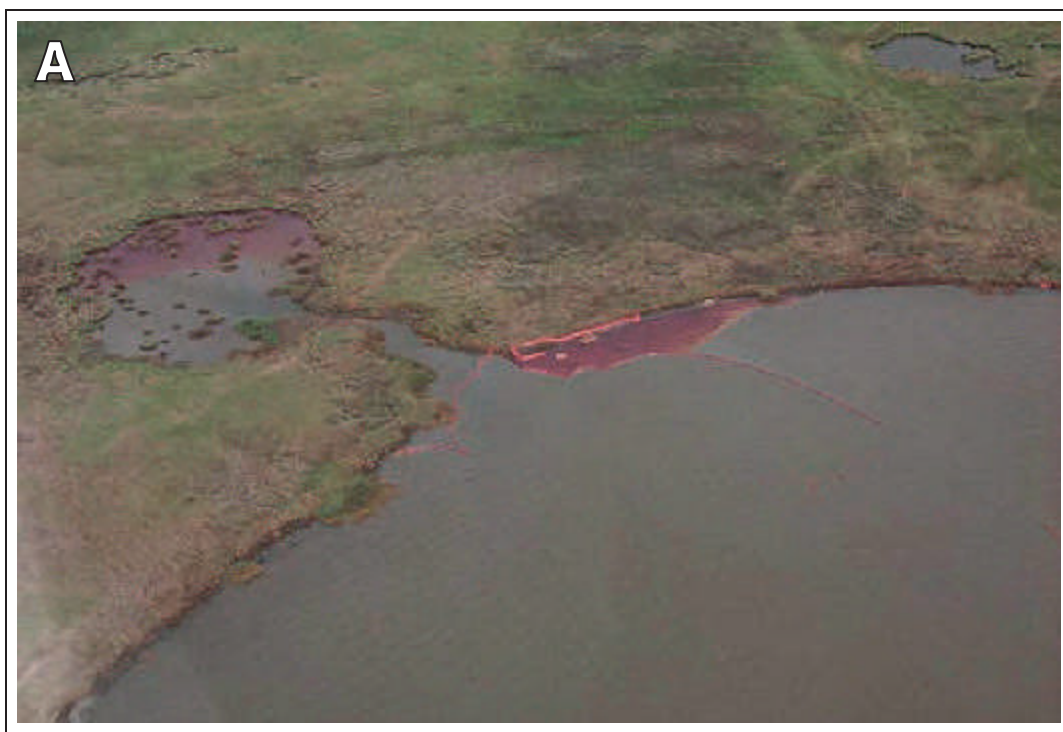
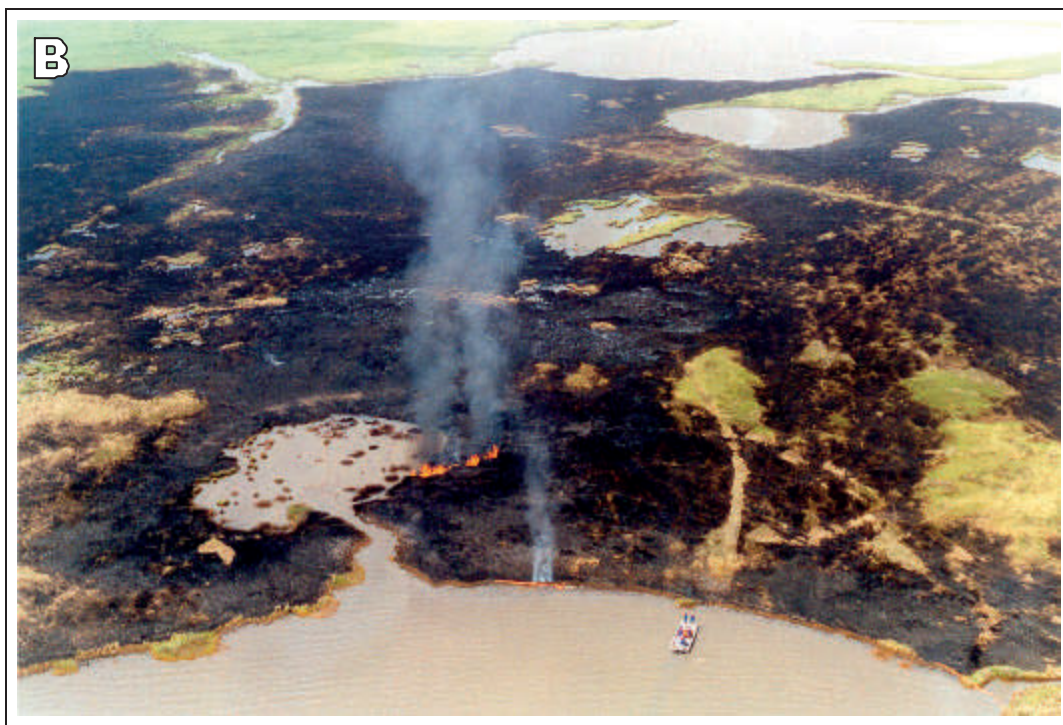
**Figure 2-2.** **A.** The small bay to the west of the original release site and the site of the first burn. Note oil accumulated against the outer bank and in the bay, taken on 9 April 2001. **B.** Zone 1 on 12 April 2001, 1 hour after the first burn ended. The firebreak is barely discernible as an arc around the small bay. The marsh burned to the downwind water's edge in most areas.

- A firebreak was placed around the burn site by repeated passes with an airboat. A flare gun was used to ignite free-floating oil held in a boom against the marsh (Fig. 2-2A).

- Once started, the fire burned quickly downwind, jumped the firebreak, and burned to the water's edge or to large patches of black rush or sedges. Figure 2-2B is an aerial photograph taken after the burn on 12 April. Note the edge of the burned areas. Twenty rails were observed to be killed by the flames.

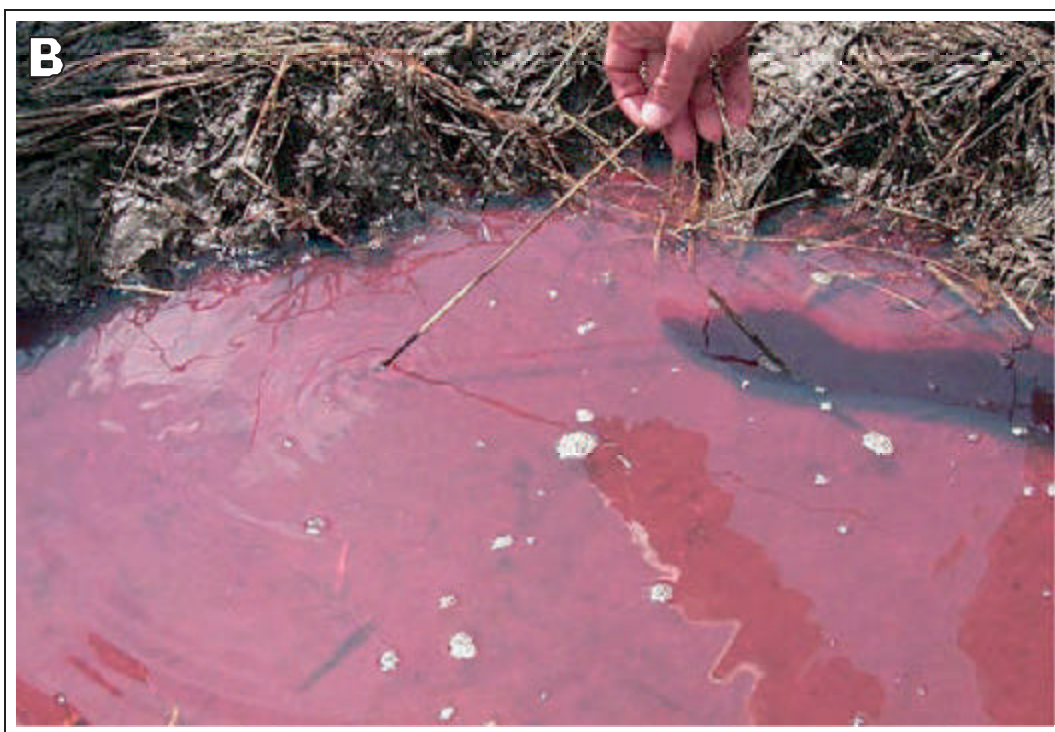
**Figure 2-3.** **A.** Condensate pooled to about 0.5 cm thick in dense vegetation, close to the release site. The dark material on the vegetation stems in the lower left corner is mud, not oil. The condensate is yellow in color. **B.** Condensate that accumulated in a small trench dug into the marsh soils adjacent to the release site. Within minutes, 1 cm of oil seeped out of adjacent sediments. At low tide, the oil penetrated the many crab burrows.

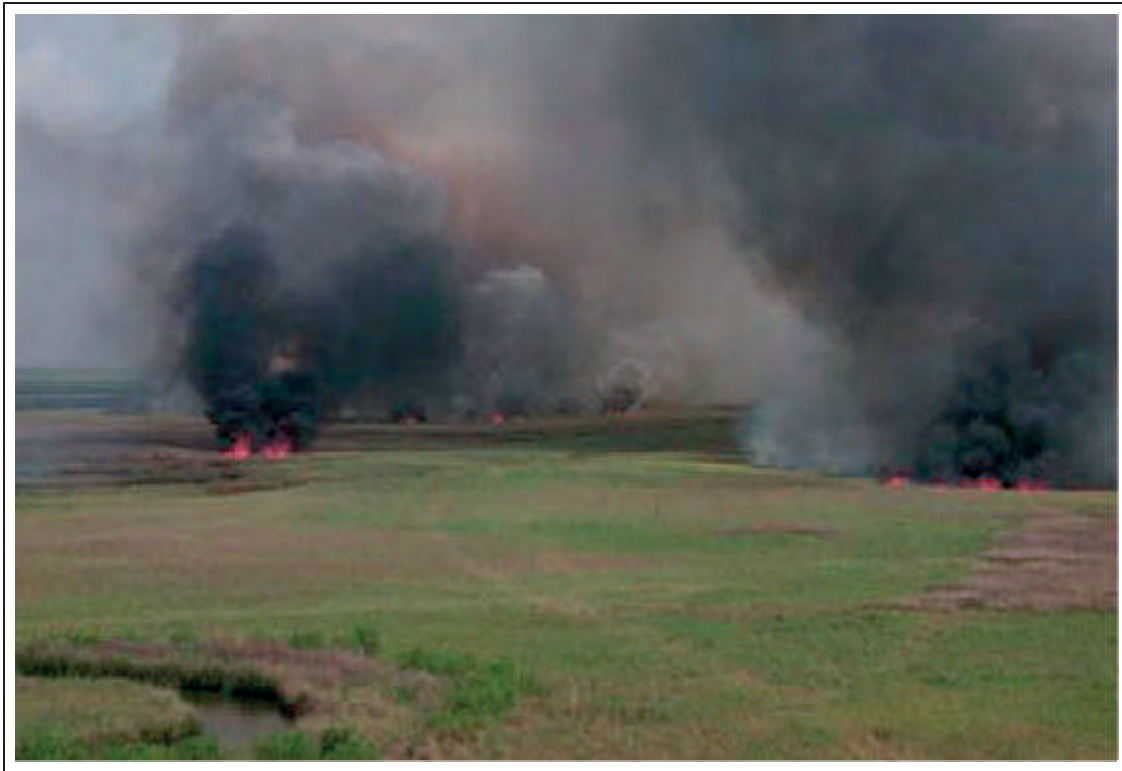
**Figure 2-4.** The second burn was conducted in the morning on 13 April. Fires were started where the oil pooled on the surface. The oiled areas burned with black smoke, whereas the unoiled vegetation burned with lighter gray smoke.

- Once again, the fire burned both oiled and unoiled vegetation, stopping mostly at the water's edge. The smoke burned black in oiled areas, whereas in unoiled areas, the smoke was light gray to white (Fig. 2-4).

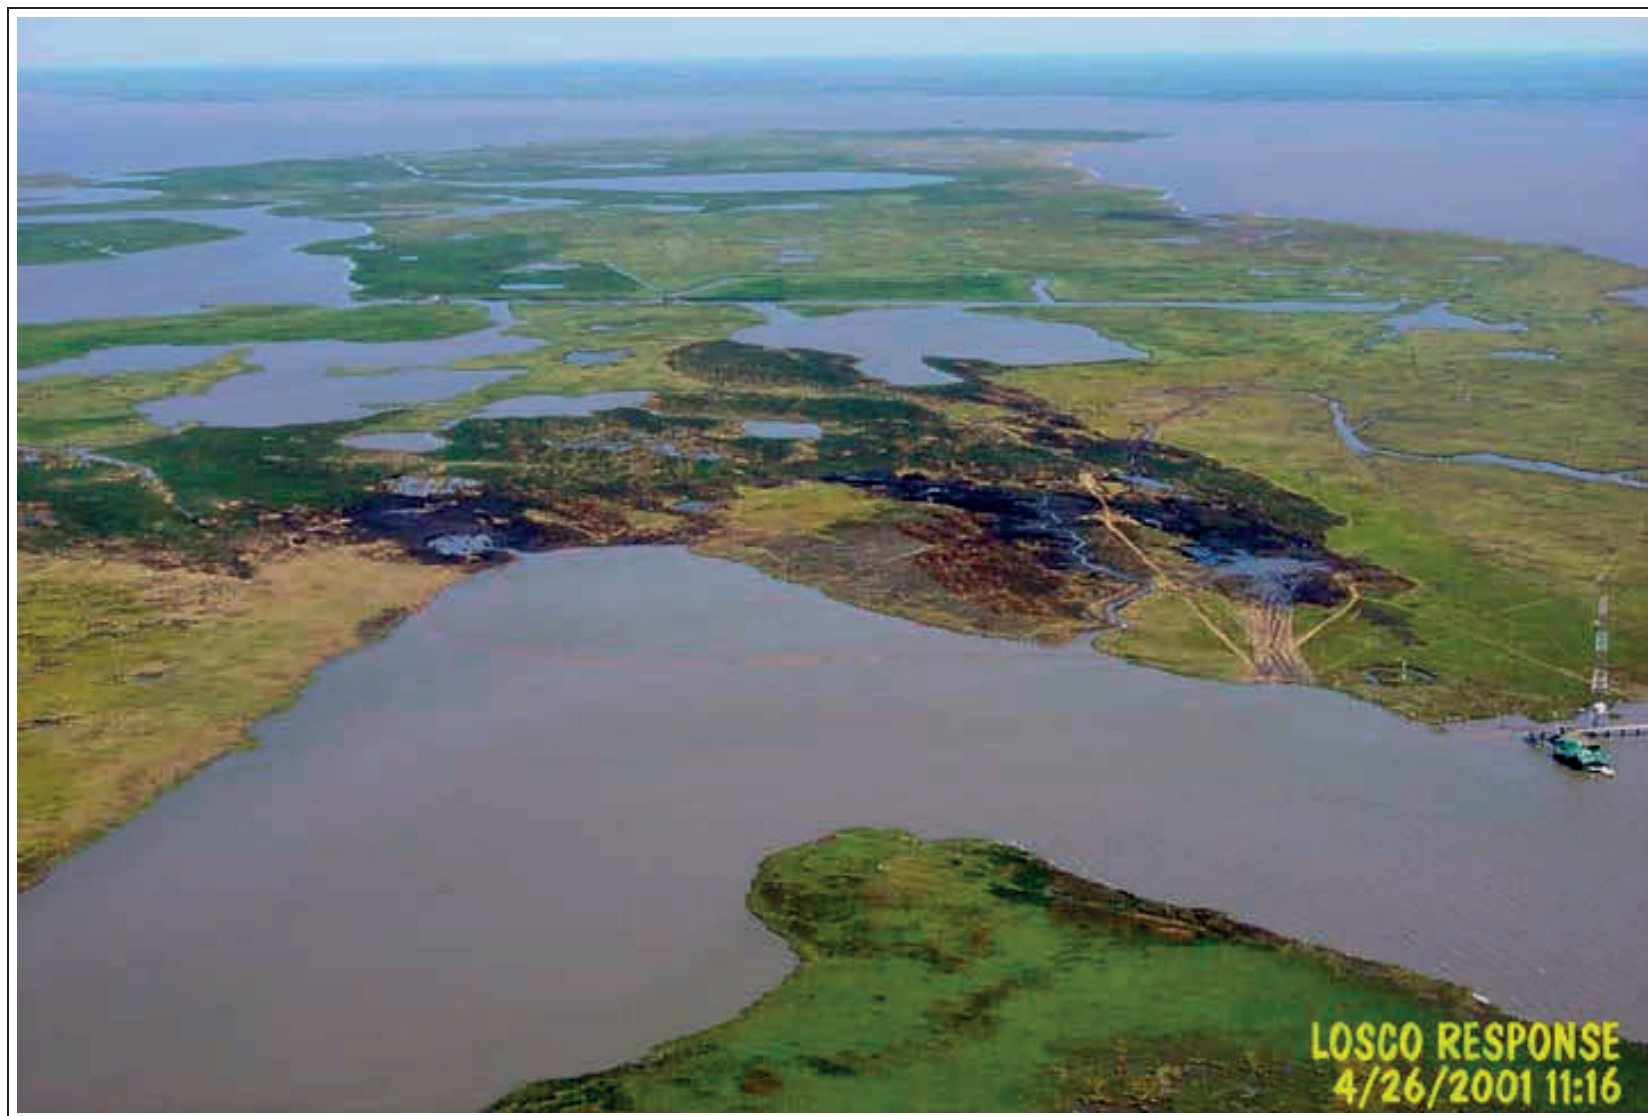
**Figure 2-5A.** Oblique view of the Mosquito Bay burn site on 26 April 2001, two weeks after the burn. The oiled/burned areas look blacker in color than the unoiled/burned areas. Note that the fire burned downwind (toward the top of the photograph) until it reached the water's edge in most places.

All of these areas were sites of pooled oil, as observed on the ground prior to the burn and indicated by the blackened patterns in Figure 2-5A, taken two weeks after the burn. The oil tended to pool at the release site, along drainage channels, and in depressions in the marsh surface. As discussed below, it is believed that these areas were exposed to high concentrations of condensate that penetrated into the soils during low tide, causing plant mortality prior to the burn.

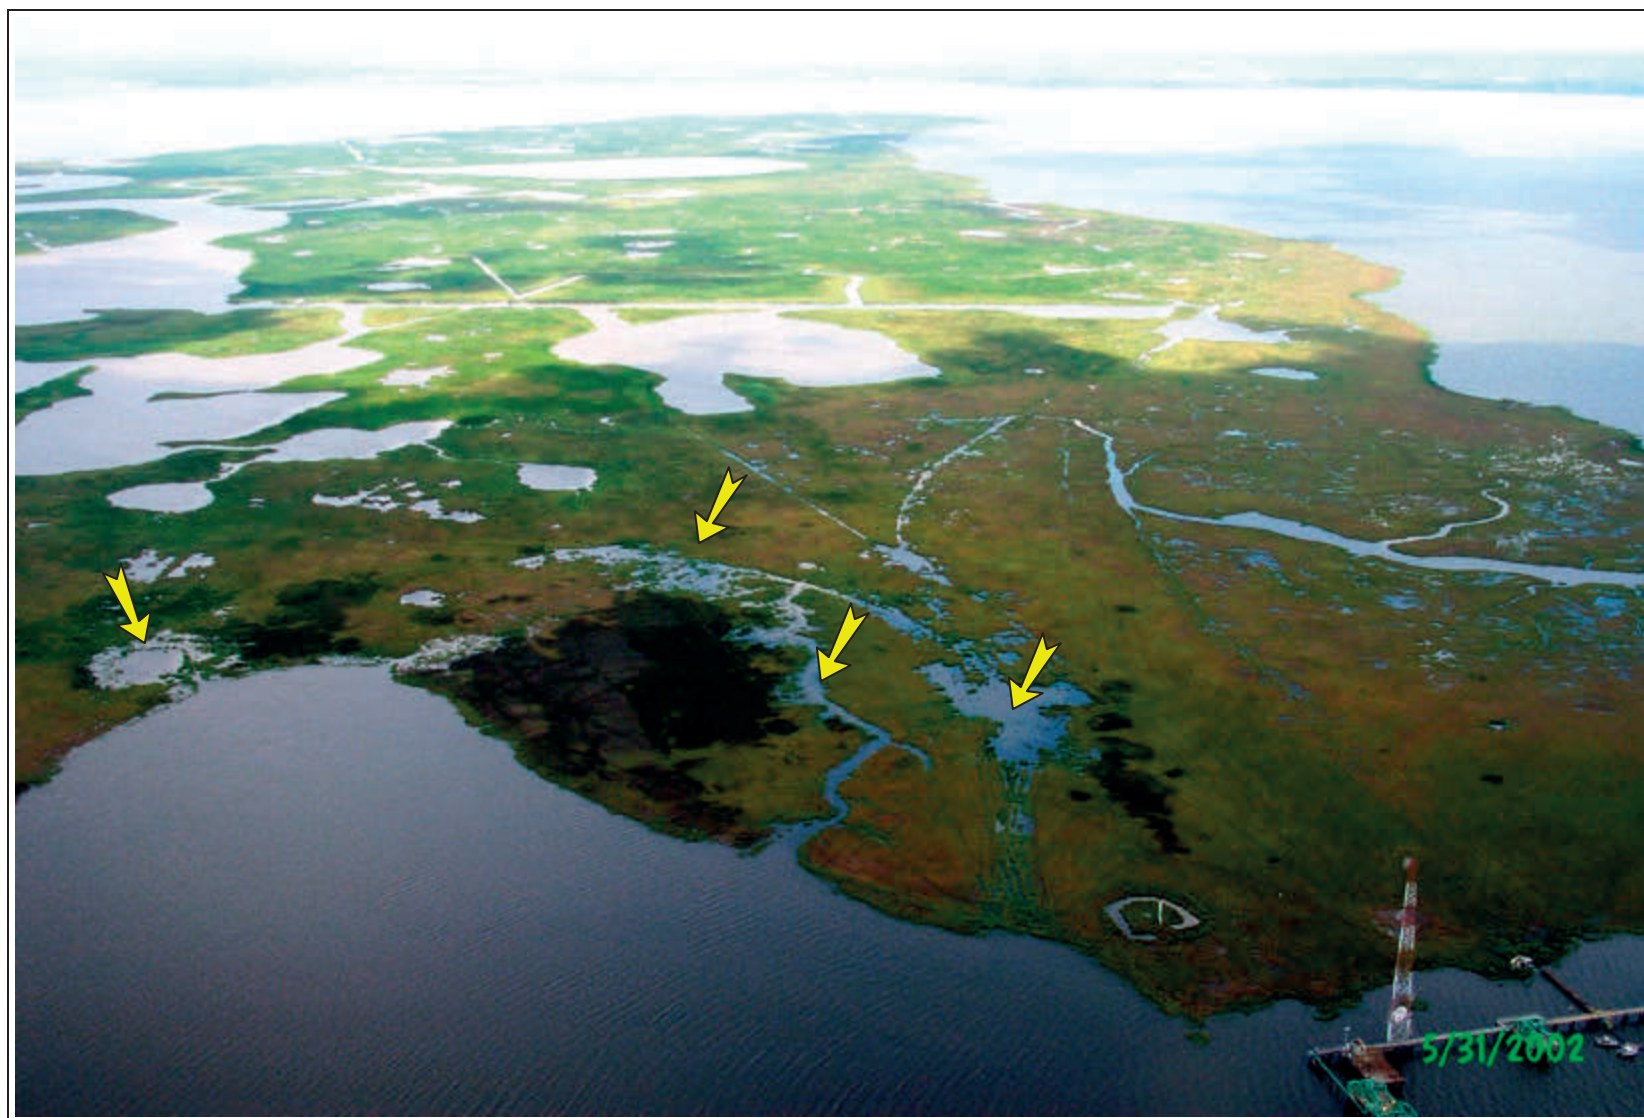
**Figure 2-5B.** Oblique view of the Mosquito Bay burn site on 31 May 2002, 13 months after the burn. The arrows point to the areas where the vegetation has not recovered from east to west around the release site, the channel, open areas north of the dark patch of vegetation, which is black needle rush (*Juncus*), and the small bay to the west.

On the May 2001 vertical photograph (Fig. 2-6) and the May 2002 oblique aerial photographs (Fig. 2-5B), the unoiled and burned areas show the “greening up” that typically follows marsh vegetation burns. Based on field observations in 2001 and 2002, the unoiled and burned vegetation was recovering as expected after a burn.

- 3) An area of open water just to the north of the dark patch of black needle rush (*Juncus*) that does not appear as open water in Figure 2-5A; and
- 4) The small bay to the west of the release site. Comparison of the two photographs in Figure 2-5 shows that a band of vegetation about 5 meters around the bay died back. Figures 2-8 and 2-9 show ground photographs at this site pre- and post-burn. In October 2001, it is clear that the vegetation was killed and did not recover. However, plugs of vegetation planted in May 2001 along the channel to the bay survived, indicating that the soils were no longer toxic (Fig. 2-10).

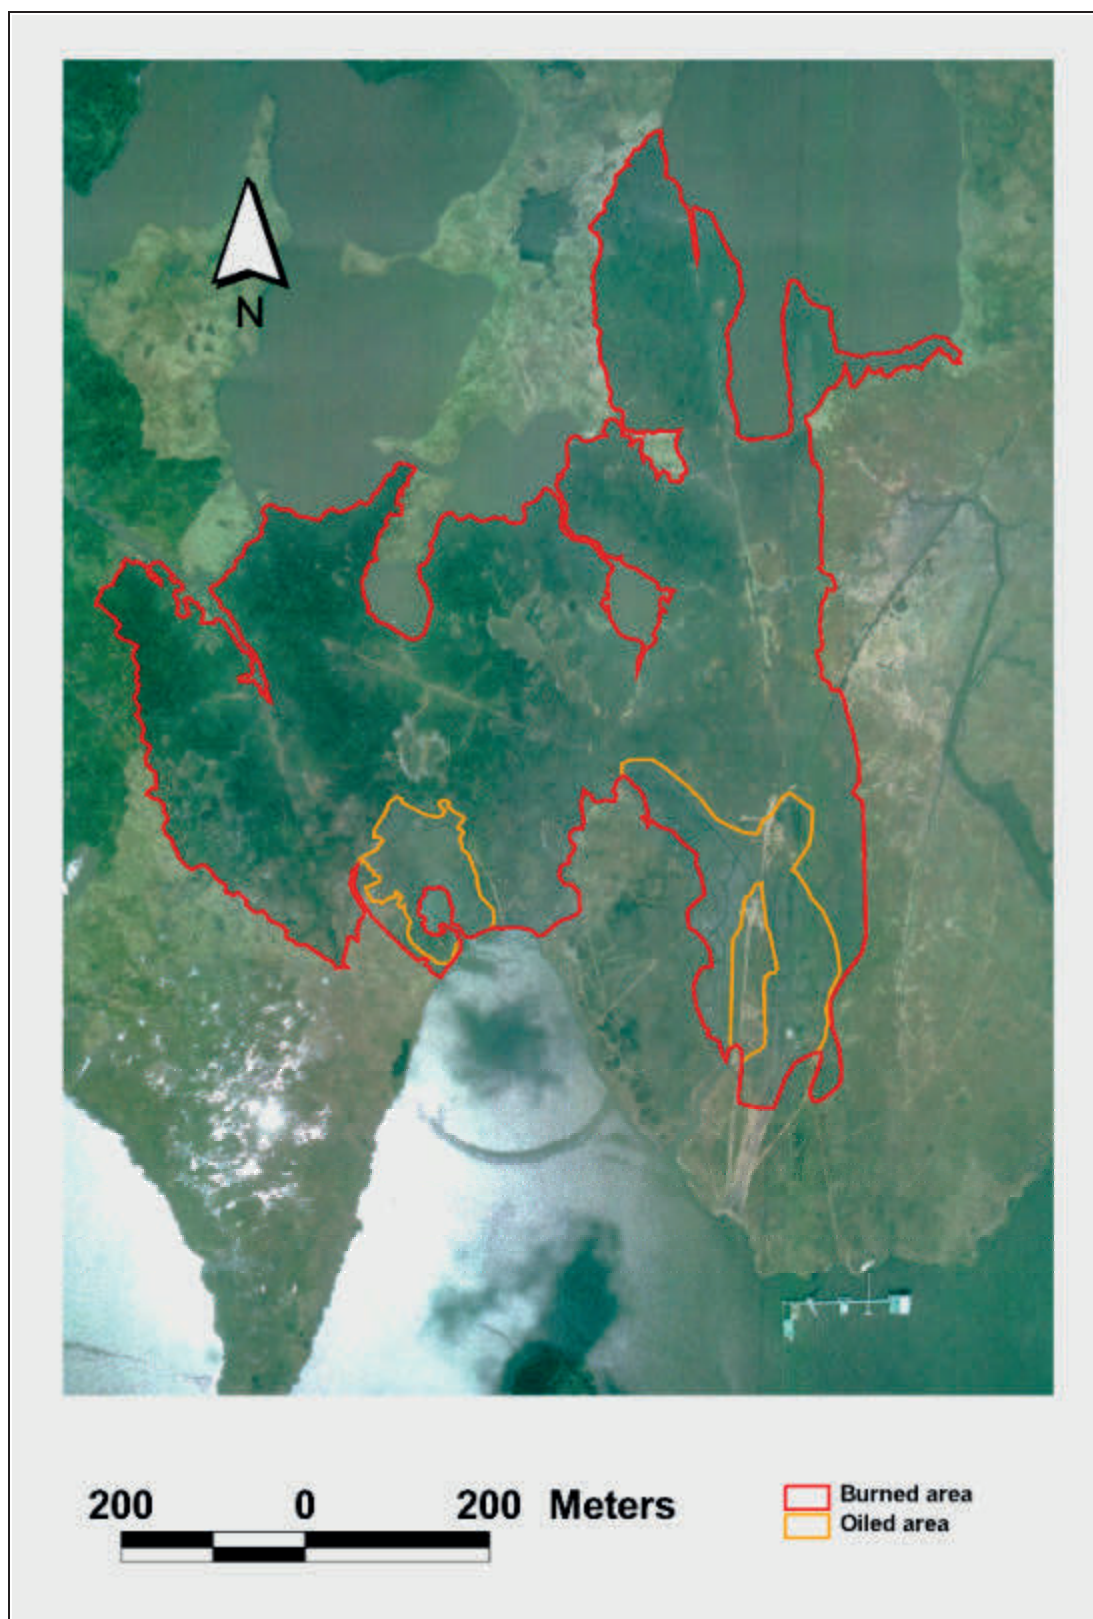
**Figure 2-6.** Vertical aerial photograph of the Mosquito Bay burn site on 5 May 2001. The oiled and burned areas are outlined. An estimated 12 acres were oiled; 98 acres were burned.

Ground surveys and the May 2001 post-burn vertical aerial photograph (Fig. 2-6) were used to estimate the area that was oiled and the total area that was burned. The oiled area covered an estimated 12 acres, whereas the burned area extended over 98 acres. Thus, the burned area was about eight times the oiled area.

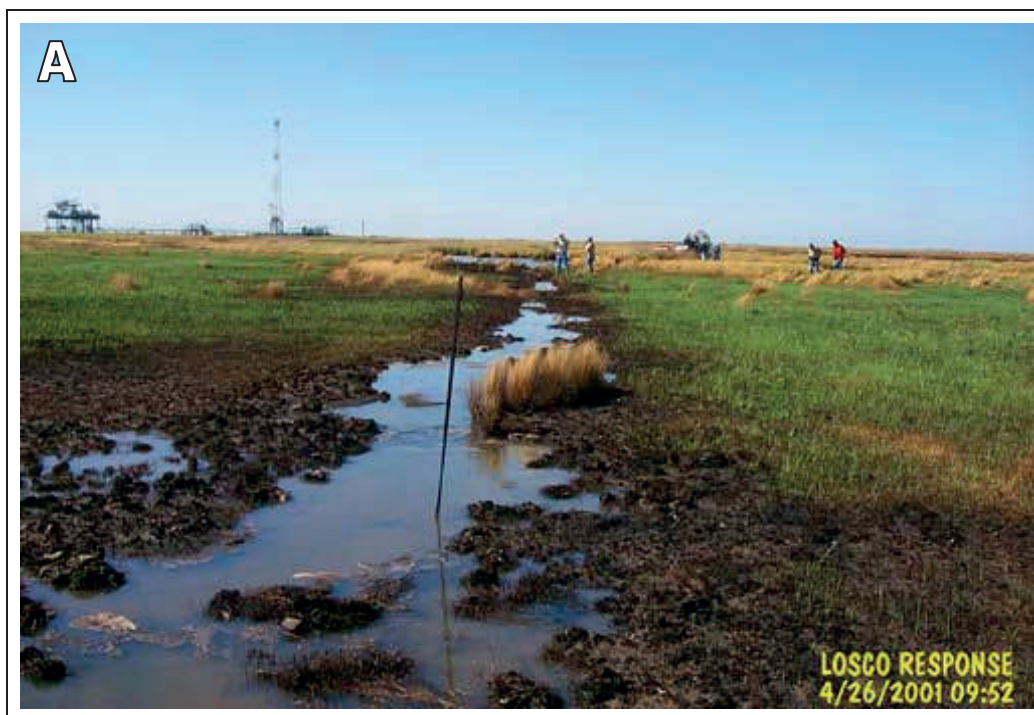
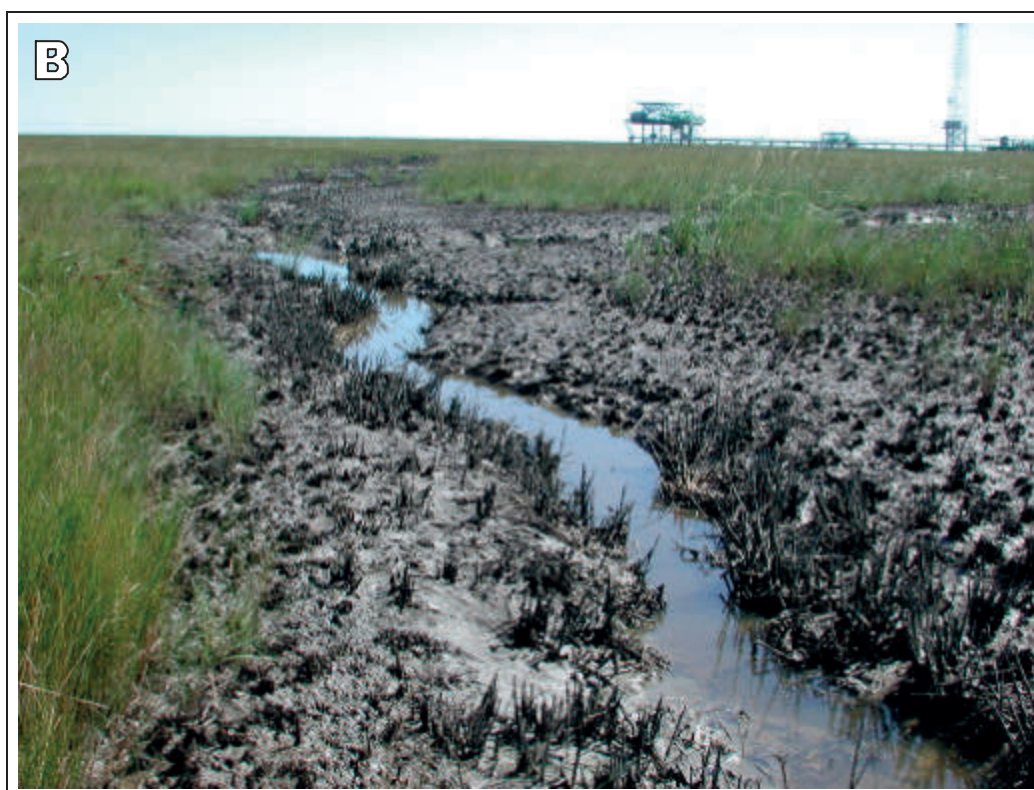
**Figure 2-7.** Main creek channel along which the condensate flowed from the release site.  
**A.** 26 April 2001, 14 days post-burn; lightly oiled/burned vegetation had started to re-grow.  
**B.** 17 October 2001, six months post-burn; no re-growth of the heavily oiled vegetation along the bank, but good recovery for the lightly oiled adjacent vegetation.

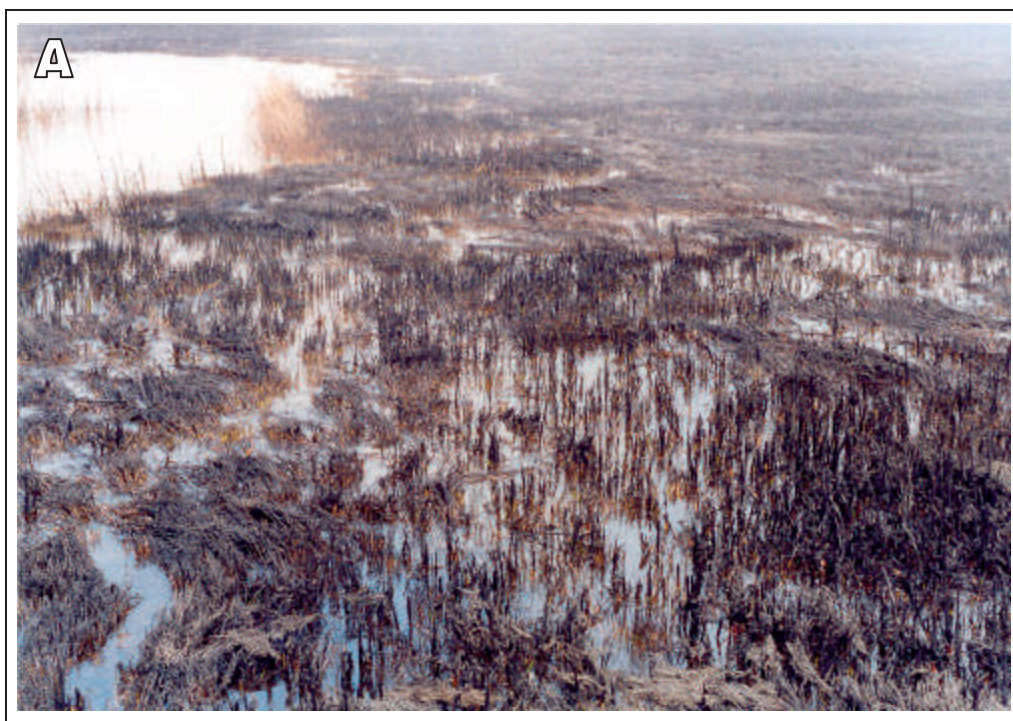
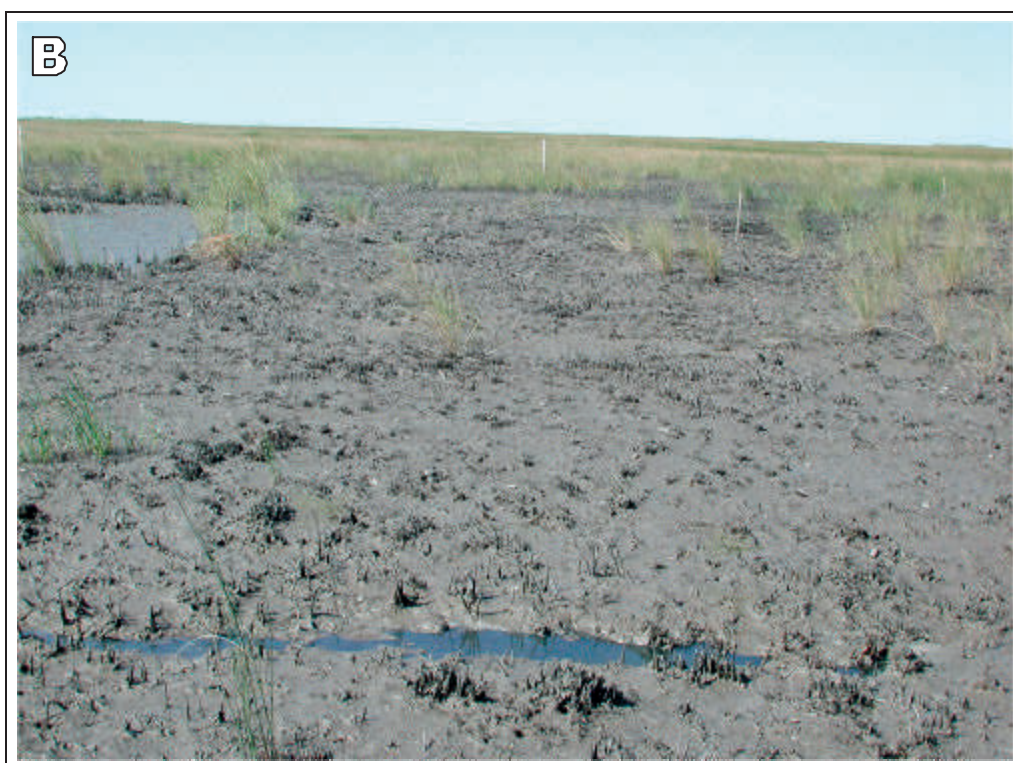
**Figure 2-8.** First burn area (Zone 1). The condensate had pooled on the marsh surface and penetrated burrows during the 6-7 days between the spill and the burn. **A.** One hour after the first burn on 12 April. There were several cm of water on the marsh surface during the burn, as indicated by the plant stems. **B.** 17 October 2001, 6 months post-burn. All of the vegetation in the heavily oiled areas died, with no recovery.

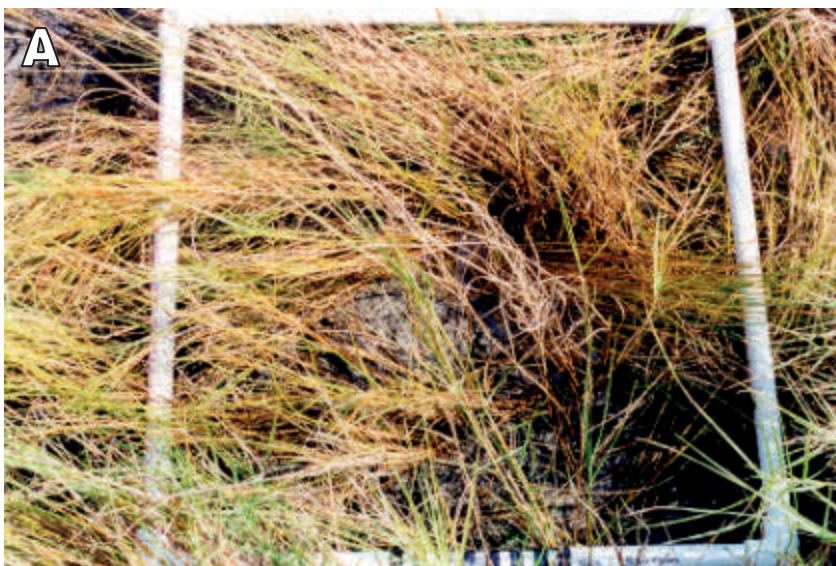
**Figure 2-9.** First burn area.

- A.** Heavily oiled vegetation (*Spartina patens*) immediately before the 12 April 2001 burn, starting to turn yellow after being in contact with the condensate for 6 days.
- B.** Same area hours after the burn. Note the lack of any oil residue.
- C.** Same area as in two previous photographs, taken on 16 October 2001, 6 months after the burn and at the end of the first post-burn growing season. The vegetation was dead with no recovery.
