# Research Report on Characterization and Monitoring of Cracking in Wet H<sub>2</sub>S Service

API PUBLICATION 939  
OCTOBER 1994

M. S. Cayard, R. D. Kane, L. Kaley, and M. Prager

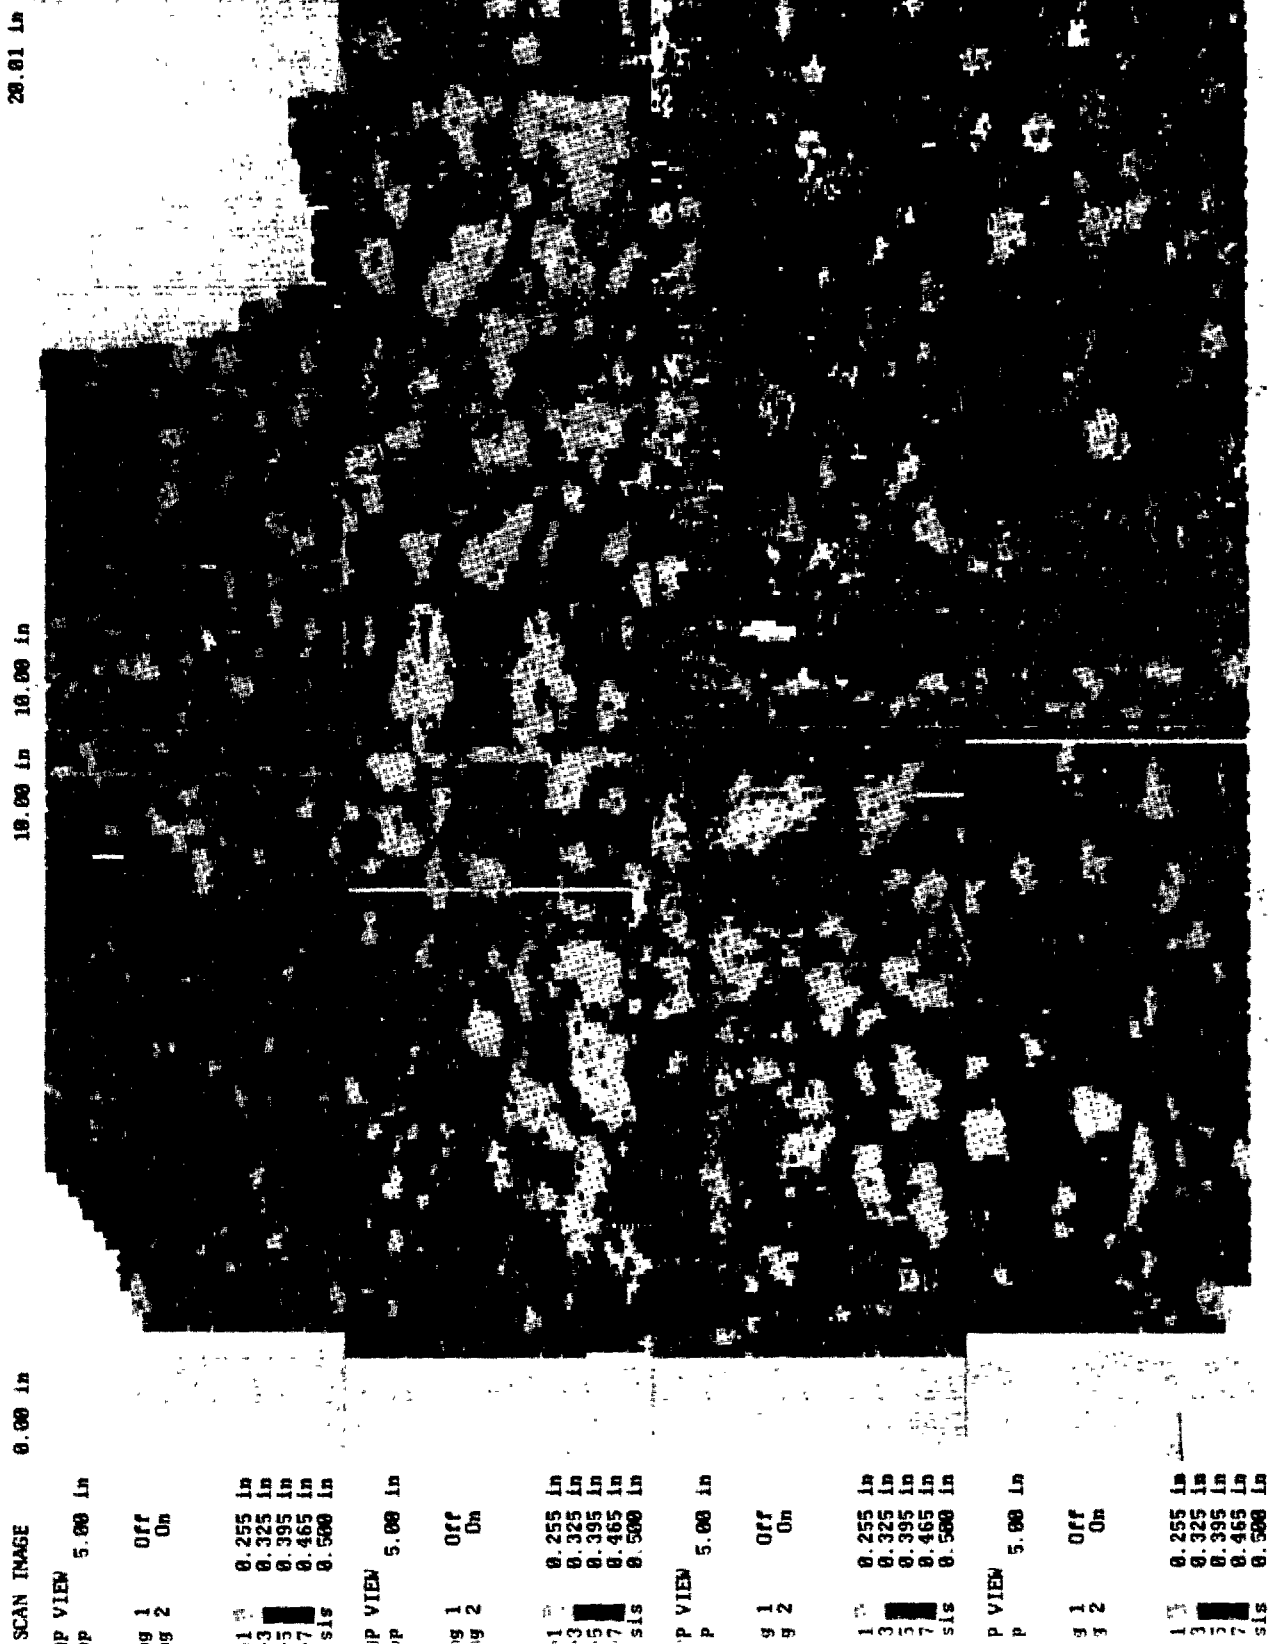
Fig. 4-15—AUT T-Scan Data Taken at the Conclusion of the Simulation of Thick Plate Behavior Evaluation

Fig. 4-15—AUT T-scan data taken at the conclusion of the simulation of thick plate behavior evaluation. For full-color version, see insert following p. 14

The print-outs of the AUT T-scans shown  
in Figures 4-1a, 4-1b, and 4-15  
are shown in full color on the following three pages.
