# ***API Publication 939-B, Repair and Remediation Strategies for Equipment Operating in Wet H<sub>2</sub>S Service***

# Repair and Remediation Strategies for Equipment Operating in Wet H<sub>2</sub>S Service

API PUBLICATION 939-B  
JUNE 2002

This report summarizes the experimental methods and findings of a research project titled *Repair and Remediation Strategies for Equipment Operating in Wet H<sub>2</sub>S Service* conducted by the Materials Properties Council, Inc. (MPC). The project was jointly funded by MPC and the API Committee on Refinery Equipment.

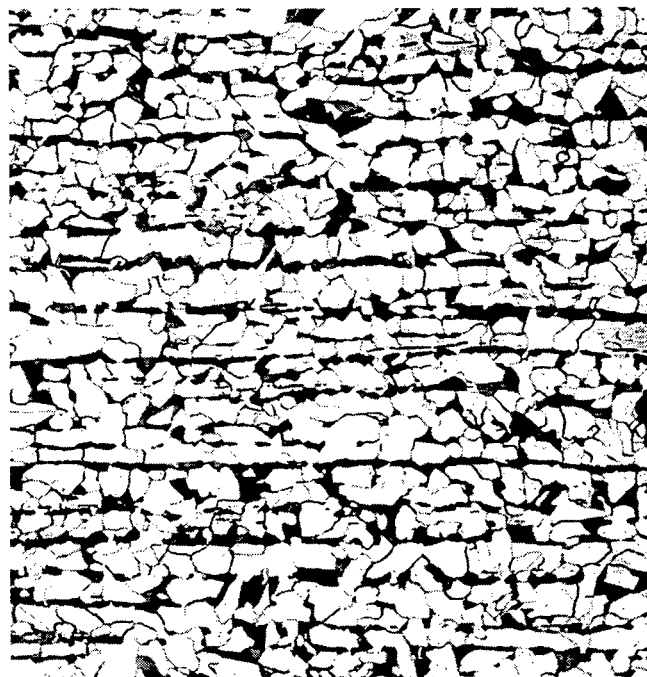
Figure 7—Structure of InterCorr 4475.  
Magnification 200 × (PN 4464-5)

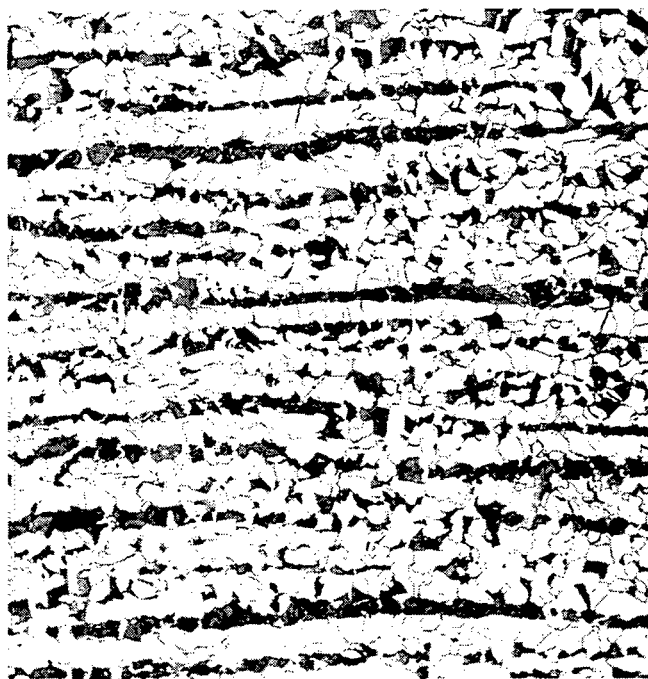
Figure 6—Structure of InterCorr 3201 HRS.  
Magnification 200 × (PN 4464-7)
