## Acetylene Cylinder Base Corrosion

### Footrings on welded construction cylinders

This Safety Information is intended to raise awareness of hazards and safety measures necessary regarding the filling of acetylene cylinders of welded construction with footrings.

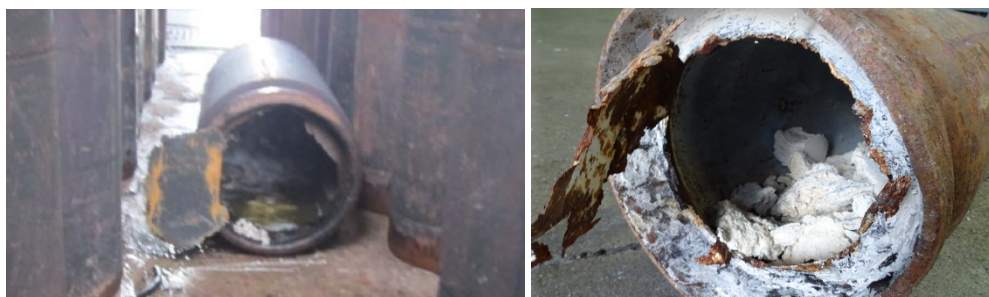
Two “loss of containment” events have occurred during filling (one in 2012 and a second in 2020), where the base has opened, and the porous material has been ejected leading to the cylinder shell going upwards.

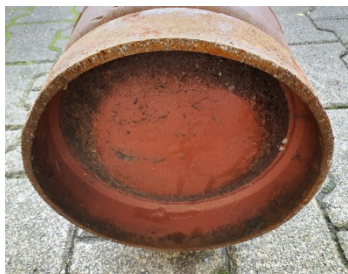
1. The style or design of the footing.  
The footing that is welded rather than shrunk onto the base of the cylinder is more vulnerable to corrosion due to accumulation or trapping of material under the weld.  
The non-ventilated footing without slots that allow air movement is more vulnerable to corrosion than one with ventilation slots due to the inability of the area under the footing to dry.

*Non-ventilated footing*

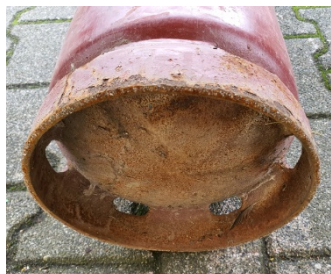
*Ventilated footing*
