| <b>12</b> | <b>GUIDE TO SSI EARTHING AND BONDING</b> | <b>1</b> |

## **12.1 About this Guide to SSI Earthing and Bonding**

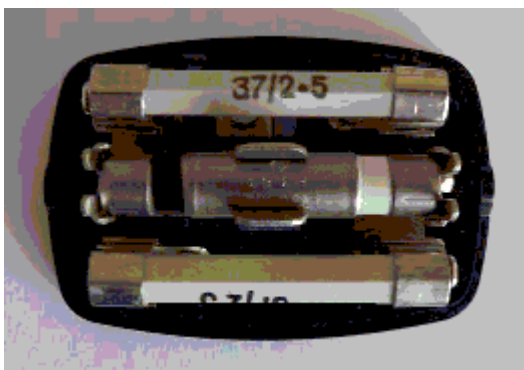
Older Data Links are fitted with a Gas Discharge tube in a housing with a black plastic cover. The internal components are standard items, clip mounted for ease of replacement.

Older Type of Data Link Surge Protection

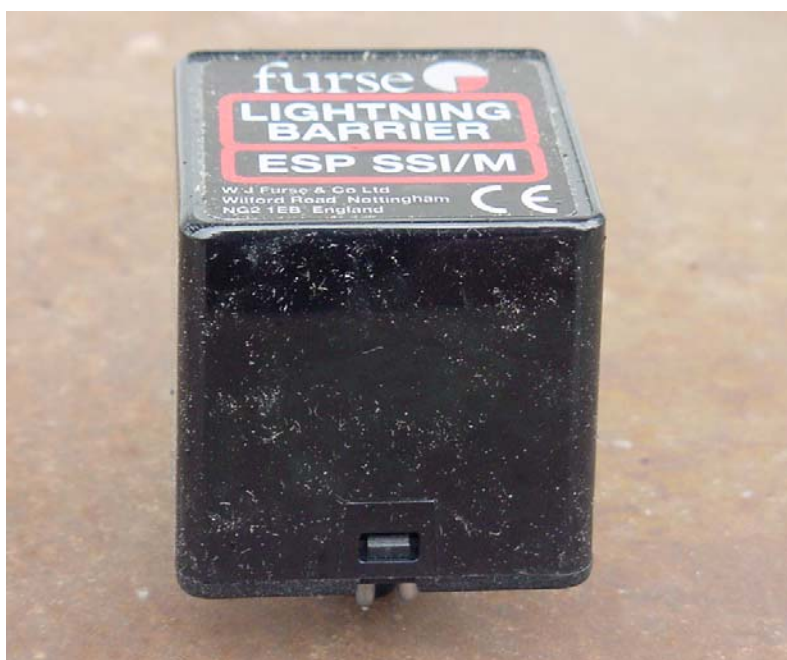
Modern Data Links are fitted with Surge Protection Units (SPUs) capable of preventing failures by diverting surges to earth. These devices are effective provided that they are correctly fitted and have an effective earthing system.

GS/ES 1937 SPU made by Furse

Both Furse- and Clipit-made Surge Protection Units (SPU) are specified to provide protection from surge voltages of 4 kV and 2 kV common-mode and differential-mode respectively and surge currents of 2 kA and 1 kA common-mode and differential-mode respectively. However, repeated operation of the gas discharge tube within these devices is known to cause a progressive reduction of the voltage at which these devices strikeover; this will eventually cause reliability issues. Therefore,

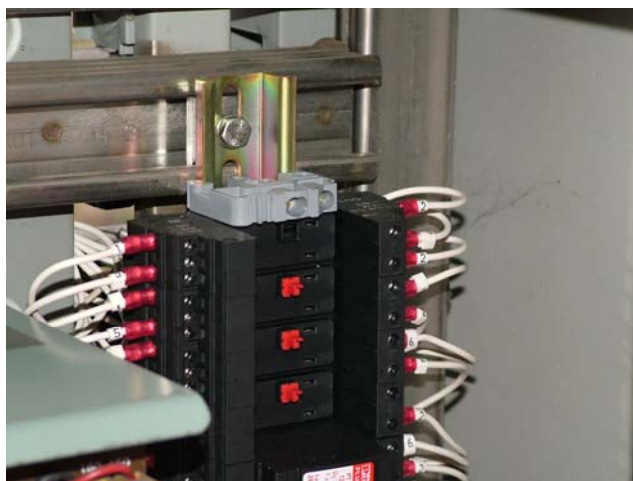
Phoenix Contact signal tail cable protection

In the above picture, the topmost surge protection position shows the empty black base unit below the grey DIN rail end stop. The second to fourth base units from the top show the configuration plug (red for this type) in position. This device is inserted when the plug-in portion is first fitted and then remains captive to ensure correct subsequent replacement. The fifth base unit has the plug-in unit fitted (shown with its label just visible in the bottom of the picture). The Phoenix Contact surge protection plug-in modules may be unplugged without interruption to the protected circuit, though of course surge protection will be lost, for testing in the Checkmaster tester.
