| Ref: | NR/L2/ELP/27009/MOD C15 |

| OVERHEAD LINE CAMPAIGN CHANGES – DATA SHEET | |
| <b>15</b> | <b>REPLACEMENT OF ROLLER BEARINGS IN TERMINATION PULLEYS</b> |

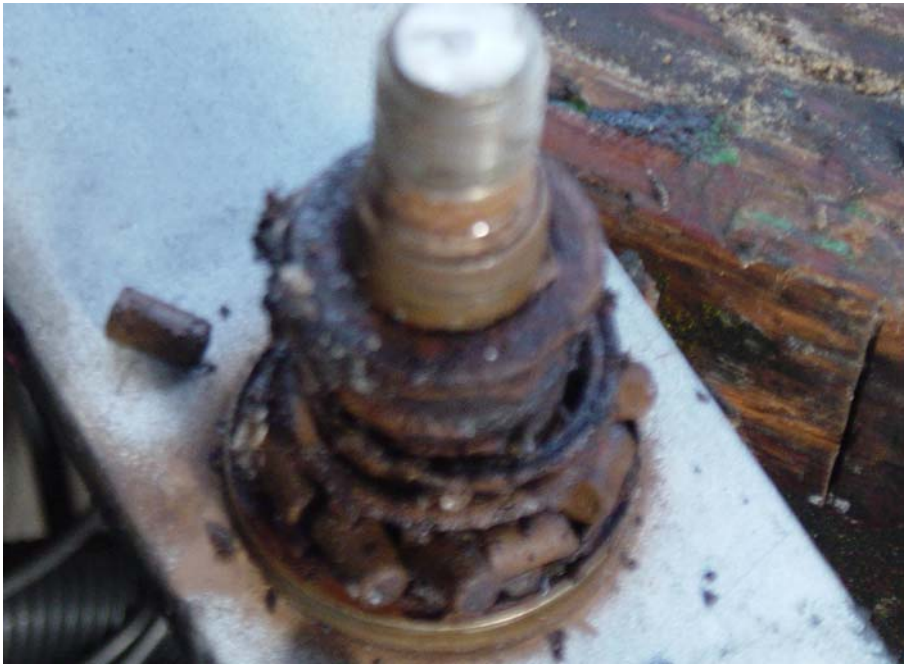
| OVERHEAD LINE CAMPAIGN CHANGES – DATA SHEET | |
|---|---|
| <b>COMPONENT</b> | Seized termination pulley wheels with poor quality roller bearings. The roller bearings concerned are a Chinese produced type and are not Timken bearings. |
| <b>PROBLEM</b> | These termination pulley wheels are prone to seize. The resulting seized balance weights will lead to poor current collection and over stressing of hard drawn copper conductors and other components. |

| OVERHEAD LINE CAMPAIGN CHANGES – DATA SHEET | |
|---|---|
| <b>ACTION REQUIRED</b> | Replace any affected stiff or seized pulley wheels with a new wheel incorporating the correct Timken roller bearing. |
