# Rollover Crash Tests on Dirt: An Examination of Rollover Dynamics

## ABSTRACT

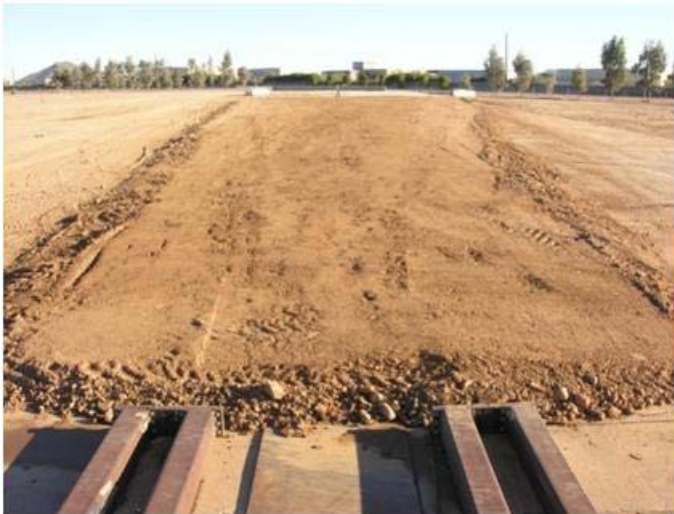
Figure 1. Dirt rollover surface.

Upon rapid deceleration of the dolly cart, the test vehicle is allowed to move and rotate toward the leading side, off of the stopped dolly, and onto the dirt rollover surface. The rollover surface was comprised of desert soil, lightly compacted after placement on the concrete crash rail, and measuring approximately 6 inches deep. Figure 1 depicts the appearance of this surface prior to one of the tests. All tests except Test 5 included this dirt surface from the point of first ground contact to rest position of the vehicles. Test 5 incorporated a bare concrete space of approximately 30 feet from the area of dolly deceleration forward to the dirt surface.

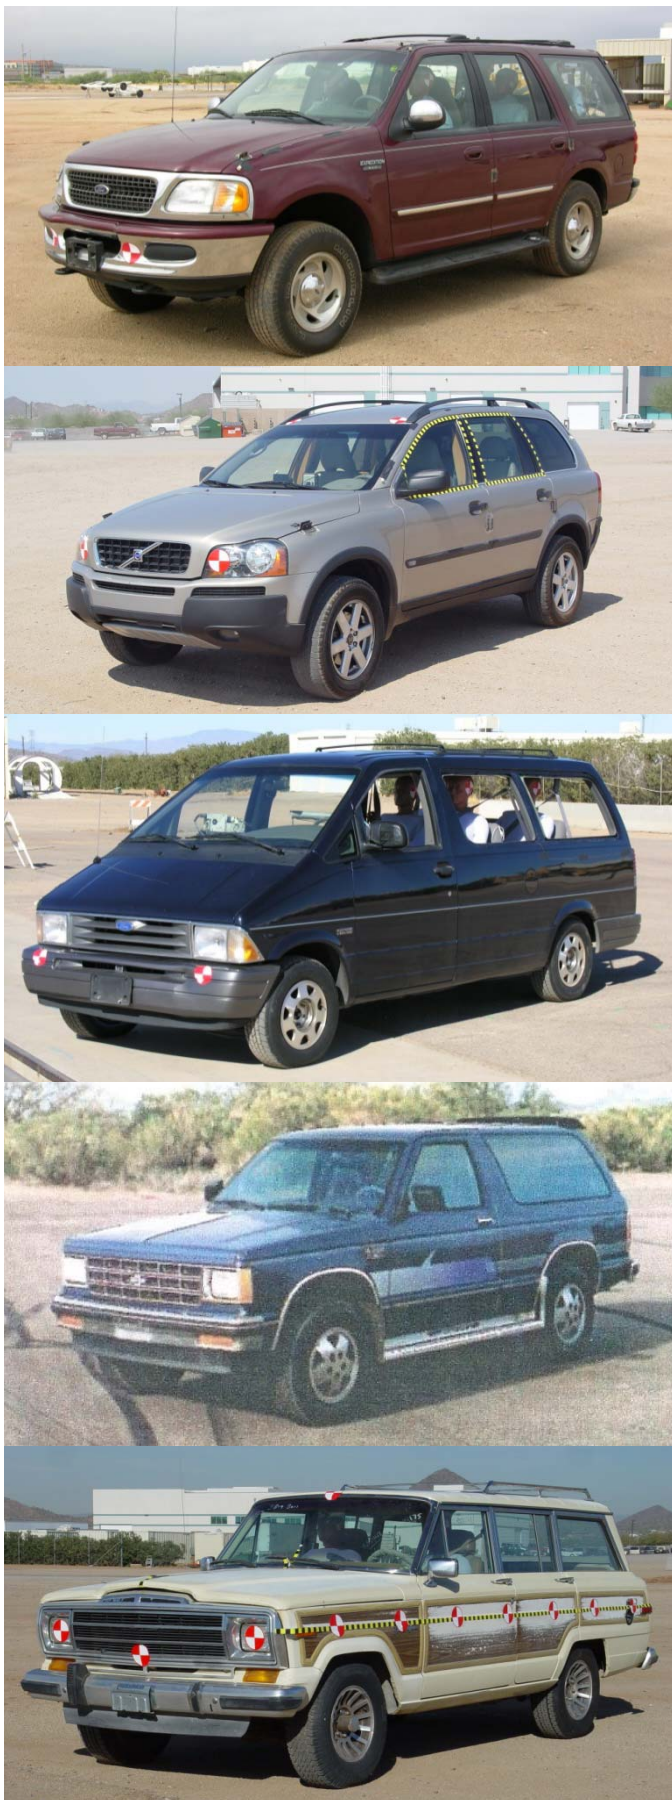
**Figure 2. Test vehicles.**

projection of the center of gravity. Test 4 did not have onboard instrumentation installed inside the vehicle. The results of Test 4 are presented here as they pertain to primary parameters such as rollover distance, number of rolls, and average deceleration rate. Figure 2 contains pre-test photographs of each vehicle.

Four full-size sport utility vehicles and one multi-purpose vehicle were used as test vehicles for this study. A summary of vehicle and test information is provided in Table 1. It has been previously commented upon that such higher profile vehicles may have unique rollover dynamics when compared to shorter (height) passenger car sedans and coupes (Orlowski, et al. 1989). Pre-test photographs of each vehicle are included in Figure 2.

All fluids were drained from the vehicles, which were ballasted to as-received curb weight and fore/aft distribution. The vehicles were equipped with tires and wheels recommended by the vehicle manufacturers. Anthropomorphic Test Devices (ATD) were utilized in each of the tests. Each ATD was added after the vehicles were ballasted. Six ATDs were positioned inside of the Expedition, four ATDs inside of the XC90 and Aerostar, one ATD inside of the S10 Blazer, and two ATDs inside of the Grand Wagoneer. A detailed study of the occupant kinematics during Tests 1 and 2, the Expedition and XC90, has been previously published (Luepke, et al. 2007).

Vehicles used in Tests 1 through 4 had onboard cameras and brackets installed that required some interior trim components and seat position hardware to be removed. Other tests, such as 1 and 2, required that tempered side glass be removed and replaced with laminated glass and that the doors be bolted shut to isolate the performance of the door glass. Additionally, test specific parameters required that the right side
