# “Sticky” Lining – the Phenomena, Mechanism and Prevention

## ABSTRACT

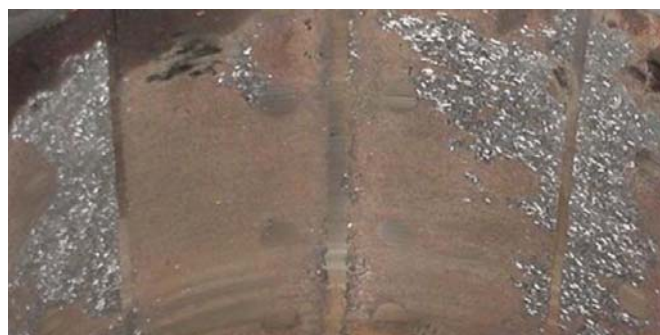
Figure 1. The residual lining was visible on the drum surface after the lining was broken free using external forces

A number of sets of brake linings and drums in city transit applications were submitted for analysis when the linings became stuck on the drums after the buses were parked overnight with the parking brakes applied. The bonding forces were so tremendous that they “over-powered” the return springs and the torque passed to the wheels was insufficient to break up the bond and free up the wheel during the buses’ start-up the next day. An example of such lining-to-drum bonding is shown in Figures 1 and 2.

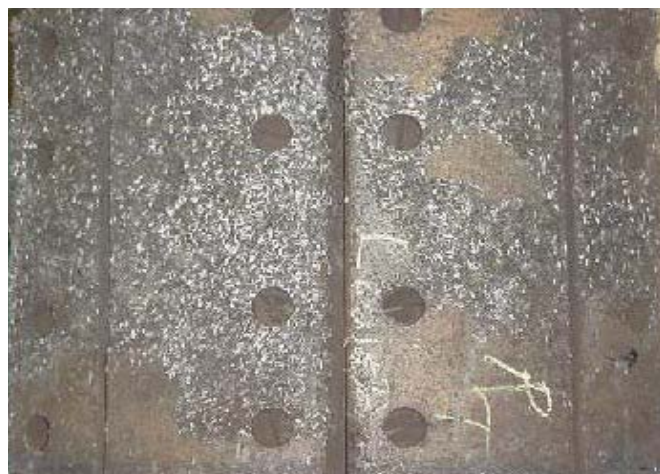
Figure 2. This photo shows damages to the lining surface from lining-to-drum bonding

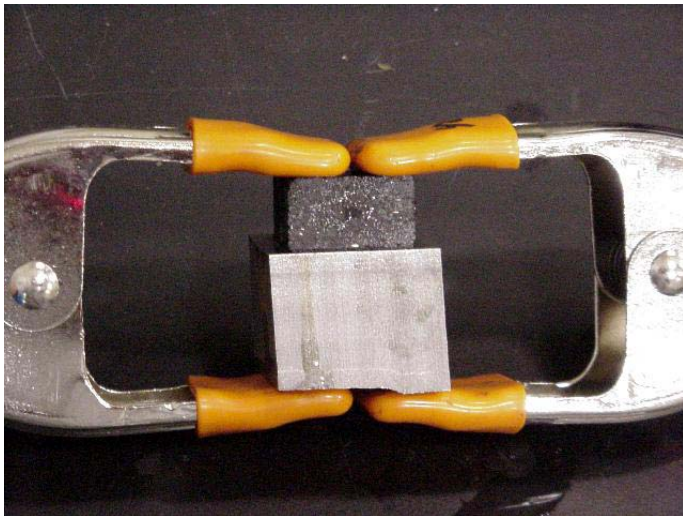
As shown in Figure 3, drum blocks in the size of 50 mm by 50 mm (2" by 2") cut from the returned brake drums and lining blocks in the size of 36 mm by 36 mm (1.5" by 1.5") from the returned linings were used. The test samples were assembled according to schedule outlined in Table 1 and kept in air-conditioned laboratory environment overnight for about 16 hours.

Figure 3. The test setup

Based on the above, a design of experiment (DOE) as outlined in Table 1 was carried out to determine the major contributing factors. A test setup as illustrated in Figure 3 was developed for ease of implementation while being relevant to the real application as much as possible.

- Clamps (Figure 3) with 40 lbs clamping force rating were employed. Two clamps would yield about 80 lbs clamping force in an attempt to simulate the force applied to the parking brake
- De-ionized tap water and alkaline soap solution used in the customer application that experienced the most problems were used in this DOE
- Road dust was collected from the brake shoes of the returned brakes. The dust was made into paste by mixing it with water and applied to the DOE matrix
- The sample size was 5 for each of the group listed in Table 1.

Bonding was said to have developed in the test assembly, if after removing the clamps the assembly could be lifted by holding the lining block alone in the position as shown in Figure 3. To simulate the parking brake releasing efforts, the axial forces necessary to remove the lining block from the test assembly were subsequently measured. We did not measure the shear forces of the bonding although they could be much larger and related to the torque loads at the vehicle startup.
