# An Investigation of Container Chassis Brake Lining Maximum Wear Rates

**William Blythe**  
William Blythe, Inc.

## ABSTRACT

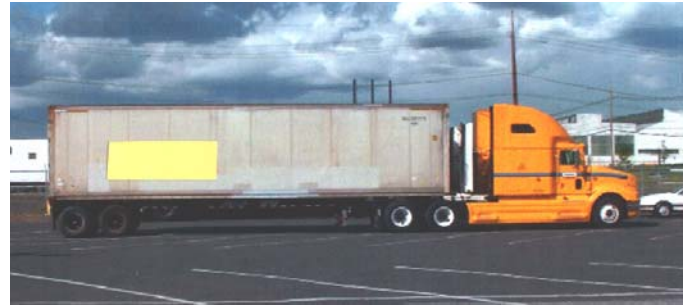
Figure 1

The tractor employed was a three-axle conventional configuration, with a wheelbase of 238 inches. The chassis was a Bush Hog Loadcraft, 1985 model, with a kingpin to first axle dimension of 31 feet,  $\frac{3}{4}$  inches, an axle separation of 48 inches, and an overall length of 41 feet,  $\frac{3}{4}$  inches. The container had a nominal overall length of 40 feet, a width of 8 feet and a height of 9 feet, 5.5 inches. The overall maximum height, when loaded, was 13 feet, 3.25 inches.

The total loaded weight of the assembled rig was 74,140 pounds. The weight on the chassis axles totaled 30,240 pounds. The container was loaded with sand bags to achieve the desired total weight and weight distribution.

The assembled rig is shown in Figure 1. Figure 2 shows a view of a portion of the container load.
