# Data Sources and Analysis of a Heavy Vehicle Event Data Recorder – V-MAC III

Copyright © 2009 SAE International

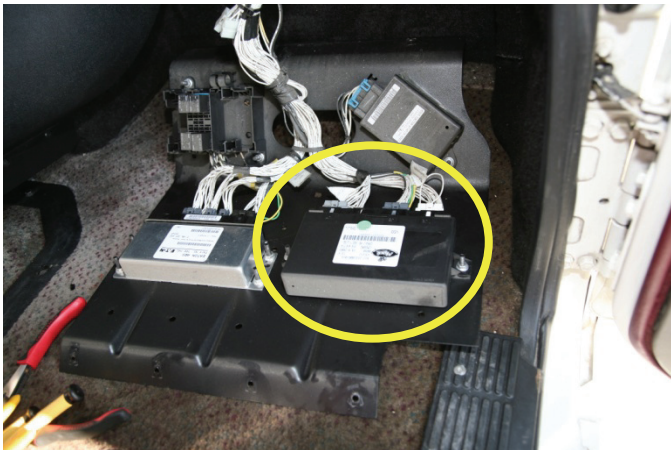
**Figure 2. VECU, black plastic box on right.**

The VECU (Figure 2) was, and usually is, mounted on a panel underneath the dashboard, directly in front of the passenger seat on conventional truck and truck-tractor models. On the LE model, the VECU is located under the left side floor panel and on the MR model, under the tunnel cover adjacent to the forward bulkhead. It also receives data from various sensors and communicates with other modules via the J1939 serial data bus.

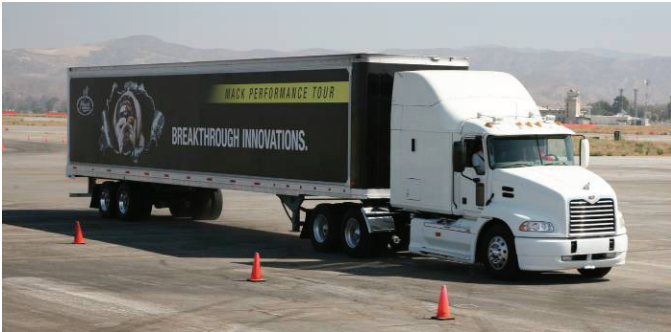
Figure 3. Test truck & trailer

A 2003 Mack CX613 6x4 conventional truck-tractor with sleeper was used for the evaluation of the MACK V-MAC III system. This CX613 was powered by a MACK AC-460 turbo-diesel engine controlled by a V-MAC III Engine and Vehicle Control Unit. At the time that testing began, the tractor had approximately 180,000 miles on the odometer.

The CX613 was equipped with an Eaton/Fuller 13-speed manual transmission and a Jacobs Engine Brake ®. The CX613 was also equipped with an S-cam airbrake system complemented with a Knorr/Bremse 4S/4M (4 sensor/4 modulator) Anti-Lock Brake System (ABS). The brake components were documented and adjustments measured prior to testing. All brake components are summarized in Table 1.
