# Protection of the C-17 Airplane during Semi Prepared Runway Operations

**Sharanpal (Paul) Sikand and John Carr**  
The Boeing Company

This paper summarizes the results of the study, including damage to the airplane when exposed to different types of SPRO environment, solution concepts, the method of selecting the solutions and the solutions being implemented for protection of the C-17 airplane.

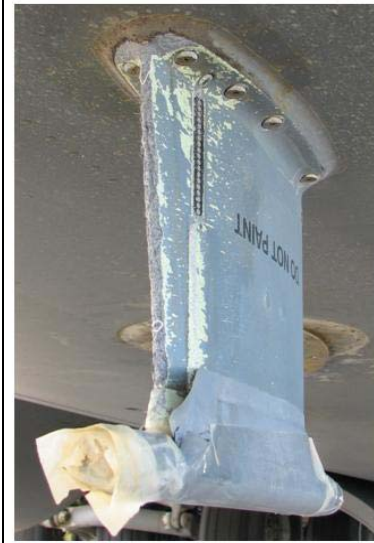
**Figure 6 - Damaged Antenna**

- Fuselage and wheel well pod skin paint
- Antennas – Figure 6
- Anti-collision light (ACL) - Figure 7
- Vents and drains – Figure 8
- Inboard MLG doors – Figure 9
- MLG axels and posts – Figure 10
- MLG pod structure – not shown
- Ram air inlet vent scoops in MLG pod – not shown
- Electrical cables – Figure 11

## Eroded antenna shell leading edges

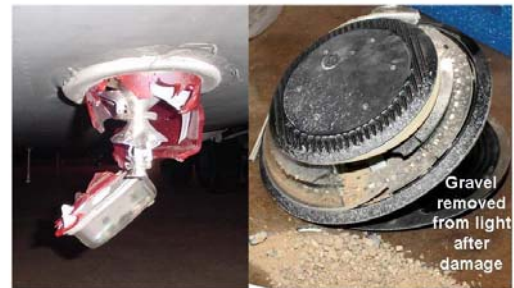
**Figure 7- Damaged lower anti-collision lights**

**High Profile ACL**

**Low Profile ACL**
