# The Effect of Electronic Stability Control Following a Rear Tire Tread Belt Separation

2010-01-0113

Donald F. Tandy, Kenneth T. Tandy, Jason Colborn and Robert Pascarella  
Tandy Engineering & Associates Inc.

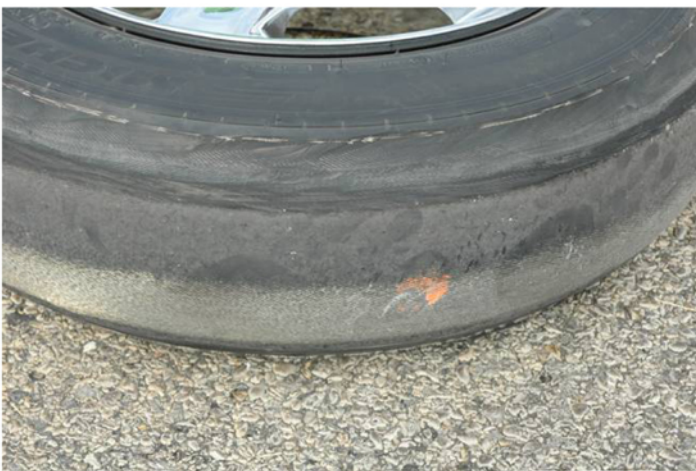
**Figure 1. Delaminated Tire**

Four new tires were purchased for each test vehicle. The tires selected were the size and type as originally specified for each vehicle. Tires were prepared by cutting circumferentially at the tread/belt interface using a razorblade knife. The tread and outer steel belt was completely removed from the remaining tire system (see [Figure 1](#)).

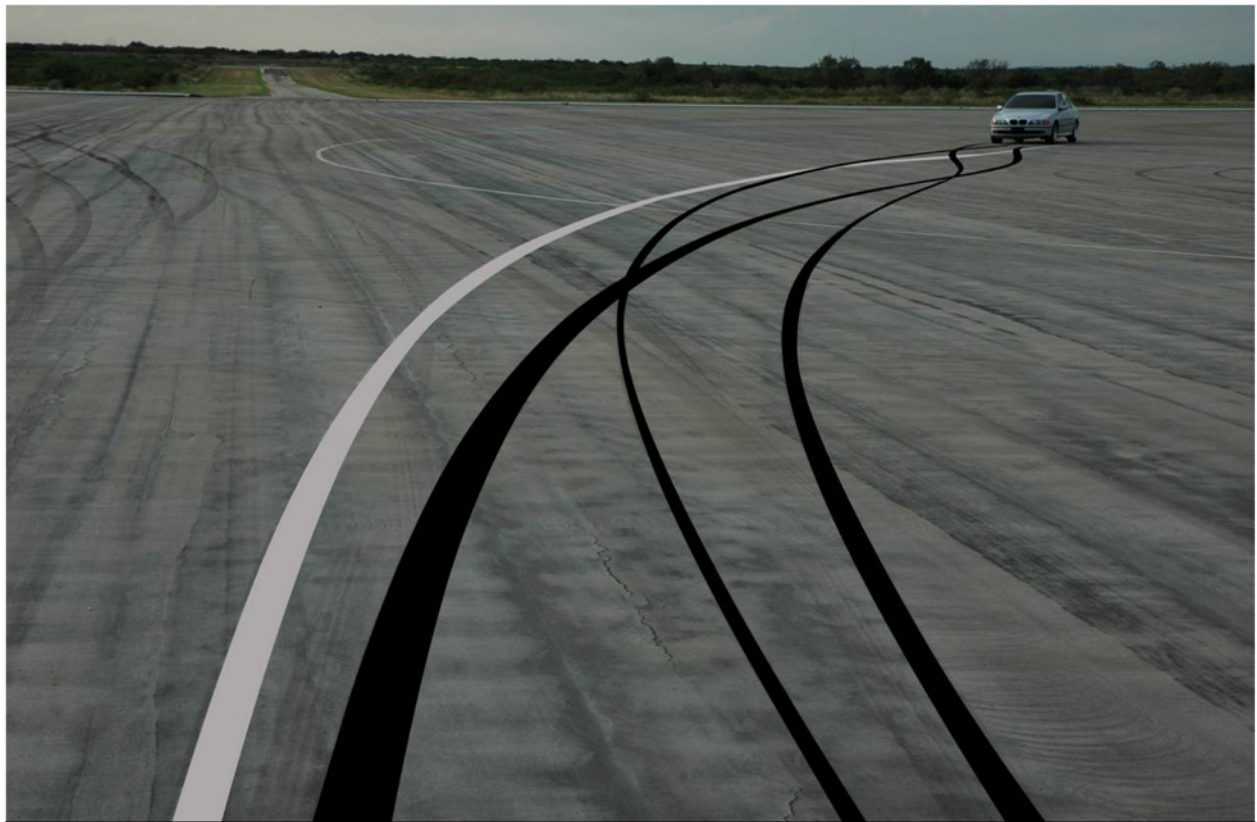
*Figure 6. 2000 Four Door Sedan Tire Marks Highlighted*

Figure 6 is a photograph of the tire marks created by a single test on the 2000 sedan. Tire marks have been highlighted to show them clearly on the test surface. Note that the delaminated tire mounted at the left rear position generates a white marking in its yaw mark (Figure 7). It is also important to notice the diverging yaw marks confirming that the vehicle spun completely broadside. Figure 8 is the corresponding data chart for that run. The steering wheel trace shown in Figure 8 was taken from in-vehicle video footage of the test run. The data shows that the test generated high accelerations and yaw rates and that the ESC system was not able to keep the vehicle from spinning out. ESC telltale video confirmed ESC intervention attempts. Figures 9 and 10 are renderings of computer generated models showing vehicle positions created using GPS survey data of the tire marks.

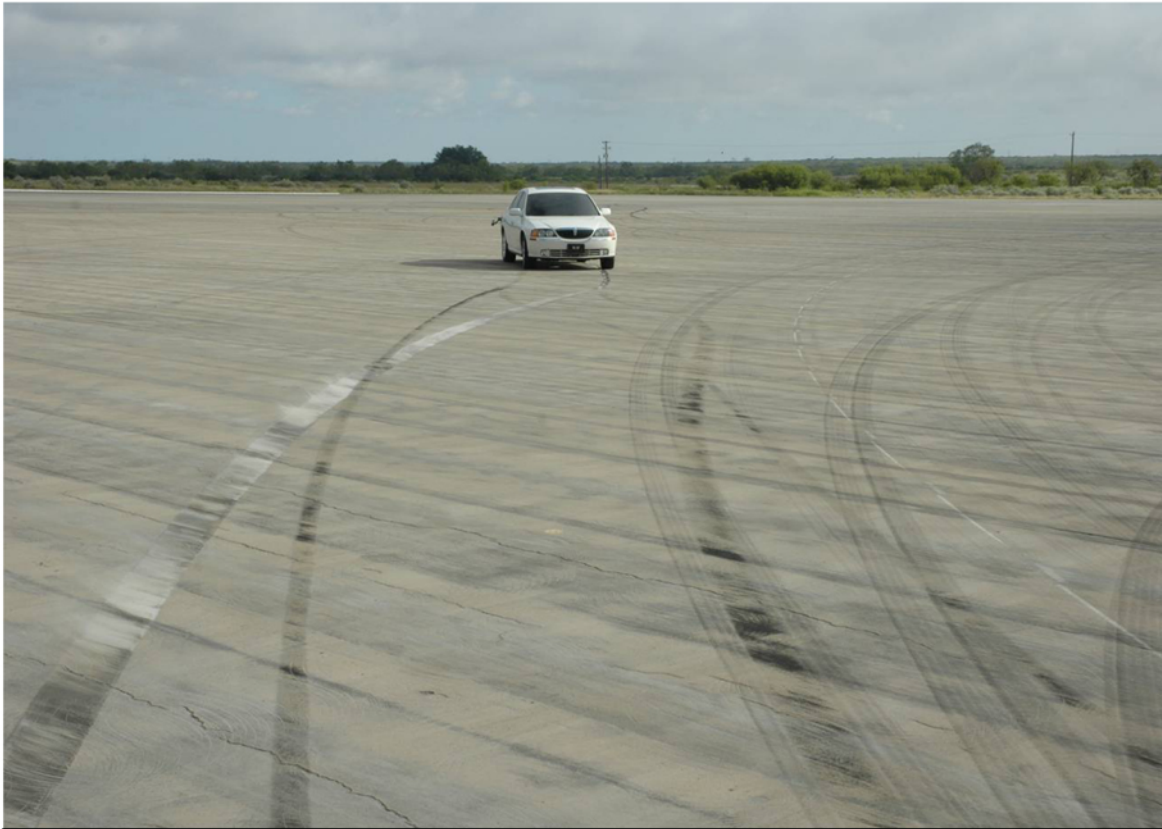
*Figure 11. 2002 Four Door Sedan Tire Marks*

Figure 11 is a photograph of the tire marks of the 2002 sedan showing the overlap documenting the spin of the vehicle. The delaminated tire was on the left rear for this test. Figure 12 is the test data for that run. The steering wheel trace shown in Figure 12 was taken from in-vehicle video footage of the test run. The data indicates once again that the steering demand forced the vehicle into an out-of-control spin. ESC telltale video confirmed ESC intervention attempts. Figures 13 and 14 are renderings of computer generated models showing vehicle positions created using GPS survey data of the tire marks.
