# Chrysler Airbag Control Module (ACM) Data Reliability

2010-01-1002

Roger Bortolin, Brian Gilbert, Jeffrey M. Gervais and James Hrycay  
Hrycay Consulting Engineers Inc.

## ABSTRACT

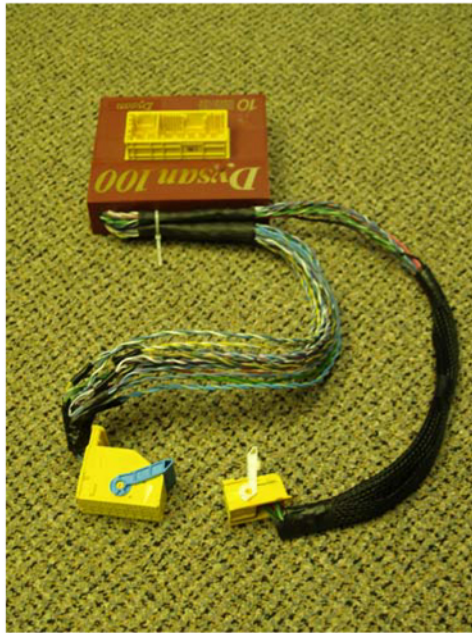
**Figure 1. Test harness**

Figure 1 shows the test harness that was created. The main components include a connector taken from a spare ACM

module, a portion of a vehicle wiring harness and the dummy resistors which are located inside the plastic box. This harness was inserted between the vehicle harness and the ACM module. For safety purposes, each of the pyrotechnic circuits were shorted out on the vehicle side of the harness, thus replicating the effect of shorting bars normally found on each pyrotechnic device.

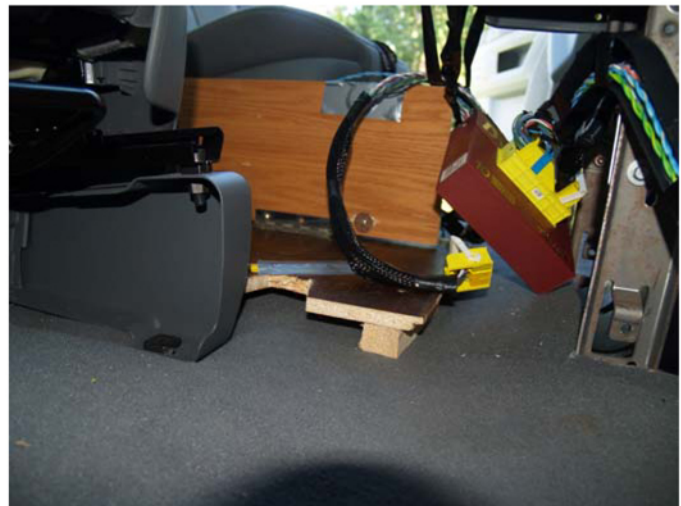
**Figure 3. ACM module and top panel rotated approximately 90 degrees, causing a deployment event.**

To capture the moment when the ACM module was rotated, a contact switch was used between the top and bottom panel. It is visible in Figure 3, attached to the bottom panel with duct tape. The V-BOX recorded this on/off status change at the instant the top panel began to be rotated. A small period of time elapsed between the moment the switch recorded the trigger and when the module had rotated enough for an event to be created. It is worth noting that earlier attempts to forcibly strike the ACM module in a rearward direction in order to simulate a frontal crash were unsuccessful. It is unknown if a higher striking force could have caused the module to deploy, though a simultaneous strike to one or both of the front crush sensors likely would have caused a deployment.
