## Development of Liftgate Hinge-to-Roof Sealing Gasket Material for Uncoated Steel Roof Panels

2011-01-0072

Carl Corman, Mark Yergin, Andy Kussmaul, Lou Conrad and Gregory Martin  
General Motors Company

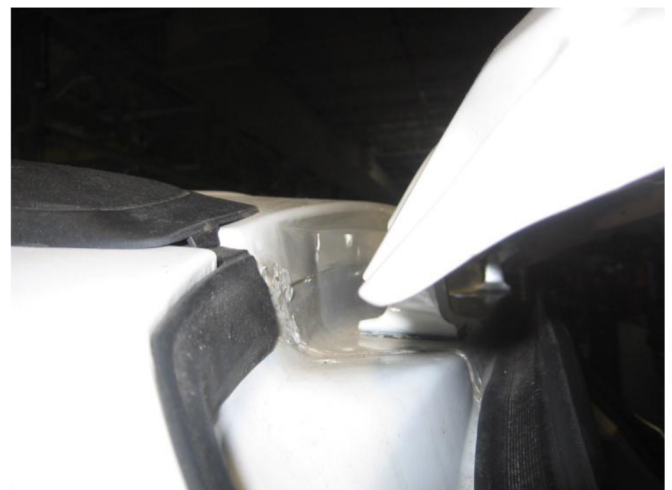
**Figure 1. Two piece roof construction.**

- One piece galvanized steel roof panel
- Fibrous material gasket located between the hinge and the roof panel
- Separately welded rear panel that utilizes galvanized steel ([Figure 1](#))
- Manual application of sealer (or zinc rich primer) on the vehicle body at the hinge surface within the body shop ([Figure 2](#))
- Manual application of sealer around the perimeter of the hinge after it has been installed. This sealing operation is done in the paint shop after E-coat. ([Figure 3](#))

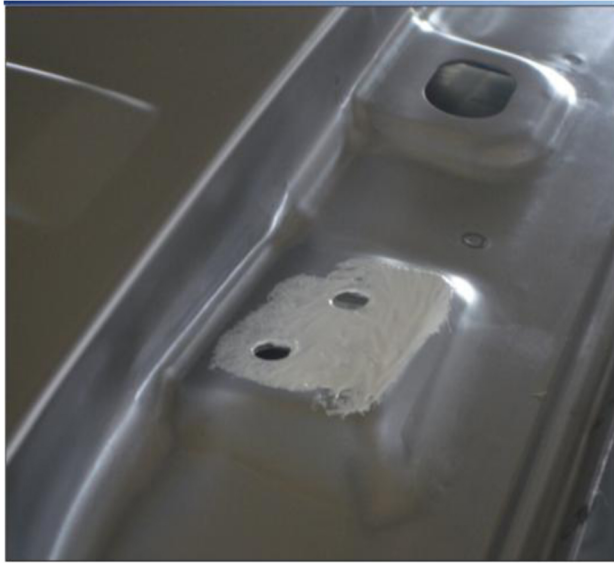
**Figure 2. Roof panel shown with roll-on sealer applied prior to liftgate hinge installation.**

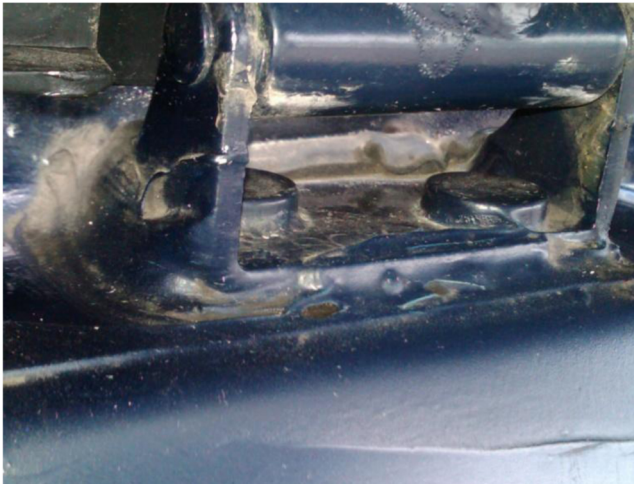
**Figure 3. Liftgate hinge shown with paint shop applied sealer around the perimeter of the hinge.**

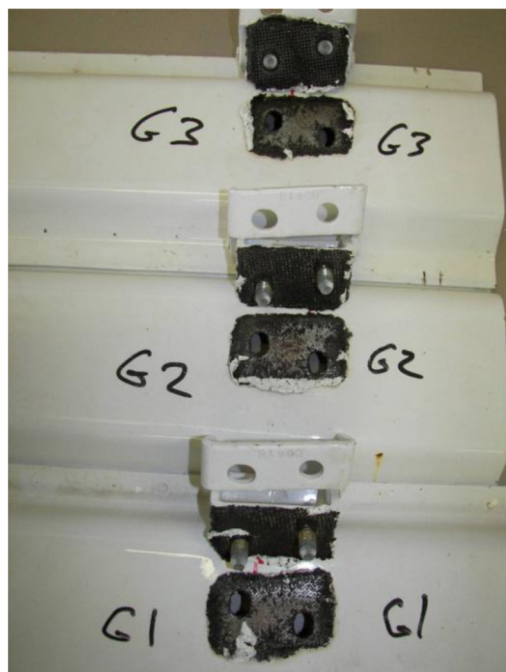
In the case of a bare steel roof panel, only samples G1-G3 met both the 5 year cosmetic corrosion requirement of no visible red rust, and the 12 year no perforation corrosion requirement ([Figure 5](#)).

**Figure 5. Expandable Sealer with Wire Mesh Samples at End-of-Test**

Test samples G1-G3 utilized a hinge gasket comprised of L&L Products sealant 9984187 and ASTM A510 wire mesh. Each material provides a specific function for the hinge gasket. The EPDM based expandable sealant has been used for years in the auto industry as a weld tape for body joint sealing. For the hinge gasket, the sealant is extruded in sheets and the wire mesh through a series of rollers is embedded into the sealant (calendar embedded). Individual gaskets are then die cut from the sheets of sealant/embedded wire.
