# The Effectiveness of Curtain Side Air Bags in Side Impact Crashes

2011-01-0104

Yoshinori Tanaka, Hideki Yonezawa, Naruyuki Hosokawa and Yasuhiro Matsui  
National Traffic Safety & Enviro Lab.

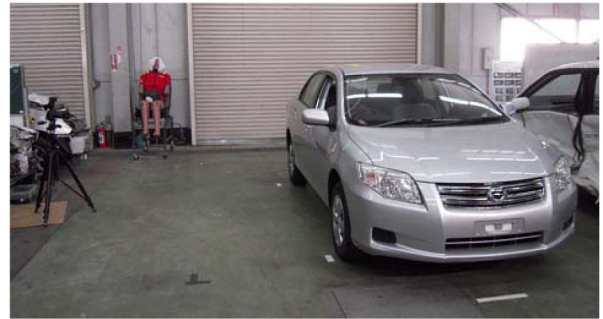
**Figure 9. The vehicle and the camera position in this study.**

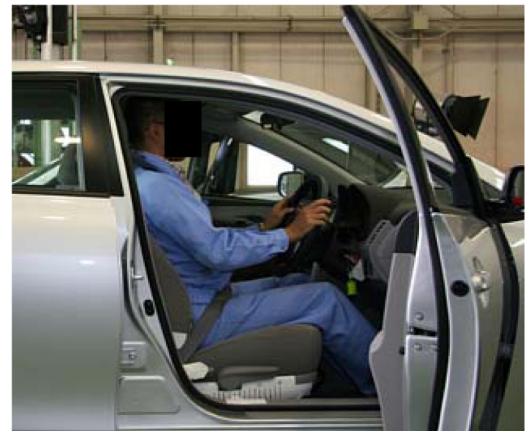
**Figure 10. The sample picture in this study.**
