# Heavy Truck Stability with a Trailing Axle Tire Blowout

Robert Larson and Joseph Cuadrado  
 Exponent Inc.

**CITATION:** Larson, R. and Cuadrado, J., "Heavy Truck Stability with a Trailing Axle Tire Blowout," *SAE Int. J. Commer. Veh.* 5(1):2012, doi:10.4271/2012-01-0238.

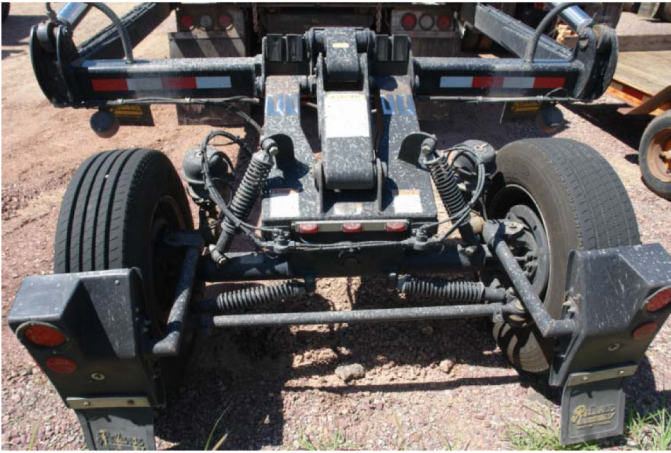
solid axle that moves vertically relative to the lowering arm with a four-bar linkage. In this design the trailing axle remains horizontal relative to the truck chassis, other than roll motion allowed through compliance in the mechanism's frame and bushings. Another design has an articulating axle that pivots about a pin joint at the center of the axle, allowing for roll or relative vertical motion of each wheel. Jounce motion of the axle is achieved through vertical movement of the entire axle mounting frame that raises and lowers the trunion assembly the axle is mounted to. This is the type of trailing axle design that was the subject of this research, and an example of which is shown in Figure 1. With both designs, the trailing axle wheels are mounted to a kingpin that allows the wheels the freedom to steer. Because of the caster angle of the kingpin, the tires typically follow the path of the axle without generating significant side force. There are also steering spring-damper assemblies mounted between the axle and hub to assist with alignment of the tires and damping of shimmy-type oscillations. The left and right wheels are connected with a tie rod, linking the amount of steering at the trailing arm wheels.

**Figure 1. Articulated design trailing axle.**

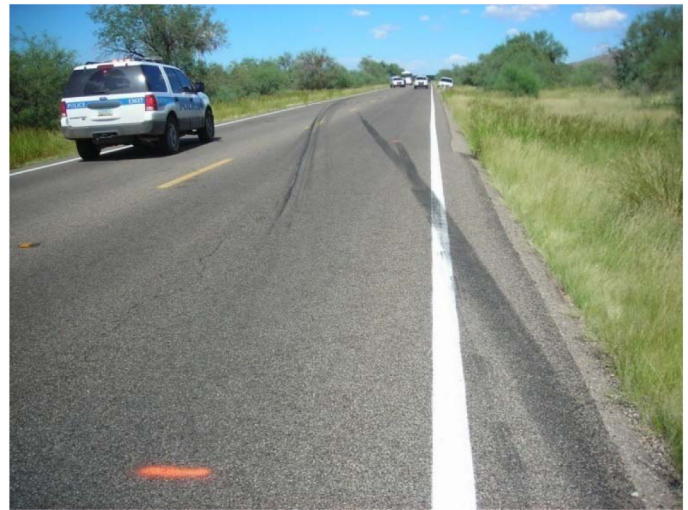
**Figure 2. Police photograph of tire marks looking upstream from the location the vehicle departed from the roadway.**

As part of the investigation, the subject vehicle and exemplar vehicles were inspected, and testing was performed with an exemplar vehicle. Review of the police scene photographs showed that the vehicle suddenly veered left and traveled across the lane of opposing traffic and went partially off the opposite side of the roadway, as shown in [Figure 2](#). Tire marks were observed from both trailing axle wheels and gouge marks were created by the right side trailing axle wheel. Pieces of the right side trailing axle tire were dispersed in the travel lane prior to the vehicle crossing into the opposing lane. The left side trailing axle tire created a tire mark starting well before the truck crossed the centerline. Based on the tire marks, the driver must have input a steer to the right as the vehicle was crossing the oncoming lane of traffic. The vehicle yawed clockwise well past 90 degrees to the direction of initial travel and rolled driver side leading nearly one full revolution, coming to rest with the trailing

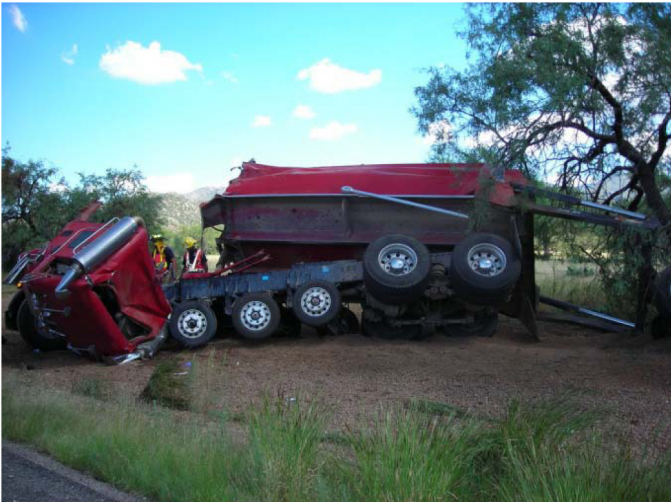
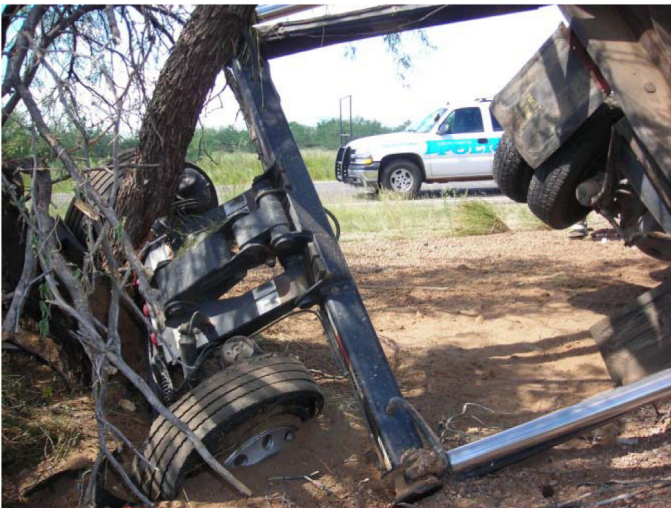
axle against a tree located adjacent to the roadway (as depicted in [Figure 3](#)).

**Figure 3. Police photographs of accident vehicle at its rest position.**

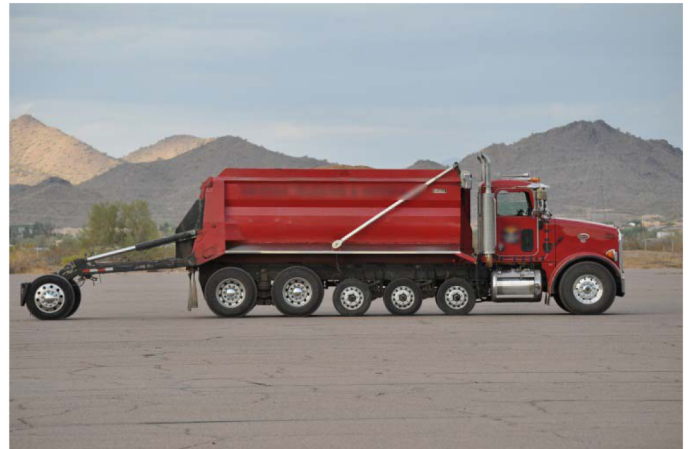
acceleration and angular rates, (3) a steering wheel torque sensor, (4) a potentiometer to measure the steering wheel angle, (5) a potentiometer to measure the trailing axle steer angle, and (6) a throttle position sensor. The vehicle was ballasted with 50,000 lb of dirt in the bed of the dump truck to replicate the vehicle load at the time of the incident. The steering limiting adjustment (stop bolts) on the trailing axle were confirmed to be at the same position as the accident vehicle. A photograph of the test vehicle is shown in [Figure 4](#).

**Figure 4. Test Vehicle: Heavy Duty Dump Truck with Trailing Axle.**

The test vehicle was instrumented with: (1) a MicroSat R20 GPS system to evaluate position and velocity, (2) a Crossbow inertial measurement unit (IMU) to evaluate

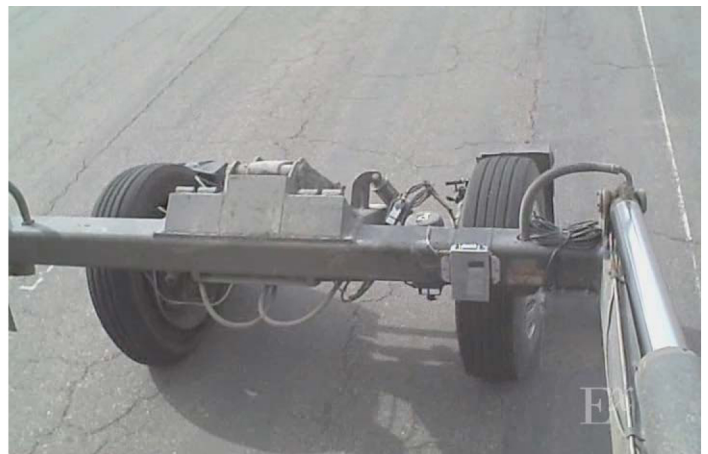
**Figure 5. Deflated right TA tire and steering left TA tire.**
