# Objective Measurement of Vehicle Steering and Handling Performance When a Tire Loses Its Air

Donald F. Tandy, B. Nicholas Ault, Jason Colborn and Robert Pascarella  
Tandy Engineering & Associates Inc.

**CITATION:** Tandy, D., Ault, B., Colborn, J. and Pascarella, R., "Objective Measurement of Vehicle Steering and Handling Performance When a Tire Loses Its Air," *SAE Int. J. Passeng. Cars - Mech. Syst.* 6(2):2013, doi:10.4271/2013-01-0748.

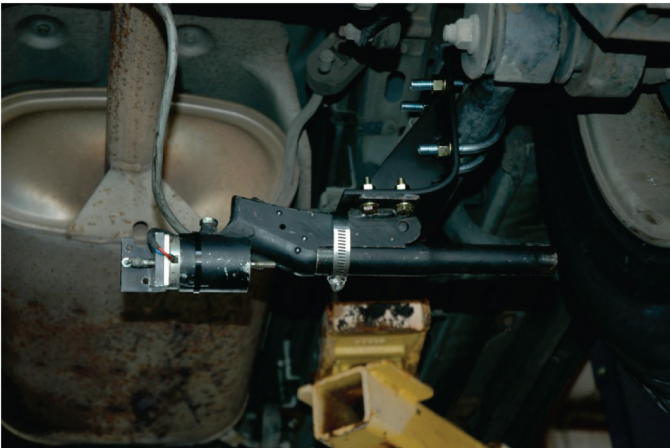
**Figure 1. Tire Air Out Device**

involve driving over a blade that either engages the front tire then moves out of the way of the rear tire or springs up to cut the rear tire after the front tire runs over it in the stored condition. For this study, the authors decided to employ an "On vehicle" device so that the driver had control over when and where the tire airs out. The air out device was a cylinder that was bolted to the frame or unitized body of a vehicle. The cylinder had a solenoid which would release a trigger when the driver would push a button on the floor with his foot. In the cylinder was a standard twelve gauge clay target shotgun shell (see [Figure 1](#) for a photograph of the air out device).

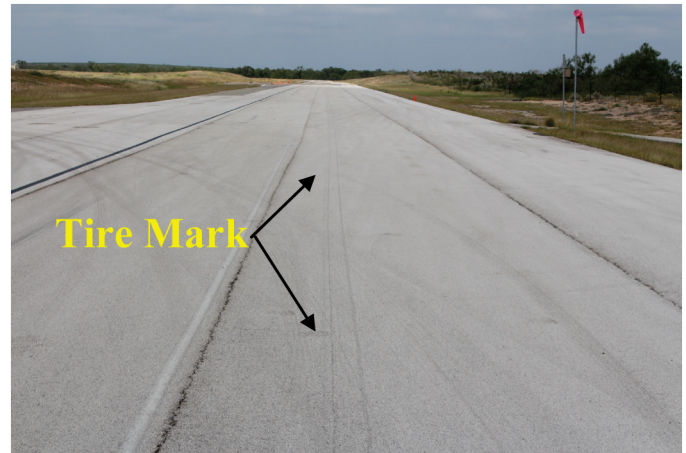
**Figure 2. Deflated Tire Mark from 2002 Compact SUV**

[Figure 2](#) shows a tire mark deposited onto the asphalt test surface by Vehicle 21, the 2002 compact sport utility vehicle. Note that there are two defined lines in the tire mark itself. With the absence of air pressure to support the middle of the tire, the outer edges of the tire are all that separate the rim flanges from the asphalt surface. The two distinct lines in the tire mark are made by the weight of the vehicle's right rear corner passing through the rim flanges to the asphalt surface through the tire rubber. The rim itself is not in direct contact with the asphalt.

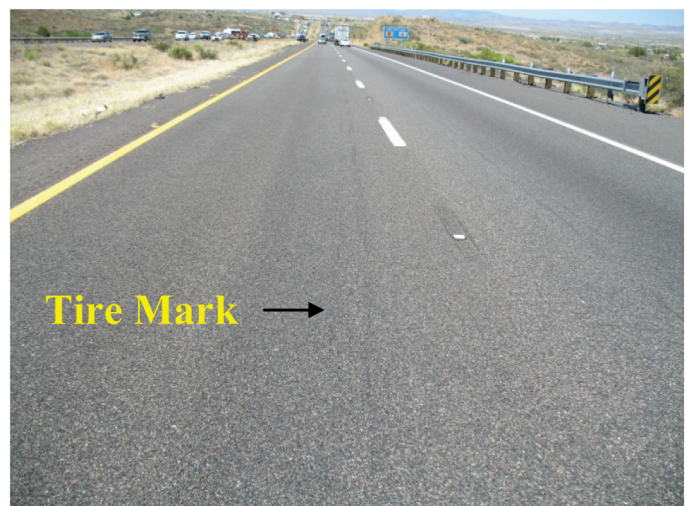
**Figure 3. Start of Tire Mark from Right Rear Deflated Tire**

[Figures 3, 4, 5](#) are a series of police photographs that show a tire mark deposited on a public road by a deflated right rear tire from a vehicle that was eventually crashed. [Figure 3](#) demonstrates the character of the tire mark near the beginning. Note that, similar to the tire mark deposited by the test vehicle and visible in [Figure 2](#), there are two defined lines in the tire mark itself. This behavior indicates the absence of air pressure to support the middle of the tire, and the outer edges of the tire are all that separate the rim flanges from the asphalt surface. As with the test vehicle, the rim itself is not in direct contact with the asphalt at this point. [Figure 4](#) presents the same tire mark, but farther down the road. At this point, the tire has become at least partially unseated from the rim, allowing intermittent contact between the rim flange and the asphalt. This contact is evident by the dashed white rim marks.

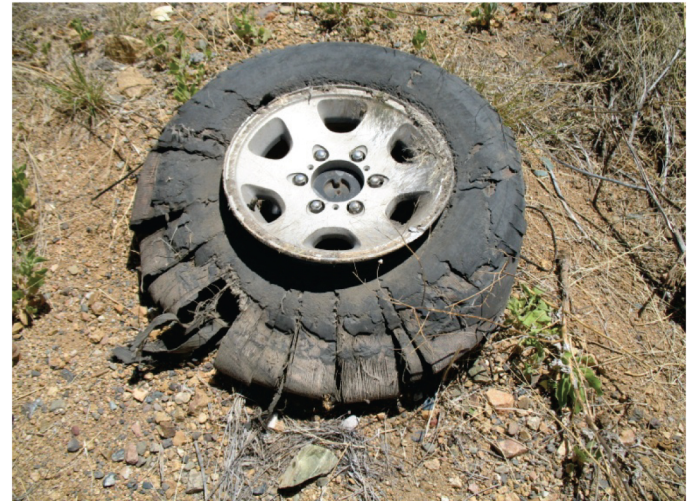
**Figure 6. Right Rear Wheel & Tire**

The end of the tire mark is shown in [Figure 5](#) which is also where the vehicle has been steered to the left and is yawing into the median. Note that the width of the tire mark has increased, and the mark itself has become solid from the increased contact between the degraded tire structure and the asphalt. Additionally, the gouge mark deposited by the rim has become more continuous, indicating a more complete unseating of the tire at the rim flange. Finally, note the additional tire mark on the shoulder of the road. The presence of this tire mark, most likely from the right front tire, indicates a significant counterclockwise slip angle of the vehicle as it was exiting the paved roadway. [Figure 6](#) depicts the condition of the right rear wheel and tire assembly after depositing the tire mark and gouges shown in [figures 2, 3, 4](#). Note the heavy abrasions around the circumference of the rim, the complete separation of the tire from the rim flange, and the radial splits to the tire itself.

In order to understand what it takes to create a tire similar to that in [Figure 6](#), vehicle 23, the 2002 model year compact sport utility vehicle, was tested in the same manner as described throughout this paper. The tire depicted in [Figure 7](#) is typical of the tested tires immediately after the vehicle has been brought to a safe stop after the air out test. Note the rubber appears fully intact and even the tire make and brand can be read off the sidewall. This same vehicle was then tested with a right rear tire set to an air pressure of zero pounds per square inch prior at the start of the test. The vehicle was then accelerated from a stop to a speed of approximately 100 kilometers per hour over a period of time of approximately 25 seconds. The driver then drove at 100 kilometers per hour for approximately 14 seconds and then brought the vehicle to a controlled stop. During the maneuver, the tread completely separated from the body of the tire, and the tire split radially in several places. Review of the test video revealed pieces of the tread blocks separating from the tire as the vehicle's speed approached 100 kilometers per hour, and full separation of the tread occurred approximately fourteen seconds after that. [Figure 8](#) shows the tire immediately after the maneuver had been completed. The over deflection of the tire carcass caused heat to build up which melted the body plies and other components causing the whole tire to disintegrate.

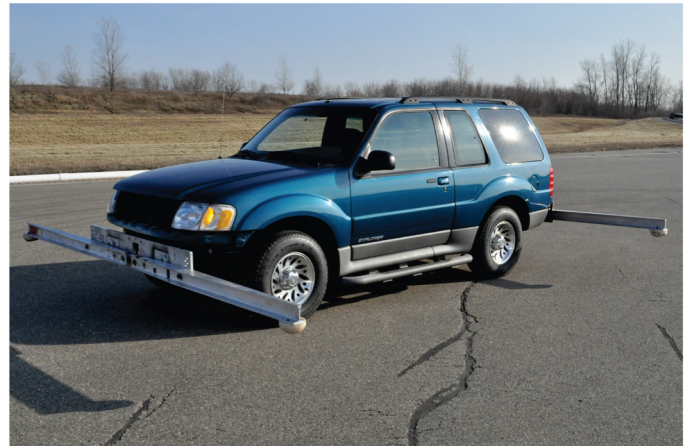
**Figure 10. 2001 4×2 Sport Utility Vehicle**

As part of this study, additional testing was conducted with a 2000 compact 4×4 sport utility vehicle and a 2001 compact 4×2 sport utility vehicle (Figure 9 and Figure 10, respectively). In these tests automated steering controllers were used (see Figures 11 and 12) to input a slowly increasing steer of constant steer rate to the left after the right rear tire was completely deflated. Speed was kept as constant as possible at around 100 kilometers per hour. The steering input rate was maintained constant until the tire eventually debanded from the rim. For comparison purposes the vehicle responses were compared to the same vehicles and steering inputs with four good tires and with delaminated tires at the right rear positions. As documented in previous studies, there were noticeable differences in understeer and lateral acceleration capability between the runs with four good tires and those with a delaminated tire on the right rear.

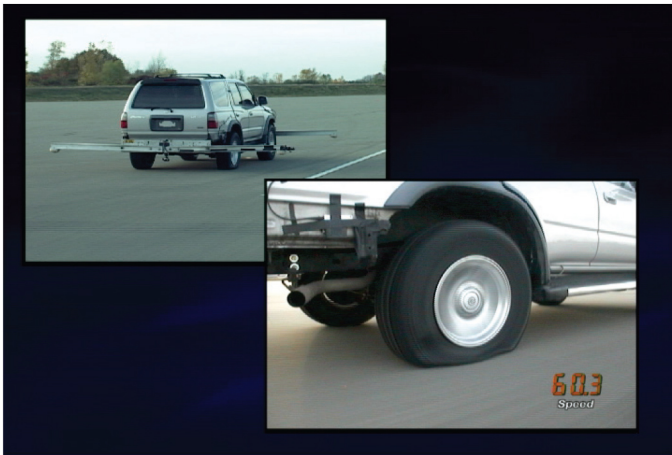
**Figure 13. 2000 Compact SUV w/ Deflated Right Rear Tire**

Figures 13 and 14 are examples of the deflated right rear tires before the steering input was applied for both test vehicles. Note that neither rim is in contact with the asphalt immediately after the air out event. The rubber stiffness and centrifugal force of the tires rotating at highway speeds provides this gap between the rim and the asphalt as long as the tires' structures remain intact.

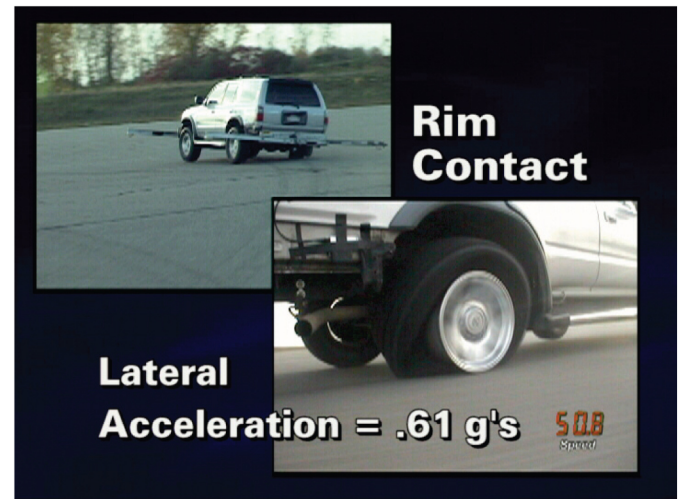
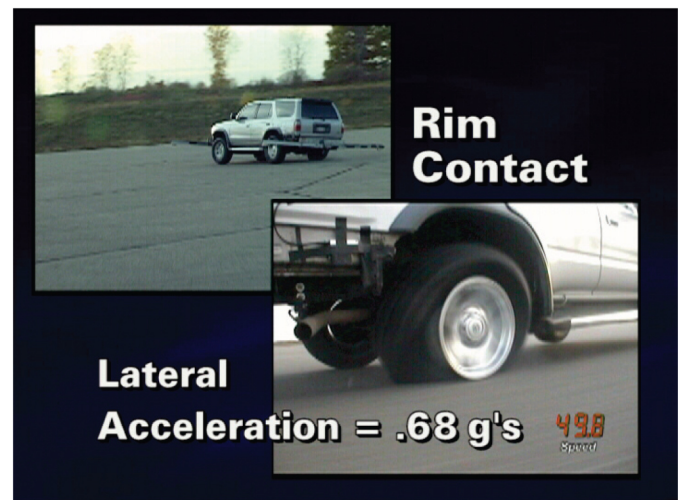
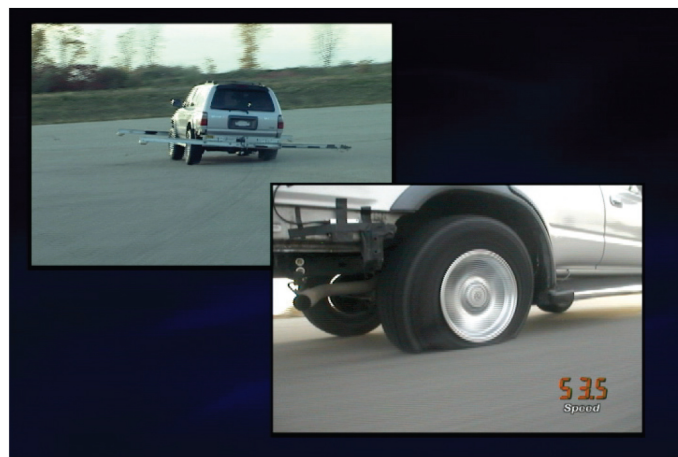
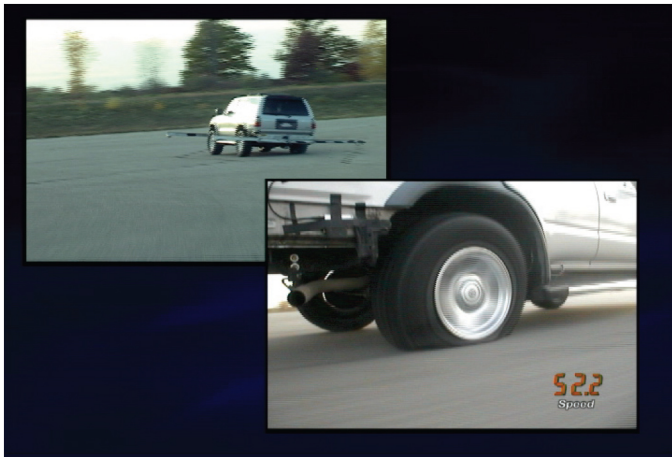
The lateral acceleration at which the tire pulls free from the rim flange was also able to be quantified using the video documentation of the slowly increasing steer tests. The outboard video camera on the outrigger which recorded the right rear tire was synchronized with the test data file in order to analyze what the lateral acceleration was exactly when the tire debeaded and the rim contacted the ground. In the runs with the 2000 4×4 SUV, the tire stayed firmly seated on the rim until a lateral acceleration of 0.61 g's for one run and 0.68 g's for the other. See Figures 17 and 18 for the video stopped just as the rim flange contacted the asphalt. As evident in Figures 19 and 20, screen shots approximately 2/3 of a second prior to rim contact, the video also documented that the rim did not contact the asphalt until just after the tire debeaded. This means even at a significant lateral acceleration the tire remained seated on the rim. At this point, the vehicle in both tests spun out.

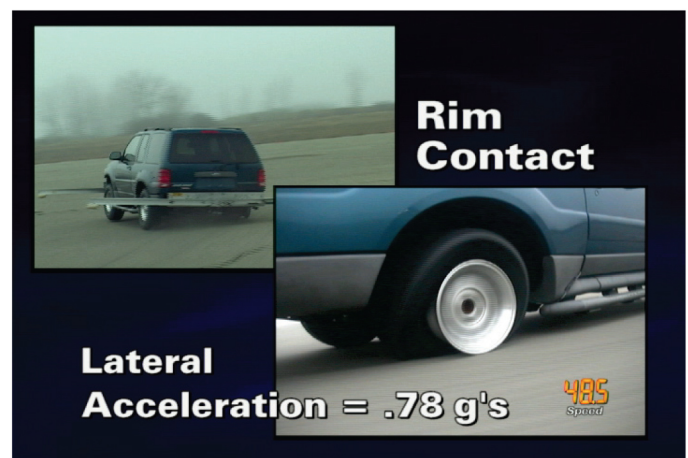
Figure 23. Run 1 Showing Rim Contact During Test

The lateral acceleration at which the tire pulls free from the rim flange was also quantified using the video documentation of the slowly increasing steer tests. As in the case of the 4×4 SUV, the outboard video camera on the outrigger which recorded the right rear tire was synchronized with the test data file in order to analyze what the lateral acceleration was exactly when the tire debeaded and the rim contacted the ground. In these runs, the tire stayed firmly seated on the rim until a lateral acceleration of 0.78 g's for one run and 0.66 g's for the other. See Figures 23 and 24 for the video stopped just as the rim flange contacted the asphalt. As evident in Figures 25 and 26, screen shots approximately 2/3 of a second prior to rim contact, the video also documented that the rim did not contact the asphalt until just after the tire debeaded. At this point, the vehicle in both tests spun out.
