# The Front Center Airbag

Scott D. Thomas  
General Motors Company

Richard A. Wiik  
Takata

**CITATION:** Thomas, S., Wiik, R. and Brown, J., "The Front Center Airbag," *SAE Int. J. Trans. Safety* 1(2):2013, doi: 10.4271/2013-01-1156.

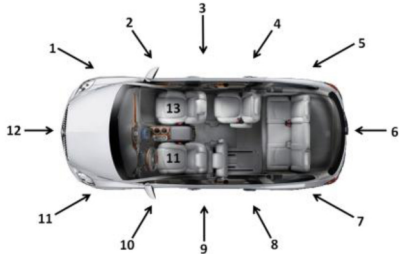
**Figure 1. Clock Directions for Impact2 and DOF1 with Seating Positions**

Some assumptions that were made for this study were: a) The principal impact point attribute (impact2) was chosen to define the impact type for each case. b) Vehicle body types for passenger cars, SUVs, vans, pickups or other light vehicles were included. c) Referring to [Figure 1](#), Far Side Impacts were defined using impact2 having clock directions of 2, 3 or 4 with a seat position of 11 or plus impact2 of 8, 9 or 10 with a seat position of 13. d) Near Side Impacts were defined using impact2 having clock directions of 8, 9 or 10 with a seat position of 11 plus impact2 of 2, 3 or 4 with a seat position of 13. e) Front Impacts were defined by impact2 of 11, 12 or 1. f) Rear Impacts were defined by impact2 of 5, 6 or 7. g) A category of Other/Unknown Impact included all other non-rollover impact types as well as those with unknown impact2.

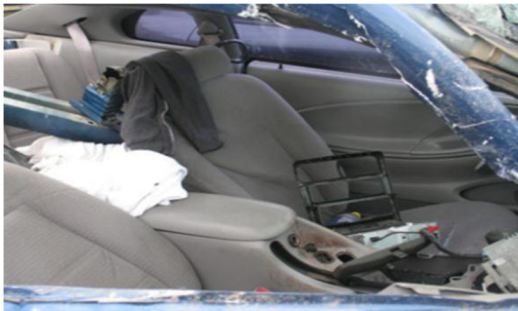
**Figure 7. Example of Torso to Center Console Contact in a Far Side Belted Single Occupant Impact, NASS-CDS Case - Rigid Console**

In the cases where apparent discrepancies were noted, the injury sources were modified to reflect what was thought to have happened. For example, in 29 of the cases that the GM team coded as involving center console related injuries, the NASS-CDS coding is shown as the transmission lever even though the text in most of these cases indicates the center console as the injury source. Those cases with observed center console loading and no observed transmission lever contact in the pictures were changed to the center console category. Figures 7 and 8 illustrate two such cases.

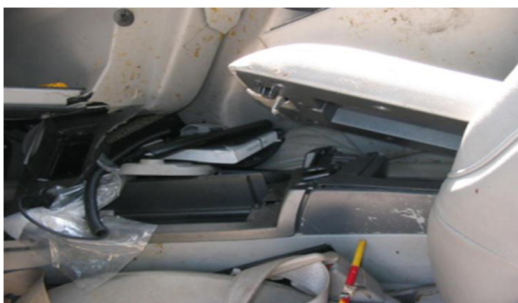
**Figure 8. Example of Torso to Center Console Contact in a Far Side Belted Single Occupant Impact, NASS-CDS Case - Deformed Console (Forward in Vehicle is to the Left)**

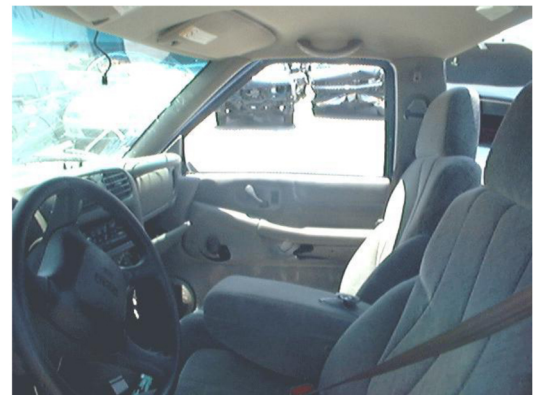
**Figure 9. Driver Orbital Fracture NASS-CDS Case**

description that the coded source was accurate. In many of these, the confidence level listed in the case for the injury source coding was less than "certain." A small number of cases also had the injury source changed based on the GM team analysis. For instance in one passenger side impact case, the driver had a right orbit facial fracture that had the steering wheel cited in NASS-CDS as the probable injury source. In this case, the adjacent passenger occupant had an upper injury attributed to the driver occupant and it appeared that the occupants were laterally aligned in the vehicle. The GM team changed the driver orbit fracture injury source to the passenger occupant since it was thought that this was more probable. Figure 9 shows a picture of the vehicle interior.
