# Passenger Car Response to Interaction with Tractor-Trailer Steer Tire Lugs

Joseph Cormier, Mark "Tony" Freund, Enrique Bonugli, and Herbert Guzman  
Biodynamic Research Corp.

**CITATION:** Cormier, J., Freund, M., Bonugli, E., and Guzman, H., "Passenger Car Response to Interaction with Tractor-Trailer Steer Tire Lugs," *SAE Int. J. Commer. Veh.* 7(1):2014, doi:10.4271/2014-01-0475.

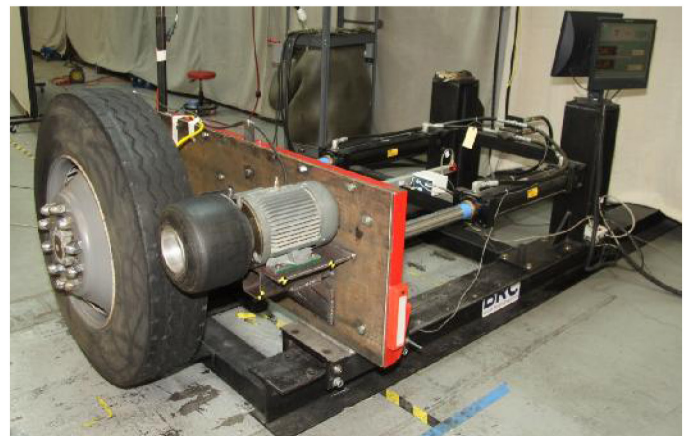
Figure 1. Apparatus used to move spinning tractor tire into passenger vehicles.

The quasi-static testing was performed by exposing the left side of each vehicle to the lugs of a spinning tractor-trailer steer tire. An apparatus was constructed that would allow the tire to spin at a rate equivalent to a speed of 55 mph while being forced against the vehicle (Figure 1). The tractor tire had an overall diameter of 43 inches and was mounted 1.5 inches above the ground. The wheel lugs had an outer diameter of 12 inches. The tractor tire was accelerated up to speed using a 3-phase electric motor which drove a smaller tire that had an interference fit with the tractor tire. The steer tire was mounted to a movable platform controlled by hydraulic cylinders which were mounted in-line with the line of action of the steer tire against the vehicle. Each cylinder was equipped with a load cell (1210AO, Interface, Scottsdale, AZ) that measured the applied load. A displacement transducer (E-Series, MTS, Cary, NC) was attached to the platform to record the motion of the wheel toward the vehicle. The motion of the vehicle was measured using video (Phantom 7.3, Vision Research, Wayne, NJ) as well as a string potentiometer (PT101, Celesco, Chatsworth, CA) mounted to the opposite side of the vehicle and the location of the tire contact. The data from the video and string potentiometer were used to calculate the actual deformation sustained by the vehicle during each test. The locations of the tests were chosen to assess the relative stiffness of the stronger structural components (hinge pillars) and the more cosmetic (door shell, fender) components of the passenger vehicles.

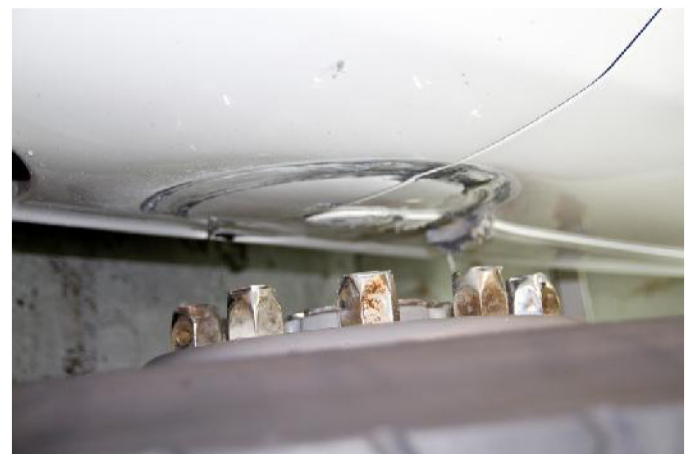
Figure 3. Post-test 4 demonstrating flattening of lug nut cover and corresponding damage to A-hinge pillar.

A total of 20 quasi-static tests were performed on the three vehicles ([Appendix A](#)). Overall, peak forces ranged from 465 to 2,620 lbs and varied with test location. Several repeat tests were performed on the same location on the Crown Victoria to provide a range of force-displacement curves at a range of deflection values. A series of repeated tests were initially performed at the A-hinge pillar of the Crown Victoria (Tests 1-6). These tests produced peak deflections of 0.6 to 3.6 inches. Since these tests were performed at the same location, the force-deflection data were merged by plotting subsequent tests such that the force at the maximum deflection value of the previous test equaled that of the subsequent test ([Figure 2](#)). The first four of these tests were performed using lug-nut covers with a rounded tip. These tests produced little permanent crush to the vehicle, but did result in a flattening of the lug nut covers ([Figure 3](#)). After exposure to a force of 1,520 lbs (Test 4), the lugs wore through the thin covers and were no longer used. The remaining tests were performed without lug nut covers.

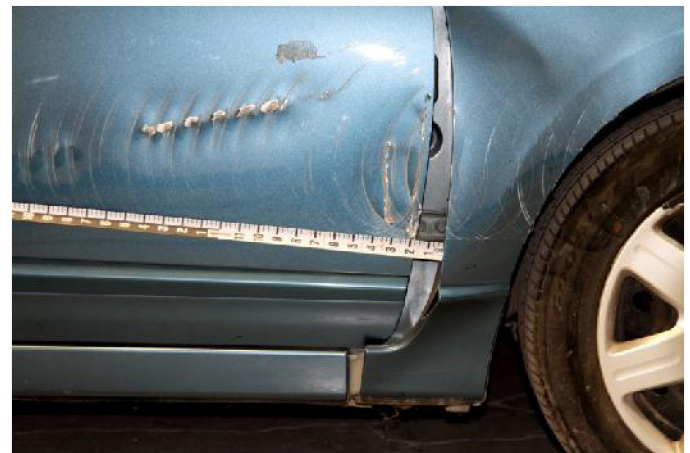
Figure 7. Post-test photograph of Honda Civic after dynamic Test 5.

A total of 8 dynamic tests were performed on the right side of each vehicle which is opposite to the side exposed to the quasi-static testing described above (Appendix B). All tests were performed at a shallow angle of approach ranging from 0.5 to 2 degrees. This angle was achieved by manually steering the vehicle toward the tractor tire to produce contact at the desired location. The approach speed was achieved by manually pushing the vehicle at speeds of 4 to 6 mph. All tests were performed with the vehicle initially moving rearward toward the tire. One test resulted in a velocity change such that the vehicle changed direction. This occurred in the first dynamic test (Test 1) and was caused by the rear wheel well snagging on the steer tire lugs. This test produced a peak acceleration of 1 g which was the highest longitudinal acceleration measured for all dynamic tests. During the dynamic tests, the steer tire lugs produced the characteristic cycloidal markings demonstrated by the previous studies on steer tire interaction (Figure 7). The acceleration data demonstrated low level variation with local short duration peaks (Figure 8).
