# Full-scale Fire Tests of Electric Drive Vehicle Batteries

Andrew Blum and Richard Thomas Long  
Exponent Inc.

**CITATION:** Blum, A. and Long, R., "Full-scale Fire Tests of Electric Drive Vehicle Batteries," *SAE Int. J. Passeng. Cars - Mech. Syst.* 8(2):2015, doi:10.4271/2015-01-1383.

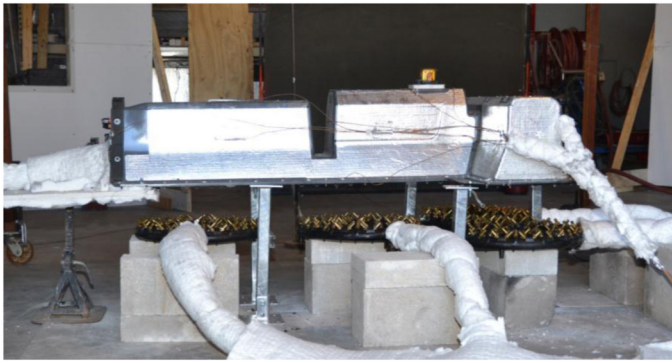
Due to the limited number of EDV batteries provided, only one battery was subjected to HRR testing. Battery B was centered under a 20-foot by 20-foot hood supported by five stainless steel legs. The leg supports held the battery in place, 20 inches above the ground to provide a viewing angle to the bottom of the battery during testing. Four propane fueled burners were placed six inches underneath the battery and provided an approximately 400 kW exposure fire to the bottom of the battery for 20 minutes (see Figure 1).

Figure 1. Battery B configuration and burner locations for HRR testing.

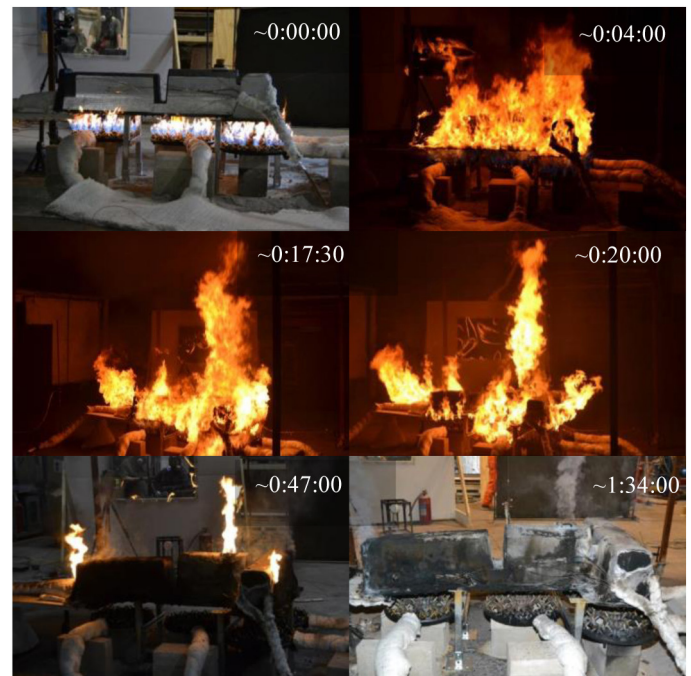
Figure 4. HRR test images: initial burner startup (top left); initial peak HRR (~550 kW) around 4:00 (top right); peak HRR (~700 kW) around 17:30 (center left); burners off around 20:00 (center right); small flames from battery vents around 47:00 (bottom left); and visible flames extinguished around 1:34:00 (bottom right).

The maximum HRR measured during testing was approximately 700 kW, at test time 17 minutes and 30 seconds (about 3 minutes prior to the burners being turned OFF). Removing the 400 kW propane burners, the peak heat release the battery attributed to the fire was approximately 300 kW. Once the burners were turned off, around the 20 minute mark, the HRR plateaued as the battery underwent self-sustaining combustion and then slowly decayed (see Figure 3). As seen in the HRR data and shown in Figure 4, after the 36 minute mark, flaming had subsided significantly on the battery to a point where the HRR was essentially zero. Small, localized flames on the battery continued for approximately another hour, at which time all visible flaming ceased. Thermal images were recorded as the battery
